# EXPERIMENTAL STUDY ON RIBBED BRIDGE DECK PANELS INCORPORATING HIGH-PERFORMANCE CONCRETE AND PRESTRESSING

**ABSTRACT:** This study evaluates the structural performance of a novel precast ribbed bridge deck slab system constructed with high-performance concrete (HPC) and incorporating prestressing. Designed as a cost-effective alternative to ultra-high-performance concrete (UHPC) ribbed slabs, the proposed system employs prestressing strands placed near the neutral axis to enhance tensile capacity and overall structural integrity. A full-scale transverse rib specimen was fabricated and tested under increasing loads, supported by code-based analysis and numerical modeling. The results showed that while the slab initially exhibited flexural cracking, it ultimately failed in shear at an applied load of 100.1 kN. Prestressing was found to significantly improve crack resistance, and the connection between the HPC ribs and cast-in-place fiber-reinforced concrete shear pockets remained fully intact throughout the test. Comparisons with AASHTO design provisions confirmed the slab's flexural adequacy and identified shear as the critical failure mode. These findings highlight the critical i

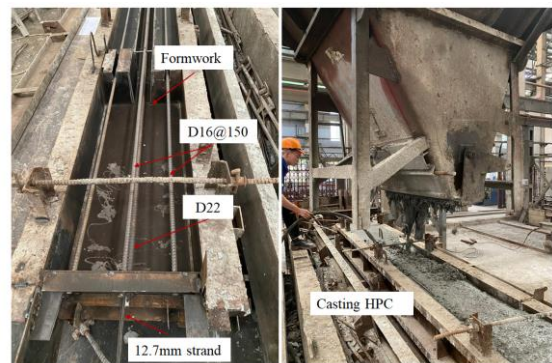
Fig. 5 Casting specimen with HPC

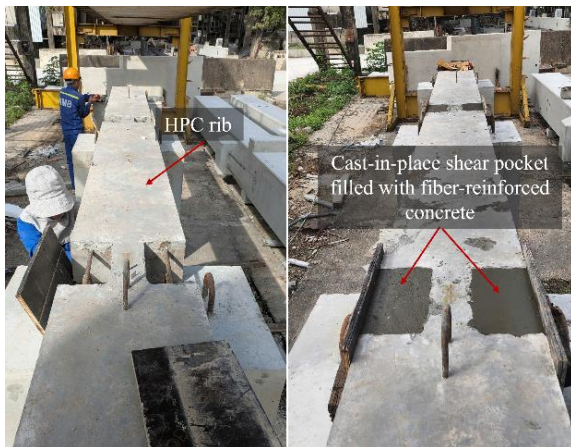
Fig. 7 Filling shear pockets with fiber-reinforced concrete

Once the HPC rib and concrete blocks reached sufficient strength (greater than 90% of their target values), they were transported to the testing site, and the cast-in-place shear pockets, reinforced with fibers, were filled, as shown in Fig. 7.

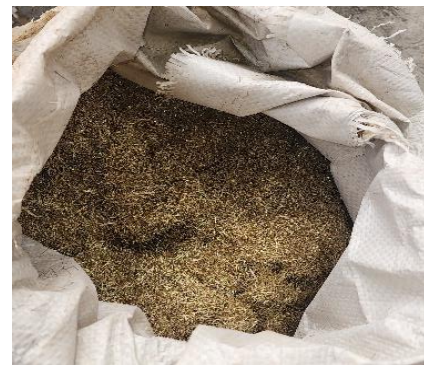
Fig. 8 Steel fibers used for shear pockets

For the shear pockets, a fiber-reinforced concrete mix was used, consisting of non-shrink grout, water, and high-strength steel fibers (13 mm in length, 0.2 mm in diameter, and with a tensile strength of 2750 MPa), as shown in Fig. 8. Steel fibers were added at a dosage of 2% by volume. Compressive strength tests on three samples of the fiber-reinforced concrete yielded an average strength of 50.8 MPa.

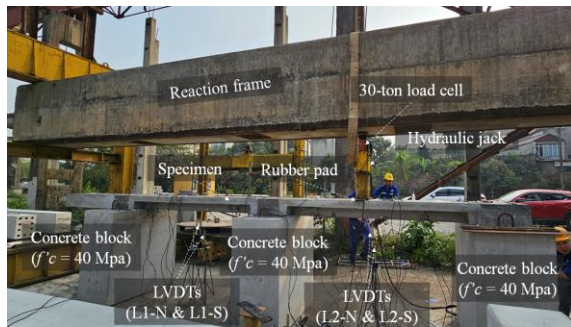
To monitor the deformation response of the specimen, Linear Variable Differential Transformers (LVDTs) were installed at two midspan locations, with two LVDTs placed at each location, as shown in Fig. 10. Additionally, 24 strain gauges were attached to the concrete surface at the two soffits and at mid-height of the rib (100 mm from the bottom soffit) to monitor strain development throughout the loading process (Fig. 11). Data from all sensors were recorded using a data logger and will be utilized for subsequent structural analysis.

Fig. 10 Load cell and LVDT placement

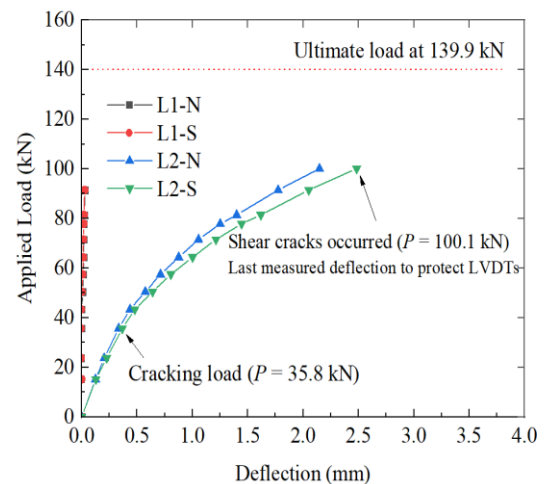
control. The load increment was carefully limited to less than 5 kN. Fig. 12 presents the load-displacement curves obtained from the test, while Table 2 summarizes the key test results. It should be noted that L2-N and L2-S refer to the two LVDTs placed directly beneath the applied load location, whereas L1-N and L1-S were positioned at the midpoint of the adjacent span.

As shown in Fig. 12, initial flexural cracking was observed at an applied load of 35.8 kN, marking the first significant deviation from linear behavior. These flexural cracks appeared in the bottom region of the HPC rib, indicating the initiation of tensile stress exceedance in the concrete. As the applied load increased, additional flexural cracks formed and propagated toward the top flange. At an applied load of 90 kN, the flexural cracks extended into the top flange region, with the measured crack width reaching 0.4 mm, suggesting significant flexural behavior and increasing crack severity (Fig. 13(a)).

Fig. 12 Load-displacement response

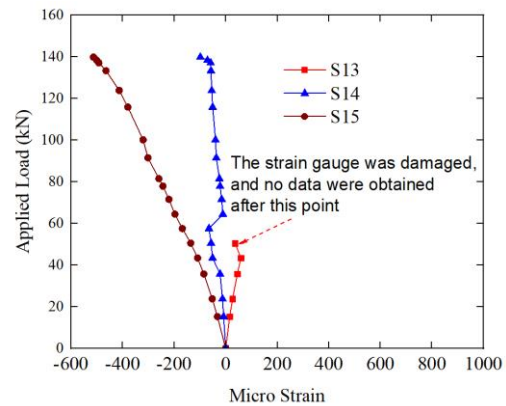
Fig. 16 Measured concrete strains – Section 5

Strain measurements obtained from gauges attached to the concrete are presented in Figs. 14 to 18. The data show that strains at Sections 1, 2, and 3 of Span 1, the unloaded span, as depicted in Fig. 9(a), were considerably lower than those recorded at Sections 5, 6, and 7 of Span 2, where the load was directly applied. Notably, at Sections 5 and 7, tensile strains were observed at the top soffit, while compressive strains developed at the bottom soffit. This strain distribution indicates the presence of negative bending moments near Supports 2 and 3. These observations suggest limited load transfer across the second support, implying that the shear pockets functioned more like fixed supports rather than pinned supports.

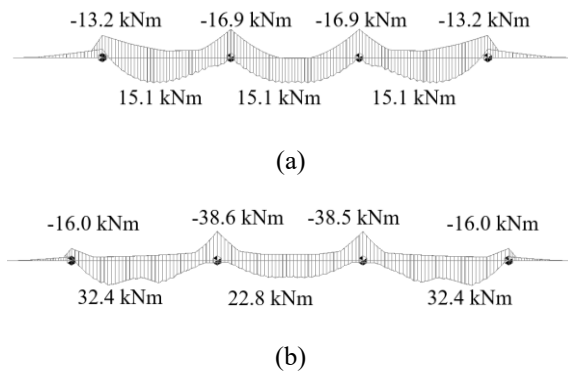
Fig. 22 Moment envelop diagram due to applied loads: (a) With girder spacing of 1.8 m; (b) With girder spacing of 2.8 m

Figs. 21 and 22 present the resulting shear and moment envelope diagrams from Midas Civil 2022, respectively, under Strength I Limit State. Two scenarios of girder spacing (1.8 m and 2.8 m) were analyzed to analyze the ultimate internal force on individual ribs. The values shown in the figures represent the factored internal forces acting on one rib, incorporating impact effect.

Fig. 22 presents the moment envelope diagrams along the ribbed slab under the combined effects of dead and live loads. For a girder spacing of 1.8 m, the maximum positive and negative bending moments are 15.1 kNm and 16.9 kNm, respectively. These values increase to 32.4 kNm (positive) and 38.6 kNm (negative) for a spacing of 2.8 m. Since the ribbed slabs did not exhibit flexural failure during testing, experimental moment capacities were not determined. Therefore, moment capacities calculated using the AASHTO 2017 provisions are used for comparison. The calculated flexural capacities exceed the moment demands induced by the combined dead load and HL-93 live load, indicating that flexural failure is not a critical concern for HPC ribbed slabs. Even with increased girder spacing, minor adjustments to the reinforcement, such as increasing the bar diameter or quantity, are sufficient to ensure that the section's moment capacity surpasses the design demand.
