NON-INVASIVE BASED INFRARED THERMOGRAPHY APPROACH FOR FIELD ASSESSMENT OF SURFACE EROSION IN TAILING DAMS

ABSTRACT: In recent years, non-destructive testing (NDT) has emerged as an efficient tool for evaluating the performance, quality, and integrity of existing structures. This study investigates novel non-destructive techniques, specifically Infrared Thermography (IRT), to detect surface erosion in real-life tailing dams. The tailing dams considered in the study are designed to store coal combustion byproducts in a slurry form, consisting of bottom ash and fly ash. IRT offers a quick and non-invasive monitoring technique to detect, identify, and describe potential anomalies in dykes impacting the integrity of these critical structures. This study captured the thermal images using a FLIR C5 thermal infrared camera during field reconnaissance of an existing starter dyke of a tailing dam located in Northern India. Analysis of these images is facilitated by different software, such as FLIR tools and ResearchIR, enabling the identification of localized temperature variations, which are indicative of potentially affected areas. This study demonstrates the efficiency of IRT in deliveri

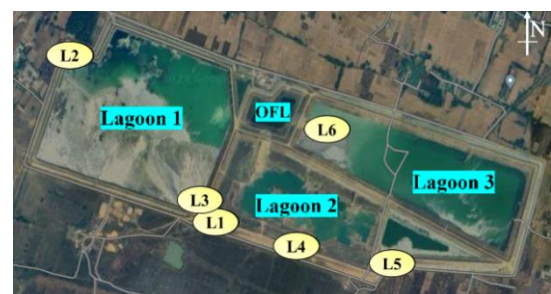
The Thermal Power Project is located in the Northern part of India. The site includes multiple lagoons: Lagoon-I (for high-concentration slurry deposit), Lagoon-II (a bottom ash lagoon), and Lagoon-III (another bottom ash lagoon). An overflow lagoon connects both Lagoon-II and Lagoon-III, while Lagoon-I is linked to a sedimentation tank (as shown in Fig.1).

Fig.1 Detailed location of six points chosen for the IRT survey

patterns and thermal color contrast in various scenarios. The results from this study can serve as a benchmark for future IRT-related field studies on dykes. Fig.1 shows the detailed location of six survey points, shown as L1, L2, L3, L4, L5, and L6, where surface cracks are predominantly present.

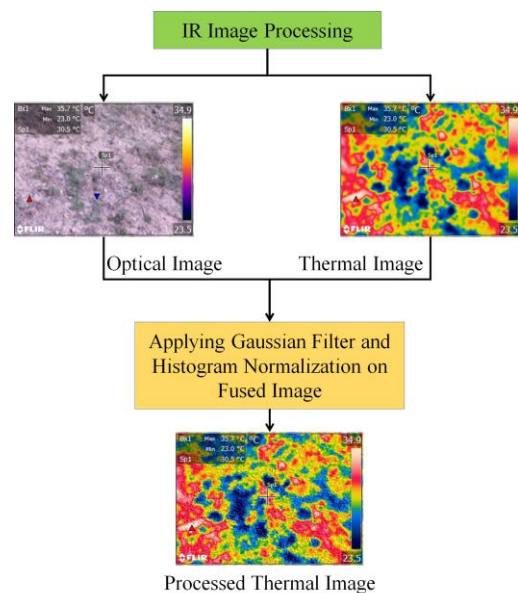
A critical aspect of IRT analysis involves extracting quantitative temperature data from raw thermal images. In this study, thermal images are enhanced using FLIR Tools and ResearchIR software. Fig. 2 shows the steps involved in thermal image processing. These programs extract unique features from both thermal and optical images, converting them into a fused image through the thermal multi-spectral dynamic imaging (MSX) function. This algorithmic fusion integrates visible spectrum information from the digital camera onto the infrared image, facilitating detailed target alignment.

Fig. 2 Steps involved in thermal image processing using FLIR tools

Further processing of the fused image involves applying a Gaussian smoothing filter to reduce background noise, which improves the resolution and makes finer changes more observable during analysis. The histogram of pixel intensities is distributed using histogram equalization, expanding the dynamic range and enhancing the thermal contrast of the image.

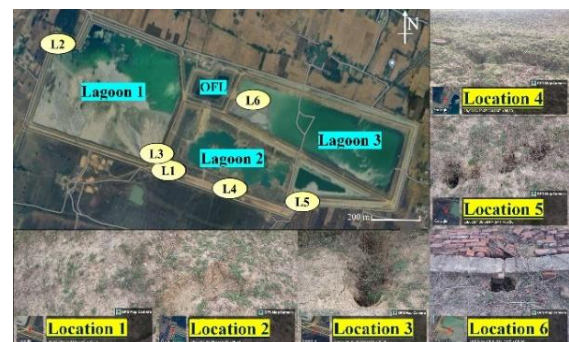
Accurate thermal images are obtained by providing appropriate input parameters in terms of atmospheric temperature, humidity, and emissivity. While atmospheric temperature and humidity can be measured on-site according to current climatic conditions, emissivity is a surface property with a specific value for different surface types. For soils, the emissivity value ranges from 0.90 to 0.95, whereas grass cover lies between 0.90 to 0.98 [20]. The images were captured on a hot, sunny day on the downstream side of the tailing dam between 10:00 a.m. and 11:30 a.m. Fig. 3 displays the optical images for the various spots selected for the survey. Location 1 (L1) is a plane surface without any rain cuts or undulations. Locations 2 (L2) and 4 (L4) exhibit differential settlement on the slope, with significant rain cuts of approximately 0.3 m deep. At Locations 3 and 5 (L3 and L5), a deep rain cut has formed, measuring about 0.5 meters in depth and width. Additionally, longitudinal microcracks have been observed, continuing from this rain cut. Location 6 (L6) shows damage to the brick lining observed on the kerb portion of the top width of the bund.

Fig. 3 Optical images for different survey locations on the ash dyke

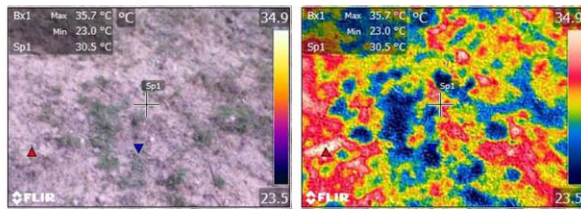
Location 1 @ 10:24 hrs. Temp difference: 12.7°C

The IR images are processed using the FLIR tool and ResearchIR software. Results are presented using rainbow color contrast with a scale showing the minimum and maximum temperature values, as shown in Fig. 4. In the morning, a temperature difference of approximately 12°C (@ Location 1) is observed on the ground with a generally flat profile. This temperature variation is due to the uneven

Fig. 4 Optical and corresponding IR Images captured from FLIR C5 thermal infrared camera for different locations during morning hrs. (defects are highlighted yellow in the optical image in the photos)

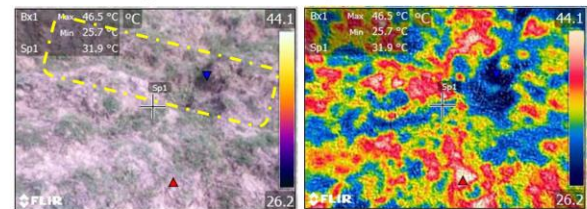
Location 4 @ 11:00 hrs. Temp difference: 21°C

heating and cooling rates of the ground surface, influenced by factors such as moisture content, presence or absence of grass turfing, etc. In areas of the ground with deep cuts and large fissures (for example, corresponding to Locations 2, 3, 4, 5, and 6), temperature fluctuations range from 15°C to 29°C.

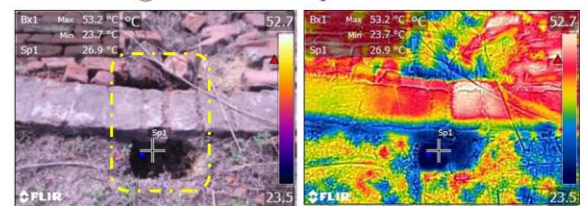
Location 6 @ 11:20 hrs. Temp difference: 29°C

These areas experience more significant temperature variations because of fractures and cuts, which can create microenvironments where heat is trapped more rapidly than in the surrounding flat areas. During the morning hours, temperatures in locations with deep cuts and significant defects are lower than those of the surrounding profile. Deeper soil, which often has higher moisture content and a more compact structure, tends to have a higher specific heat capacity [22], meaning it requires more heat to raise its temperature compared to the top surface. Additionally, these areas are slower to warm up due to reduced exposure to direct sunlight. As a result, a clear temperature gradient with lower temperatures for the deeper surfaces is observed during peak morning hours.

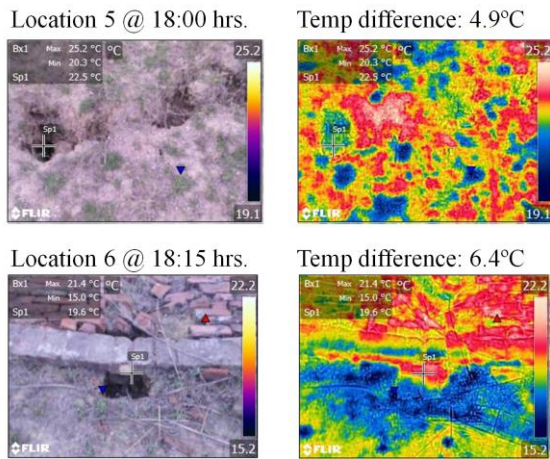
In the evening, when images are captured for the same locations (as shown in Fig. 5), the temperature gradient becomes more uniform, reducing to nearly 5°C. This is because the deeper soil, with a higher

specific heat capacity, can store more heat during the day but also loses heat more quickly once the external heat source (sunlight) is removed. The heat stored in the soil is lost to the cooler evening and night air through the surface. The soil emits infrared radiation throughout the night, decreasing its overall temperature. The hot spots on deeper surfaces for particular imaging frames remain more pronounced than the plane ground.

Fig. 5 Optical and corresponding IR Images captured from FLIR C5 thermal infrared camera for different locations during evening hrs.

The infrared camera detects temperature variations around the cracks due to the relative difference in specific heat capacity between the surface and deeper soil within the embankment, which disrupts natural heat transfer. This differential thermal behavior highlights the cracks and deep cuts. In the morning, when the embankment is cooler, the reduced heat flux towards the surface due to the presence of cracks results in a localized cooler zone, appearing blue in the IR image. This creates a higher temperature difference between the defect area and the surrounding profile. Conversely, in the evening, when the embankment has warmed up, the increased heat transfer through the crack creates a localized warmer zone, appearing as a hot spot in the IR image, leading to a lower temperature difference between the defect area and the surrounding profile.

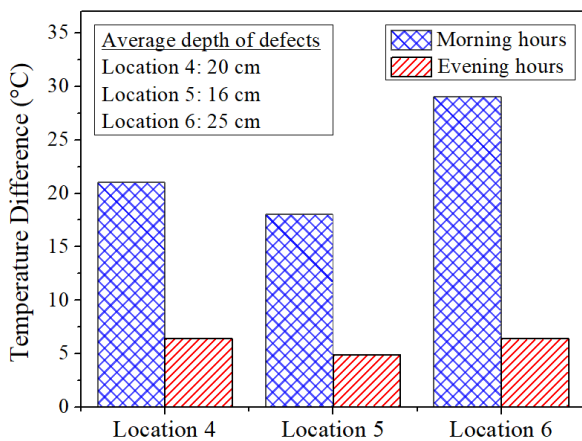
Figure 6 presents temperature differences ($T_{\max} - T_{\min}$) recorded at various locations with different defect depths using a thermal infrared camera, highlighting the thermal bridge effect (a phenomenon where deeper defects cause greater temperature variations due to disrupted heat flow). Depth values were obtained through direct on-site measurements using a calibrated scale, not inferred from thermal imagery. The IR images, captured at a resolution of 160×120 pixels, visually correlate to defect depth with temperature variation but do not serve as a depth estimation method. The images are captured from a 2-meter distance, covering approximately 3.14 m^2 ($2.04 \text{ m} \times 1.54 \text{ m}$) based on the field of view (FoV) of the camera (equal to 54° in horizontal and 42° in vertical), ensuring sufficient spatial resolution for defect analysis.

Fig. 6 Temperature variation at different locations

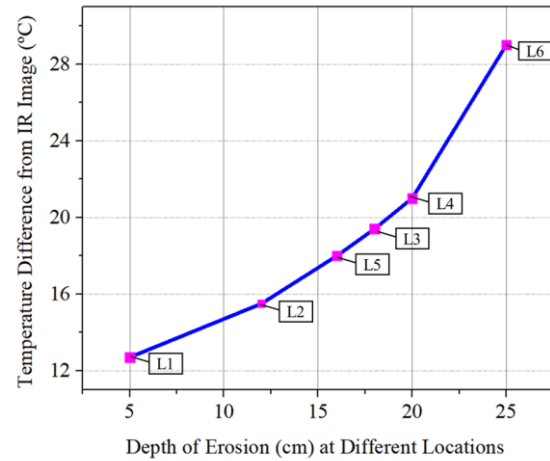
Fig. 7 depicts the relationship between the average depth of erosion and temperature difference derived from thermal infrared (IR) images captured during morning hours. The temperature difference ($T_{\max} - T_{\min}$) is obtained from the thermal color

contrast of IR images at different locations (L1–L6). The results demonstrate an increasing trend, signifying that deeper erosion sites exhibit higher temperature differentials due to the thermal bridge effect, indicating greater heat retention and dissipation variations.

Fig. 7 Correlation between temperature difference and depth corresponding to morning hours

The IR camera takes advantage of this contrast in thermal conductivity to visualize cracks, even those invisible to the naked eye. This allows for the proactive identification of potential weaknesses in the embankment before they escalate into critical issues. The size and depth of the crack influence the magnitude of the temperature variation, with larger cracks creating more pronounced anomalies. Additionally, stable ambient temperatures during inspections are preferred to minimize misinterpretations caused by rapid temperature fluctuations. In summary, IR cameras effectively detect cracks in earthen embankments by exploiting the differing thermal properties of soil and air, aiding in maintaining structural integrity.
