# EVALUATION OF RETAINING WALL COLLAPSE RISK UTILIZING VIBRATION CHARACTERISTICS

**ABSTRACT:** Since 1955, Japan has experienced a period of rapid economic growth, during which various social infrastructure facilities were constructed. Recently, however, the aging of these infrastructures has become a significant issue. Inspection and maintenance are essential for the upkeep of these infrastructure facilities. Currently, visual inspections are the mainstream method, making it challenging to quantitatively identify damage. In this study, vibration sensors were installed at the base and top sections of retaining walls, and vibrations from adjacent trains were utilized to evaluate the collapse risk of the retaining walls based on their vibration characteristics. The vibration characteristics were quantitatively assessed by calculating the primary natural frequency from the transfer function and observing temporal changes in the natural frequency to determine the degree of deterioration of the retaining walls. The analysis results showed no significant changes in the vibration characteristics of the retaining walls, indicating no collapse risk. By understanding the inherent vibration

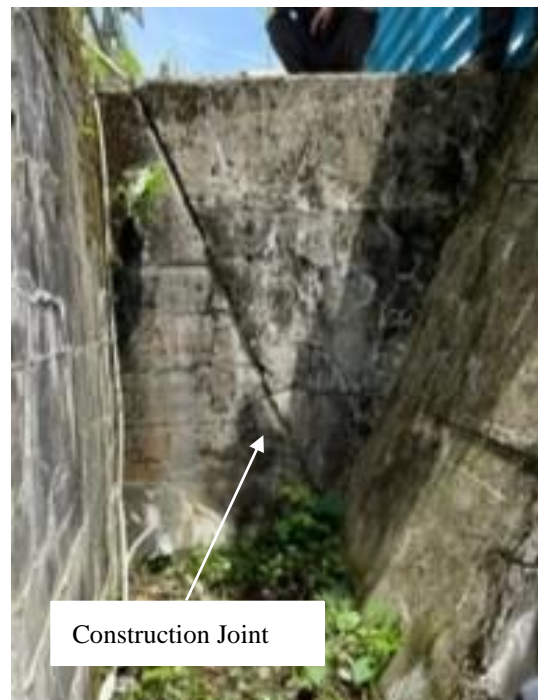
Fig. 2 shows the front view of the retaining wall, where a diagonal construction joint can be observed. Additionally, fine cracks were identified on the retaining wall closer to the observer.

Fig. 2 Target Retaining Wall

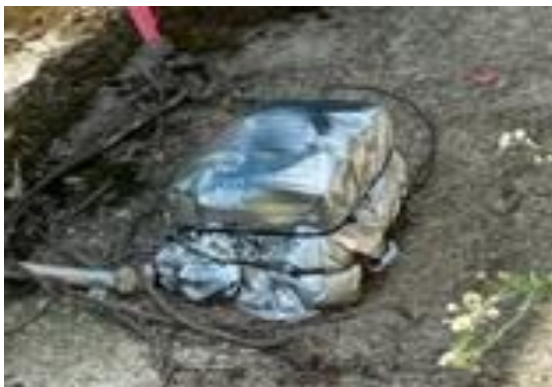
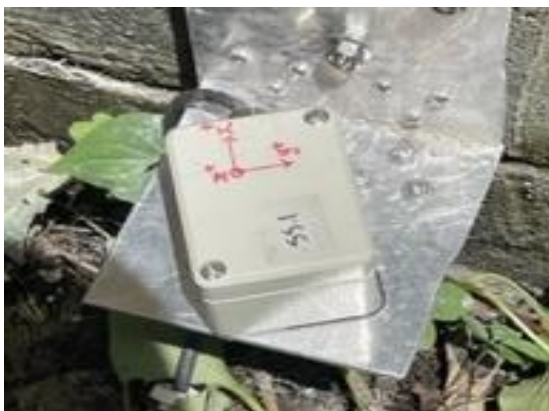
A) Top Installation

B) Bottom Installation

Fig. 3 MEMS Type Acceleration Vibration Sensor

In this study, we used train-induced vibrations to quantitatively measure the deterioration of a retaining wall by analyzing changes in its vibration characteristics, to assess the wall's health (stability). To conduct the measurements, we employed MEMS-type accelerometer sensors owned by Chuo Kaihatsu Corporation. The accelerometer sensors were installed at two locations: the lower side of the retaining wall (No.1) and the upper surface of the retaining wall (No.2), to measure acceleration

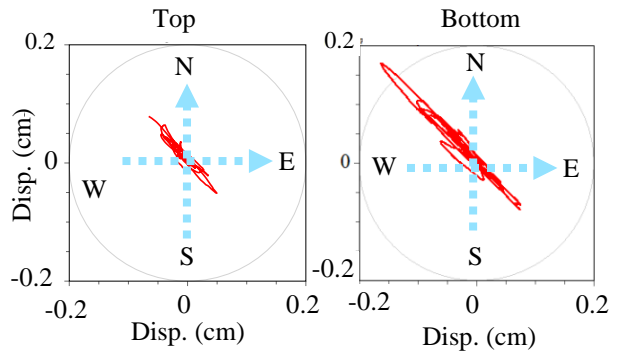
Fig. 7 Trajectory of Displacement (during train vibration)

The displacement waveform trajectories during vibrations were derived from the acceleration waveforms obtained by the sensors. Comparing the displacement waveforms from train-induced vibrations on May 1, 2022, and the Noto swarm earthquake on May 5, 2023, it was observed that the displacement at the base of the retaining wall was greater than at the top in both cases. Additionally, the displacement trajectories revealed that during both the train-induced vibrations and the Noto swarm earthquake, the retaining wall swayed primarily in the NW-SE direction.

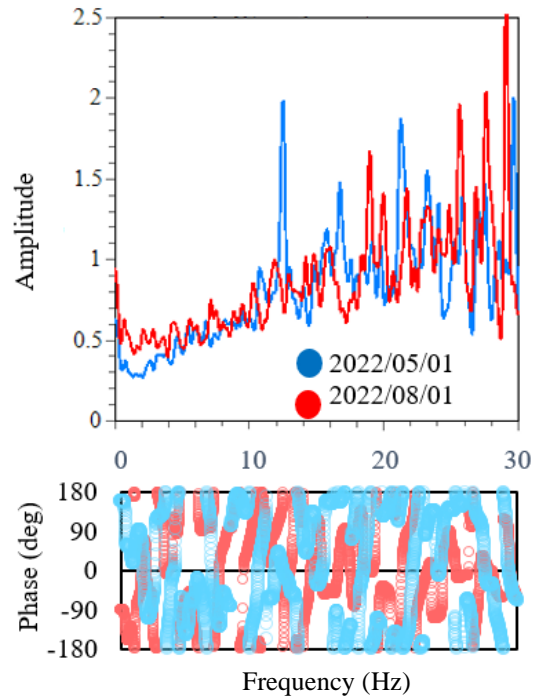
Fig. 9 Fourier amplitude spectrum ratio (upper graph) and Fourier phase spectrum ratio (lower graph)-NS direction

Fig. 9-11 shows the Fourier amplitude spectrum ratio (upper graph) and Fourier phase spectrum ratio (lower graph) of response amplification for the NS component (Fig. 9), EW component (Fig. 10), and UD component (Fig. 11) on May 1, 2022, and August 1, 2022. The Fourier amplitude spectrum represents the intensity of each frequency component in the frequency domain, while the Fourier phase spectrum shows the phase difference for each frequency component. From the Fourier amplitude spectra of the NS and EW components, prominent frequencies appear as multiple natural frequencies. The authors evaluated the first natural frequency of the retaining wall as 12 Hz at this point. The UD component, unlike the NS and EW components, exhibited a gentle, hump-shaped waveform around 22 Hz. The authors considered the 22 Hz peak in the UD component to represent its natural frequency. Although this paper presents data from May 1, 2022, and August 1, 2022, the data during the measurement period for the NS, EW, and UD components showed very similar results. Additionally, the significant fluctuations in the phase spectrum are believed to be caused by the complex vibrations from the train, which include various types of noise, leading to unstable resonant conditions and, consequently, the rapid variations in the phase spectrum.

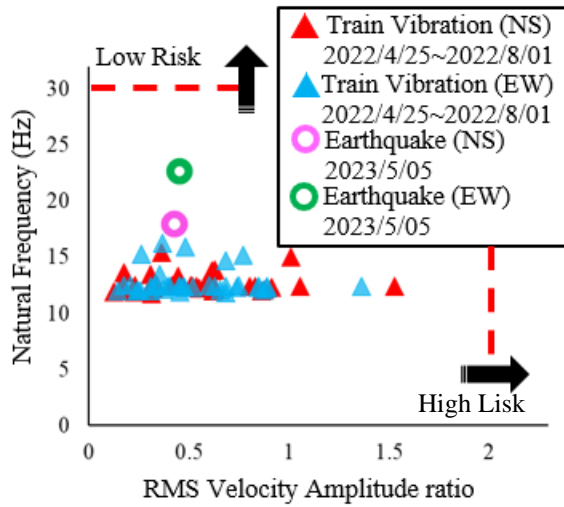
Fig. 15 Collapse Risk Assessment of Retaining Walls (NS direction)

Based on the three vibration characteristics obtained from the above, the risk of retaining wall collapse was assessed. Fig. 15 shows the relationship between the natural frequencies and RMS velocity amplitude ratios for the NS and EW directions. Additionally, the threshold was calculated based on the method by Ogata et al. and is indicated by the dashed line in the figure. There was no observed temporal decline in the natural frequencies of the retaining wall from April 25 to August 1, 2022, when the train vibrations were used as the excitation source. The natural frequency of the retaining wall remained approximately at 12 Hz. Therefore, it can be concluded that there was no risk of destabilization of the retaining wall during the measurement period of train vibrations. During 2023 Noto earthquake on May 5, 2023, the natural frequencies of the retaining wall increased to 18 Hz in the NS direction and 22 Hz in the EW direction. This increase in natural frequency is considered to be due to repair work conducted on the retaining wall after August 2022. However, even though the retaining wall was affected by seismic motion, it was confirmed from the natural frequency that the integrity of the retaining wall was not compromised. The RMS velocity amplitude ratio maintained values less than 1 in April, May, and June, but started showing values close to 1.5 from July. This indicates that the amplitude difference of the vibrations at the upper part of the retaining wall was 1.5 times that of the foundation. A potential cause for this increase could be a reduction in the resistance (friction) at the joint surfaces. Nevertheless, during 2023 Noto earthquake on May 5, 2023, the RMS velocity amplitude ratio was close to 0.5. Thus, it is concluded that the deterioration was not critical for the retaining wall, and its integrity was maintained. Fig. 16 shows the relationship between the damping constant and RMS velocity amplitude ratio for the NS and EW directions. The threshold considered dangerous for the damping constant was set at 0.2 or lower, but the results were significantly below this value. Over the measurement period, it was observed that the damping constant converged to approximately 0.02 to 0.04. According to the Architectural Institute of Japan's "Guidelines for Building Loads and Commentary," the damping constant for concrete structures is considered to be 0.02 to 0.04, similar to the values observed for the retaining wall in this study. From this, it can be concluded that the risk of collapse of the retaining wall due to normal train vibrations and seismic motion from 2023 Noto earthquake is low. During the Noto Peninsula earthquake on January 1, 2024, larger vibrations were observed than those presented
