# ANALYTICAL STUDY ON THE SEISMIC BEHAVIOR OF NON-STANDARD REINFORCED MASONRY HOUSES RETROFITTED WITH CROSSED FERROCEMENT LAYERS

*Keywords: Earthquake, Reinforced Masonry, Retrofitting, Ferrocement Layer, Tensile Stress*

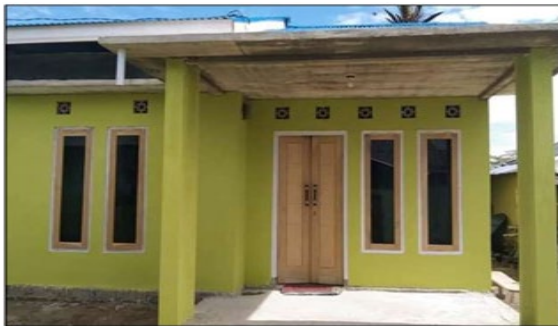
Fig.2 A simple RM house

In general, RM houses are built using reinforce/iron on concrete column and beam elements, as shown in Fig. 2. The building of this house is usually strong against earthquake loads, but if the construction of the RM house has structural elements such as beams and columns that are not in accordance with building standards, then it does not have strength against earthquake loads [4-6]. When an earthquake occurs, this house can suffer minor to severe damage, and it can even collapse suddenly.

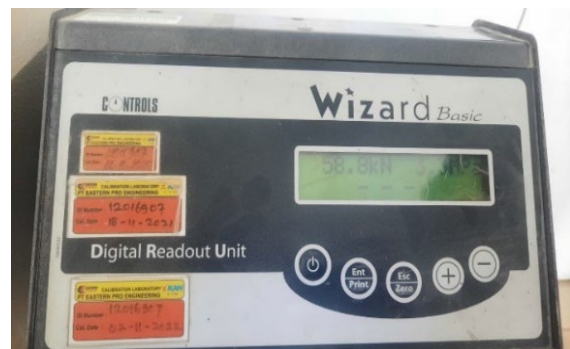
Fig. 7. Compressive strength value of hollow brick

The hollow brick has a compressive strength ( $f_c'$ ) of 3.3 MPa (Fig.7), a shear modulus of 3096 MPa, an elasticity modulus of 7431.35 MPa, and a specific gravity of 1600 kg/m<sup>3</sup>. Plastering has a compressive strength ( $f_c'$ ) of 9.9 MPa, shear modulus of 6161.75 MPa, elastic modulus 14788.2 MPa, and specific gravity of 1600 kg/m<sup>3</sup>. The woven wire has a yield strength ( $f_y$ ) of 275 MPa, the highest tensile strength ( $f_u$ ) of 620 MPa, a shear modulus of 187500 MPa, and a specific gravity of 8.0 g/cm<sup>3</sup>. The reinforced concrete has a comprehensive strength ( $f_c'$ ) of 15 MPa, and the reinforcement bar has a yield strength of 280 MPa, and the highest tensile strength ( $f_u$ ) of 420 MPa [12].

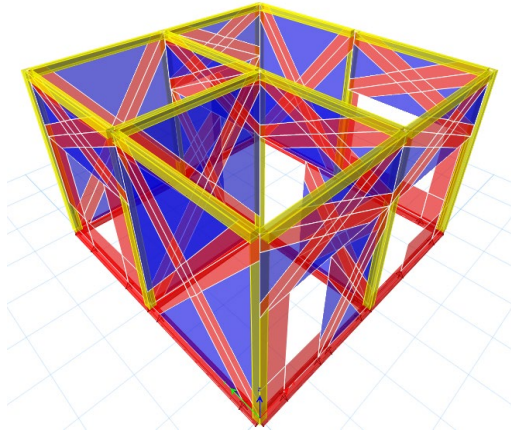
Fig.9 Modeling of the non-standard RM house retrofitted with a ferrocement layer with a crossed system.

Meanwhile, Fig.9 shows the modeling of the house with its retrofitting, where the red section is the area of the wall with retrofitting, and the blue section

is the area of the wall without retrofitting. The section properties of the retrofitted wall are shown in Fig.11, which is defined as a wall consisting of 5 (five) layers. The modeled column is a column that does not meet earthquake safety standards, both in terms of its cross-sectional width and depth, as well as its reinforcement configuration (Fig. 12).

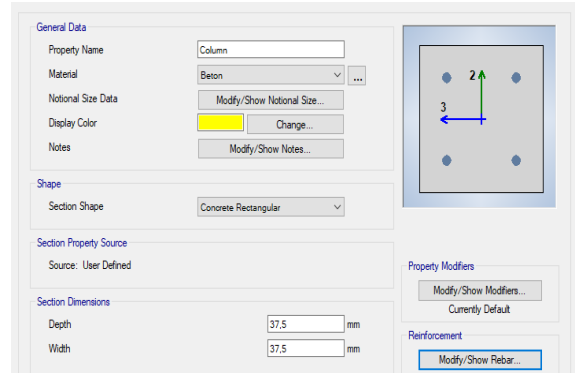
Fig.12 Section Properties of Column
