SIMULATION OF THE EFFECTIVENESS OF THE SCOURING PREVENTION STRUCTURE AT THE EXTERNAL RAIL BALLAST USING PHYSICAL MODEL

ABSTRACT: Rail ballast is a rockfill construction that serves to bind sleepers and rail which distributes trainload to ground. The function of rail ballast is vital to the quality and strength of the rail track, but are prone to overtopping. The relationship between overtopping high and scouring has been investigated, as well as the effect of the high external prevention structure against the length of scouring. This study focuses on the effectiveness of external prevention structure at downstream in its ability to dampen and reduce the length of scouring due to overtopping by the mean the physical model. This research simulates the scouring prevention structure at downstream of ballast with several variations of type (T) and structures distance (L) so that the most effective structure is obtained, i.e. the structure which can maximum reduce the length of scouring. From the research, the most effective structure is the Type T1 at L1 distance. The modeling was carried out at the Hydraulic Laboratory of Civil Engineering Diponegoro University, with the prototype of

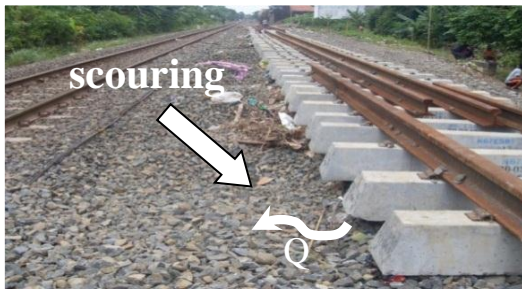
Fig.1. The scouring of rail ballast after flooding

At the end of 2013, there was a flood which caused overtopping at the Mangkang-Semarang rail track (Indonesia) and there was an indication of scouring at station KM.12 (Fig.1). If it keeps occurring then the ballast's capacity to support and to distribute incoming load will be reduced. Furthermore, the rail track failure could occur and it would endanger the passing trains. This is why the authors feel compelled to perform this research.

After the flooding occurred at the prototype location, there was a sign of scouring, however, there was no accurate data regarding the water level of the overtopping occurred in Fig. 1.

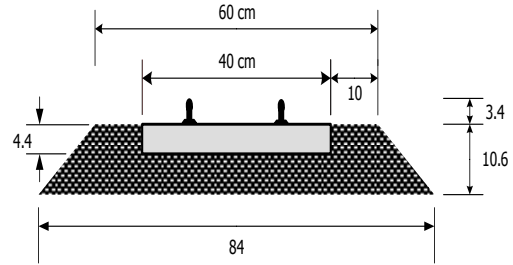
Fig.2. The section of the ballast model

Fig. 2 depicts the section of the rail ballast with its dimension. Fig.4 depicts the location of the

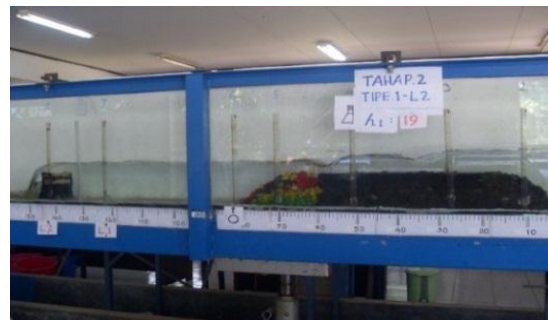
Fig.3. The flume and the ballast model

The flume was equipped with the regulating valve and the spillway to release the excess water. The water from the tank will be pumped and circulated back to the model again. The stilling basin was set at the upstream of the flume so that the downstream flow became steady. The setup of the flume and the rail ballast are illustrated in Fig.3. Various sorts of prevention structure were tested i.e. T, T1, and T2 type as in Fig. 5.

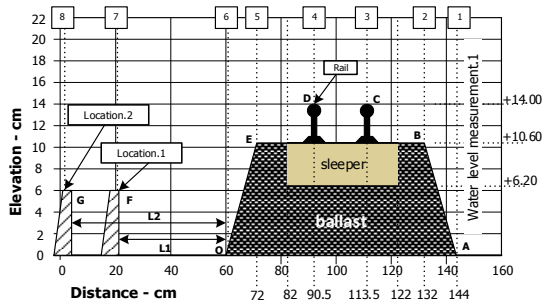
Fig.4. Eight locations of the water level measurement points and the location of the prevention structure.

structure, but the former was higher by 2 cm while the T2 was higher by 4 cm. The overview of the protection structure is illustrated in Fig 5. The position of the prevention structure at L_1 (F) is 40 cm at the downstream of the ballast toe O, while L_2 (G) is 60 cm (Fig. 4).

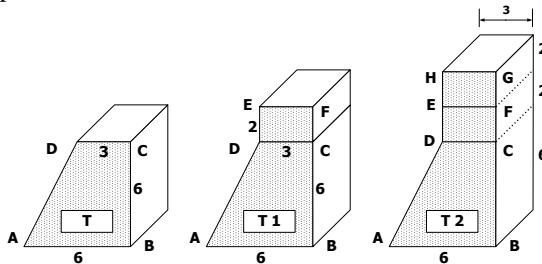
Fig.5. The T, T1, and T2 type of external prevention structures (in centimeter)

The field measurement comprised topographical survey, real elevation, the dimension of the rail ballast components, and the sampling of the rail ballast stones' dimension. The real dimension of the ballast stones ranged between 2-6 cm hence the stones used for the model ranged between 0.2-1.2 cm. The T1 structure is like the T

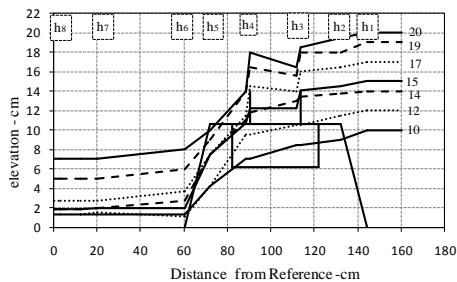
Fig.6. The profiles of various water levels simulated without prevention structure ($h_1 = 10-20$ cm)

The simulation with various water levels $h_1 = 10, 12, 14, 15, 17, 19,$ and 20 cm produced the resulting water level h_1-h_8 as displayed in Table 2. The illustration of the water profile and the scouring profile are presented in Fig.6 and Fig. 7.

In the experiment without prevention structure (Fig.6), it was apparent that the stones were scoured due to the resultant of the horizontal hydraulic force which passed through the ballast and hydraulic force cause of overtopping. Moreover, the mainstream-ward force was greater than the stones' weight and friction. After the scouring, the stones would be carried away to downstream. The scouring length varied proportionally to the water height h₁ (Fig.7).

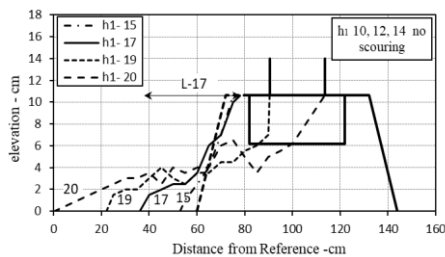
Fig.7. The scouring profile resulting from the modeling without protection structure

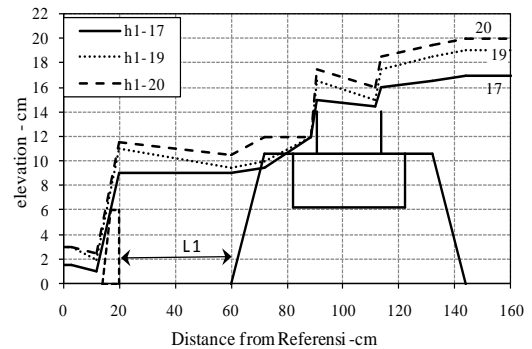
Fig.8. The water level profile variation of the T structure modeling at L_1

The water level profile for one condition as Fig.8, the others are not drawn cause of page limitation. The scouring profiles are displayed in Fig. 9 until 11. The simulation with $h_1 < 17$ cm was not conducted as scouring did not happen.

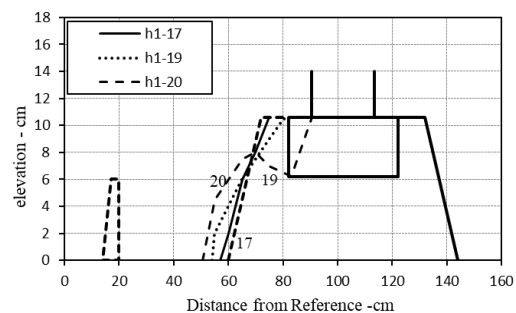
Fig.9. The scouring profile of the T structure modeling at L_1

The external structure of the ballast's downstream was proven to shorten the scouring length (Fig. 9, 10, 11, 13, 14, and 15). The overtopping height varied and was correlated to the structure type and to its position (Table 5). The values of the scouring length and the damping effectiveness (the percentage of scouring length

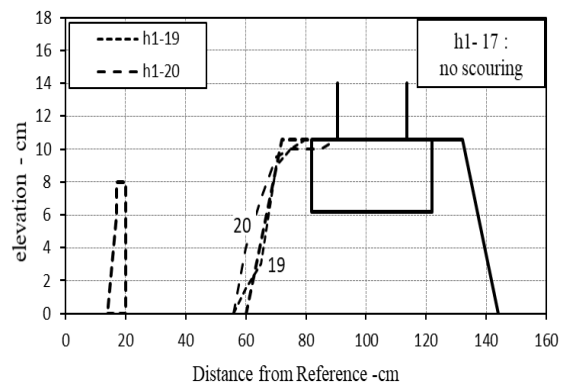
Fig.10. The scouring profile of the T1 structure modeling at L₁

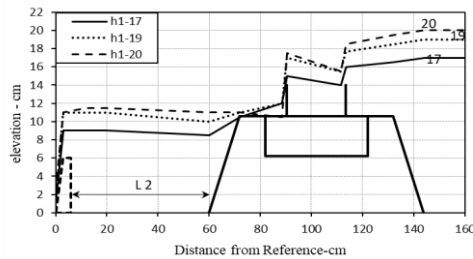
Fig.12. The water level variation of the T structure modeling at L₂

The water level profile for one condition as Fig. 12, the others are not drawn cause of page limitation. The scouring profiles are displayed in Fig. 13-15. Resume of overtopping height and scouring length are displayed in Table 5 and Table 6.

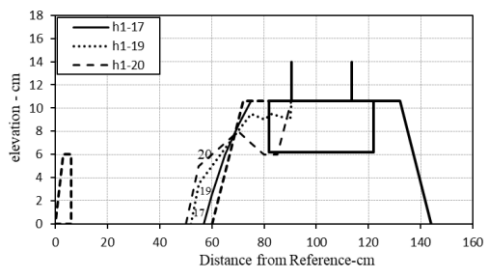
Fig.13. The scouring profile of the T structure modeling at L₂

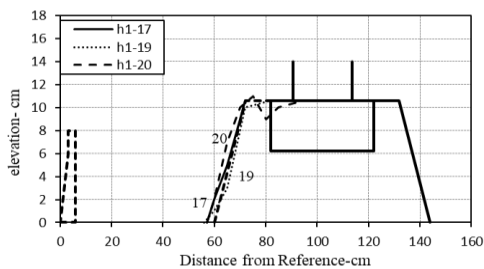
Fig.14. The scouring profile of the T1 structure modeling at L₂

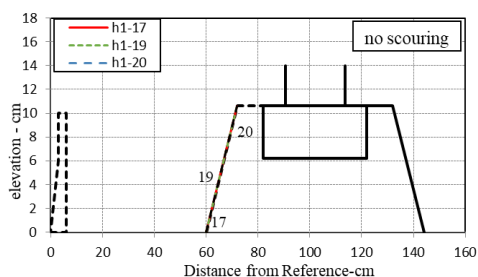
Fig.15. The scouring profile of the T2 structure modeling at L₂

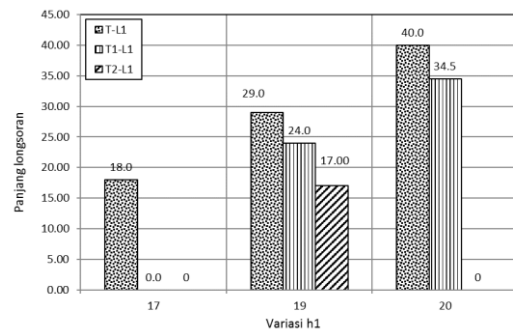
Fig.16. The scouring length structure at L1

From the table above, it suggests that the higher structures are more effective in shortening the scouring length given that they stand at the same location (Fig.16 and Fig.17). By comparing the average effectiveness of the scouring length's damping, the protection structure at L1 (with the similar type) is more effective than the structure at L2. The structure at L1 resulted in the shorter scouring length and the larger percentage of the scouring length's reduction. There was also a scouring case when the T2 structure positioned at L1 (Fig.11) while the precisely similar structure at L2 produced no scouring at all. However, from the data and the scouring profile, the scouring was not significant occurred. It was possibly due to the imperfect assembling of the ballast aggregates.

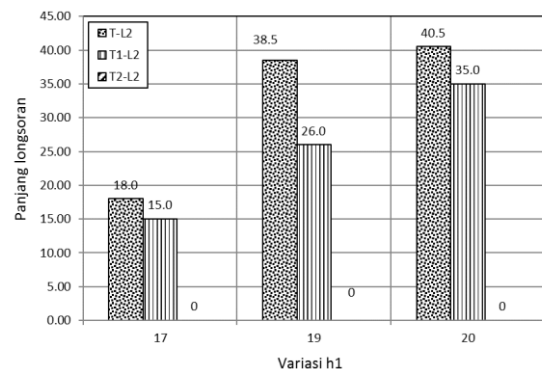
Fig.17. The scouring length structure at L2
