## IN-PLANE BEHAVIOR OF UNREINFORCED MASONRY (URM) WALLETTES WITH SELF-HEALING GEOPOLYMER MORTAR USING DIGITAL IMAGE CORRELATION (DIC)

\*Albert A. Griño Jr<sup>1</sup> and Jason Maximino C. Ongpeng<sup>2</sup>

<sup>1</sup>Civil Engineering Department, Adamson University, Philippines; <sup>2</sup>Civil Engineering Department, De La Salle University, Philippines

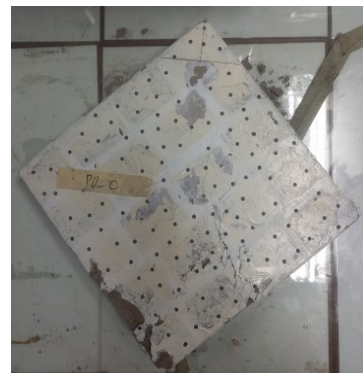
Fig.5 P0c wallet specimen showing the diagonal cracks after the test

P0 and P4 displayed a classic diagonal shear failure as shown in Figures 5 and 6, with cracks extending into the clay bricks, emphasizing the robust interlocking pattern. Additionally, tensile brick failure was observed, indicating strong brick-mortar adhesion. Conversely, P3b experienced a combination of diagonal and sliding shear failure, as illustrated in Figure 6.

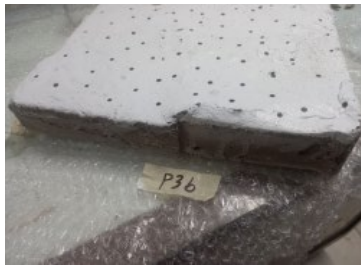
Fig.6 P3b wallet specimen showing the diagonal cracks and sliding shear failure of the material
