KINEMATIC ASSESSMENT OF SLOPES AT HANDLEBAR HILL OPEN CUT MINE, MT. ISA, QUEENSLAND, AUSTRALIA

Maged Al Mandalawi, Greg You, Kim Dowling and Peter Dahlhaus

Faculty of Science and Technology, Federation University Australia, Australia

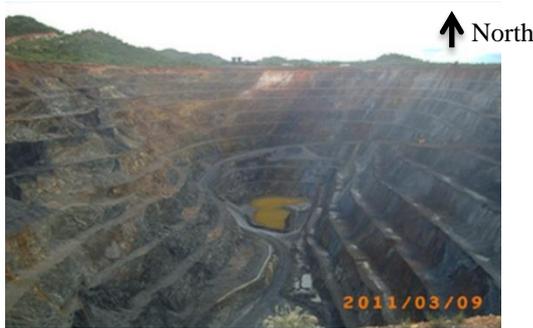
Fig.1 HHOC pit and view looking north, this study focuses on the western wall, located to the left of the image.

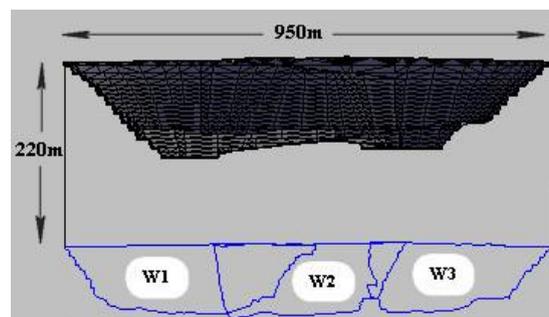
Fig.2 Outline of west wall (front view) shows total divisions applied to the west slope of the pit using AutoCAD. The slope is divided into three main elements to include the discontinuities of each element separately.

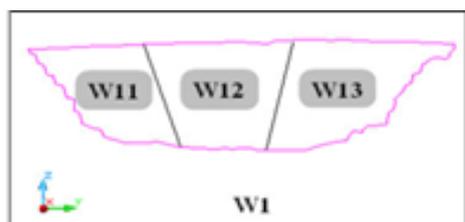
Fig.3 Subdivision outline of W1 slope of the pit into three vertical slices to study each slice (wall) with its own discontinuities.

From the kinematic analysis of W11, a potential wedge sliding failure mode was defined through the intersection of two rock planes and the plane friction cone. The slope angle was 45° , which presents the steep portion of the west slope. The internal friction angle for discontinuities was assumed to be close to the residual value of the heterogeneous rock mass, and was estimated to be 25° . Rocscience (2014) described the key elements of the wedge kinematic analysis modeling as slope plane, intersection plotting and plane friction cone, and the friction angle is measured from the perimeter of stereonet.

For the potential wedge failure, 65 pole vectors intersect within the friction circle (friction angle $<$ slope dip angle $<$ intersection dip angle) and will daylight from the slope face, resulting in a high probability of wedge failure. The primary critical pole vector zone for wedge sliding is the red crescent area located inside the plane friction circle and outside the slope face. A wedge may slide along the line of intersection of two planes or on one of the two planes when one plane has orientation for sliding more suitable than the line of intersection. So, the mode of wedge sliding is built on the study of intersections of rock planes on the slope. The dip angles of the two planes were considered to check if wedges will slide on a singular plane or two planes. Typical wedge failure along discontinuities intersection lines are illustrated and a number of intersections within the critical zone are counted. Wedge failure is kinematically feasible when the discontinuity plane or the intersecting line of two discontinuities dips lower than the slope face at W11, but steeper than the internal friction angle of the discontinuities. The peak orientation of the

dominant intersection on W11 slope is 25° (dip angle) and 75° (dip direction). However, the result of kinematic analysis indicated a probable flexural toppling mode of rock failure at the top of W11.

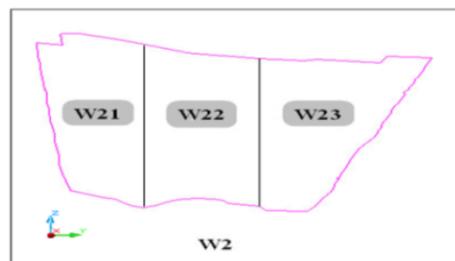
Fig.7 Subdivision outline to W2 slope element of the pit into three vertical slices to study each slice within the slope with its own discontinuities.

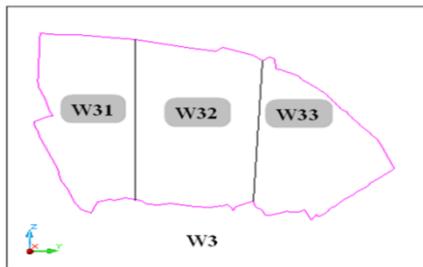
As illustrated in Fig. 11 the slope W3 was subdivided into three parts (W31, W32 and W33), where the data of discontinuities of each was verified. W3 west slope element is located at the north-west of the pit and kinematic stability analyses using stereographic constructions in which the relative directions of plane of weakness in the rock mass and the slope face are to define the rock failure mode.

Fig.11 Subdivision outline to W3 slope element of the pit into three vertical slices to study each slice with its own discontinuities.
