RESEARCH OF DAMAGED CONDITION BY THE 2016 KUMAMOTO EARTHQUAKE AND GROUND INVESTIGATION ON STONE WALLS AND EARTH STRUCTURES IN KUMAMOTO CASTLE

In this research, the tendency of the damage of stone walls and earth structures will be clarified based on the survey team of the Geotechnical Engineering Society and the Kumamoto Castle Research Center, and it is discussed on the mechanism of collapse occurrence by estimating the geological structure under the several sites in Kumamoto Castle by surface wave profiling method and so on.

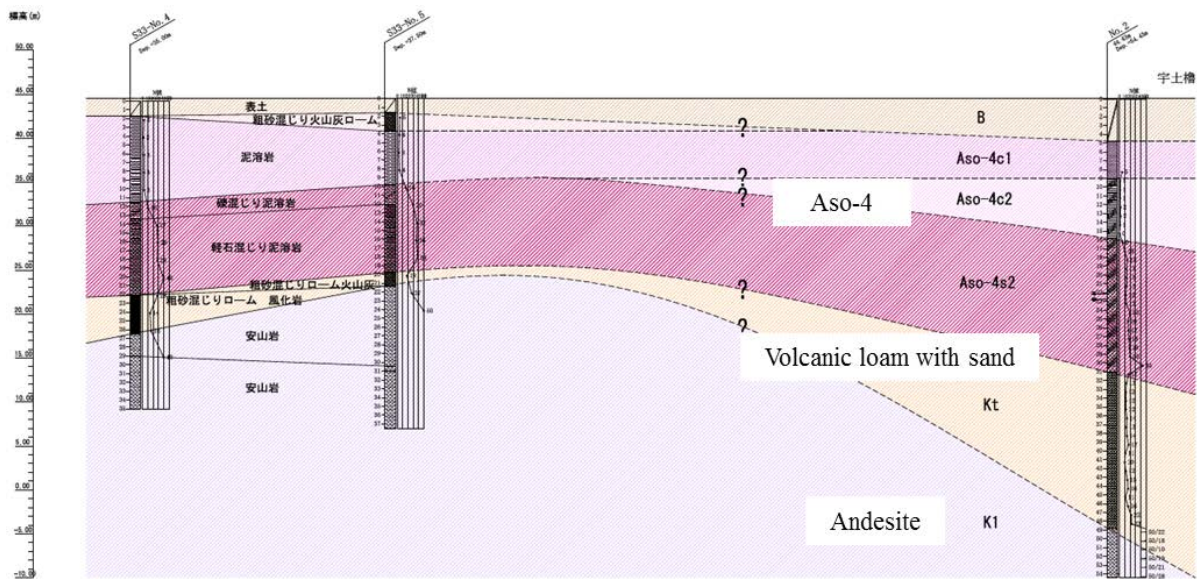
Fig. 4 Geological structure under the tower of Kumamoto Castle. [6]

Fig. 3 and 4 show the geological cross-section based on the past boring survey in the Kumamoto Castle [6]. There are only 12 boring data collections around northern part of the castle tower surveyed in 1958 or 2015. Developed land material and volcanic cohesive soil that N Value is around

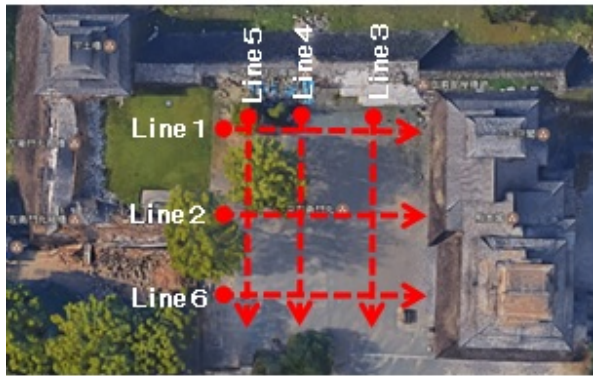
Fig.11 Survey lines of Surface wave exploration at Heizaemon-maru

Fig. 11 shows survey lines of Surface wave exploration at Heizaemon-maru of Kumamoto Castle. 6 measuring lines are located in a reticular pattern. Fig. 12 shows situation of surface wave

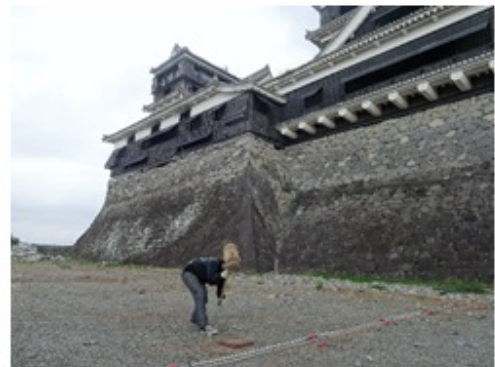
Fig.12 Situation of Surface wave exploration at line 6

prospection at line 6 of Heizaemon-maru.
