## LANDSLIDES AND DEBRIS FLOWS AT KHAO PHANOM BENJA, KRABI, SOUTHERN THAILAND

**ABSTRACT:** A detailed investigation of the characteristics of the 2011 catastrophic landslides of Khao Phanom Benja, Krabi, Thailand was conducted. The landslides on the slope faces of the high relief granitic mountain led to devastating debris flows of large rock boulders that buried houses in the foothill area. The unfavorable orientations of four major joint sets of the mountain created high kinematic instability of rock wedge slides along the stream channel direction as well as rock wedge formation on the channel walls in the eastern sides of the mountain. Weathering and joint opening in the areas of slopes and stream channels increase the vulnerability of rock slides, in particular for a prolonged heavy rainfall. The heavy rainfall and stream channel flow on slab block of rock slope erosion along stream bank caused down bank slope failure. The increasing upward water pressure caused the increase in uplift force behind the rock block and rock wedge failure. In addition, the hazard zone delineation of debris flows deposition was mapped out using a MATLAB codenamed as FLOWS. Majority of slides on th

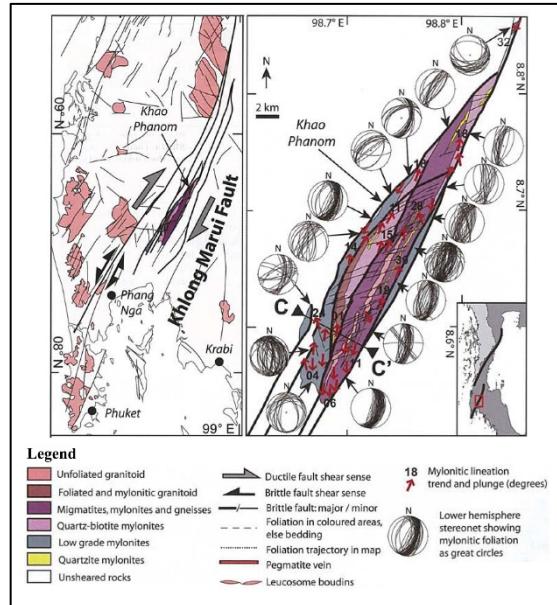
Fig. 3 Khao Phanom Benja and discontinuities mapped at Klong Marui Fault at Khao Phanom, Phang Nga (after Morley et. al. 2011)

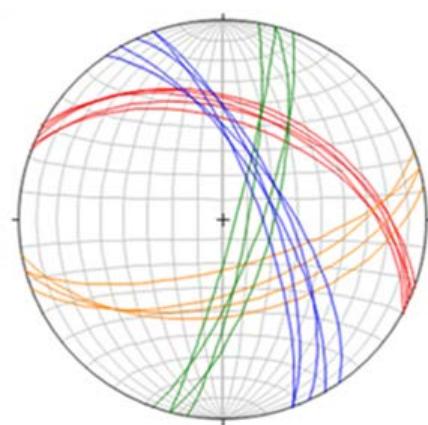
Fig. 4 Major joint sets in granitic rocks

Mapping of geologic discontinuities along the stream channels and landslide scars revealed orientations of predominant joint sets in the granitic rocks as summarized in stereonet plot in Fig. 4 as well as marked in the geologic map in Fig. 5. It can be seen that there are four major joint sets of

The two conjugated sets of steeply dipping (60-80° to East) with a strike more or less in N-S direction. The two sets of moderately dipping (40-50° to N-S direction) with a strike in more or less E-W direction. It is noted that the steeply dipping set with a strike of N5°E is of the same direction with the major fault zone traversing Khao Phanom Benja and the steeply dipping cliff faces of the mountain on the eastern slope are of the same orientation of this set. The orientations of the four major joint sets promote the formation of the cliff face and plane slide of rock blocks toward the east direction and formation of rock wedges along the stream channels flowing eastward and on the channel banks.

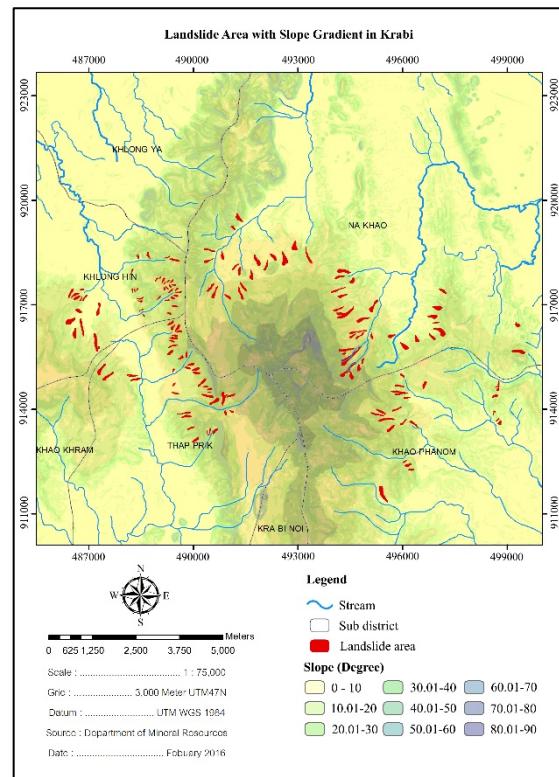
The past landslides in Thailand recorded the potential of landslides with the rock groups and showed that the granitic and sedimentary rocks have the highest frequency potential of landslides [5]. Both of these rocks are dominant at Khao Phanom Benja. Identifications of the spatial relations between landslide occurrences and influencing factors in term of slope gradient and types of rocks were made using Geographical Information Systems (GIS) as shown in Fig. 9.

Fig. 9 Relationship between landslides and slope gradient

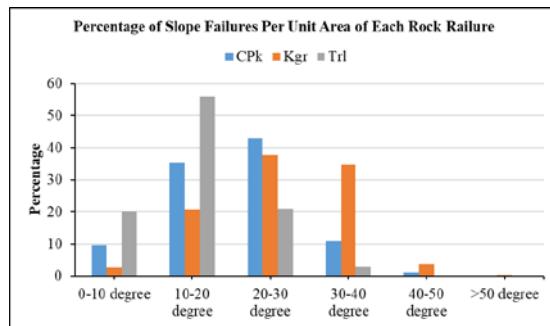
Fig. 11 Distribution of percentage of slope failures per unit area of each rock failure

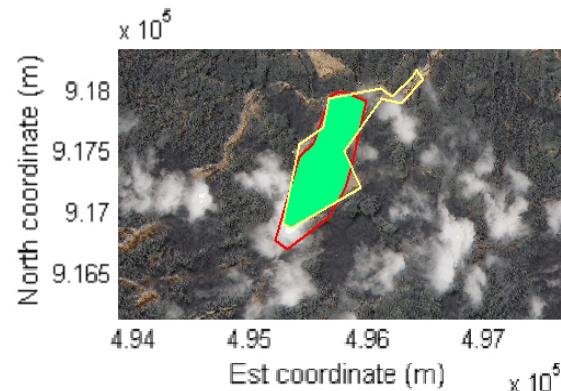
As shown in Fig. 12 and 13, the evaluation of debris flow inundated areas by DFLOWZ simulations (Red Line) is in good agreement with the areas detected from satellite image (Yellow Line). The green-shaded polygon shows a good overlapping hazard area by DFLOWZ simulations and satellite image. More comparison details for three inundation areas estimated by these two methods are shown in Table 4.

Fig. 12 The comparison between the deposition areas at Ban Tonharn by 2011 landslides and the hazard zone delineation areas calculated by DFLOWZ

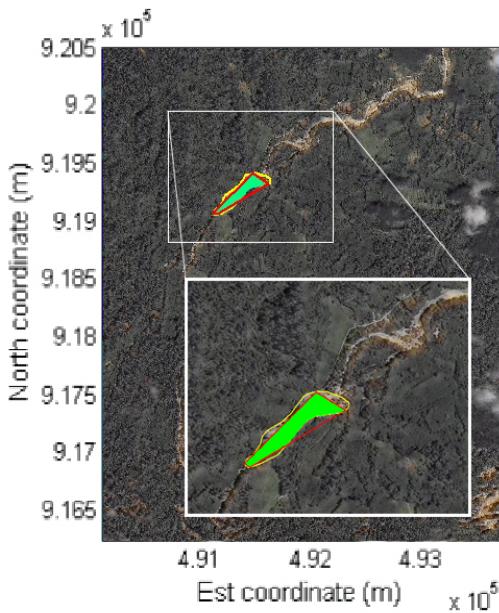
Fig. 13 The comparison between the deposition areas at Ban Huynumkeaw by 2011 landslides and the hazard zone delineation areas calculated by DFLOWZ

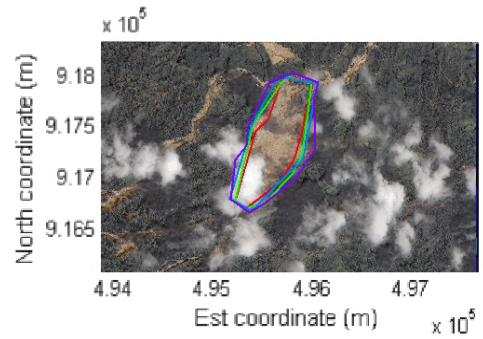
The first step of prediction of debris flows settlement areas at Khao Phanom Benja starts with the estimation of debris flow volume and the corresponding probability of occurrence (magnitude-frequency relationship). In this study, maximum debris flows volume was assumed to be 125, 150 and 200% of the debris flow event in 2011. Fig. 14 and 15 show the evaluation of debris flow inundated areas of DFLOWZ simulations (Red Line) and hazard zone delineation areas with 125% (Green line), 150% (blue line) and 200% (violet line). The comparison between the deposition areas of two study areas shows that the debris flows starts to spread on deposition area at the same location and spreading wider. DFLOWZ cannot indicate the depth of inundation. We compared the areas of inundation with those in the previous case to identify the possible location of debris flow settlement. The percentage of inundation areas are lower than the percentage of the design volume of debris flow. In other words, the major factors affecting the large debris flow volume at Ban Tonharn and Ban Huynumkeaw are the larger thickness of the deposition area. Moreover, the results indicated that the deposition areas of debris flows are not significantly different from previous landslide and debris flow.

Fig. 14 The comparison between the deposition areas of 2011 DFLOWZ simulation and hazard zone delineation areas at Ban Tonharn

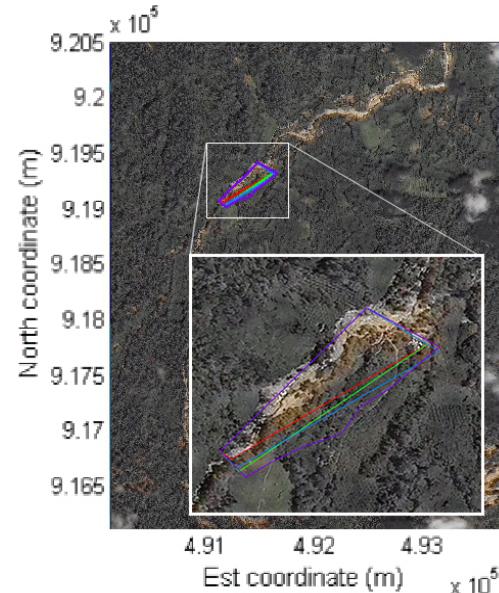
Fig. 15 The comparison between the deposition areas of 2011 DFLOWZ simulation and hazard zone delineation areas at Ban Huynumkeaw
