# UNDERSTANDING DOWNSTREAM SLOPE FAILURE IN EARTH DAMS: CAUSES AND REMEDIES - A CASE STUDY OF TRIEU THUONG NO.2 DAM, QUANG TRI, VIETNAM

**ABSTRACT:** Lessons learned from dealing with earth dam incidents have made a significant contribution to surveying, designing, constructing, and repairing works. However, disseminating these lessons to the public must be done carefully. This study aims to analyze the causes and remedial measures for the downstream failure of the Trieu Thuong No. 2 earthen dam in Quang Tri province, Vietnam. To achieve this, the finite element software, MIDAS, was used for seepage and slope stability analysis. The simulation was based on design documents, past responses to dam incidents, and additional geological survey data. The results indicated that there were three major causes of instability in the dam: (1) the existence of a soft soil layer beneath the upstream slope foundation that was not recognized in the original design; (2) a difference in hydraulic conductivity between the original dam soil and the backfill; and (3) the absence of a drainage arrangement between the new and original layers of the dam. Therefore, proposed solutions include (1) reducing

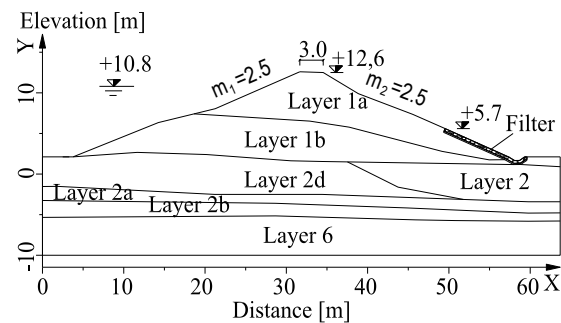
Fig.2 Typical cross-section of the dam when completed in 1989—Case 1 (elevation is in meters)

total length measured roughly 515.6 meters, and the major dimensions of its typical cross-section upon completion in 1998 are depicted in Fig. 2.

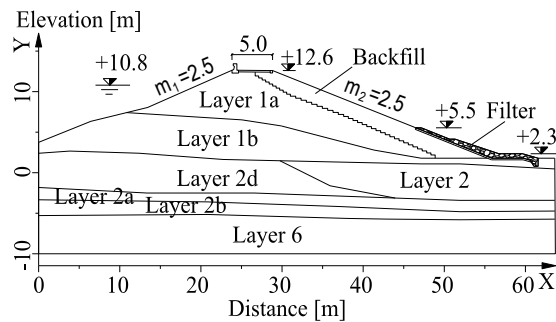
Fig.3 Typical cross-section of the dam after the improvement by adding the backfill and the filter in 2016.

In September 2016, the surface of the dam was expanded to a width of  $B_2 = 5.0$  m, with an upstream slope coefficient of  $m_1 = 2.5$  and a downstream slope coefficient of  $m_2 = 2.5$ . Measures were taken to improve the downstream slope, including the addition of drainage ditches, a drainage filter structure, and grass planting. A typical cross-section of the dam after the improvement in 2016 is presented in Fig. 3.

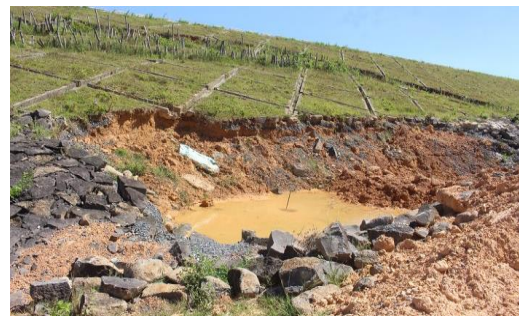
Fig.5 Location of the geological surveys on the downstream slope of the dam in 2018.

subsidence reaching between 120 cm and 150 cm from elevation +2.0 m to elevation +10.0 m. The sliding area totaled around 2000 m<sup>2</sup>, as depicted in Fig. 4c. In 2018, an additional geological survey was conducted to compare treatment options before and after the rainy season. Fig. 5 shows the location of the geological surveys carried out on the downstream slope of the dam in 2018, while Fig. 6 depicts the construction of soil-cement columns intended to stabilize the dam downstream in the same year. Fig. 7 displays the stable downstream slope of the dam in 2022, four years after the improvements were made.

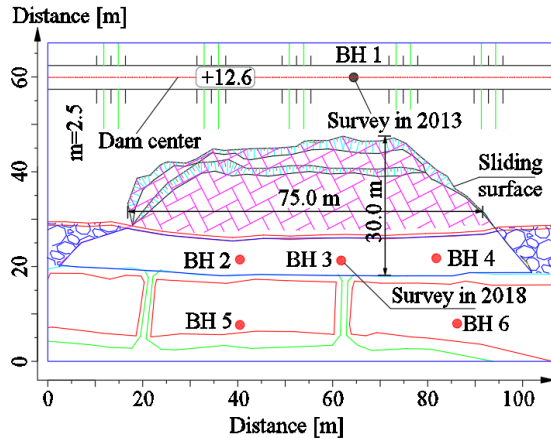
Fig.8 Plane view of geological boreholes surveyed for dam upgrading in 2013, and dam evaluation in 2018 (BH = borehole).

Back in 2013, surveys and assessments were conducted to improve the structure of the dam, but the investigation only covered the center of the dam, leaving the geological conditions of the site insufficiently described. In 2018, additional surveys were carried out with five more boreholes (Fig. 8). These surveys revealed the existence of a soft soil layer (Layer 2) deep beneath the downstream side of the dam, with varying thicknesses ranging from 0.8 to 4.3 meters, as shown in Fig. 9.

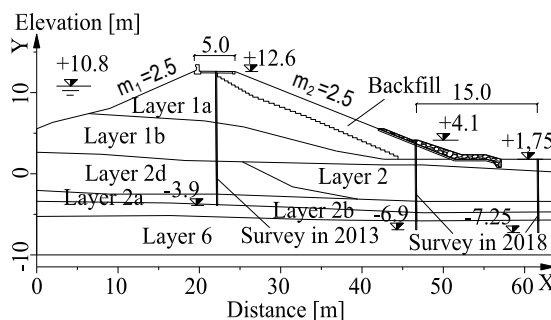
Fig.9 Cross-section showing the borehole distribution (elevation is in meters).

Layer 2 is composed of clay mixed with sand and organic matter. It is in the liquid-plastic state, with high compressibility and a dark gray color. This soft soil layer is distributed throughout the survey route, with a thickness varying from 0.8 m to 4.3 m. It originates from the old river alluvium (al.Q).

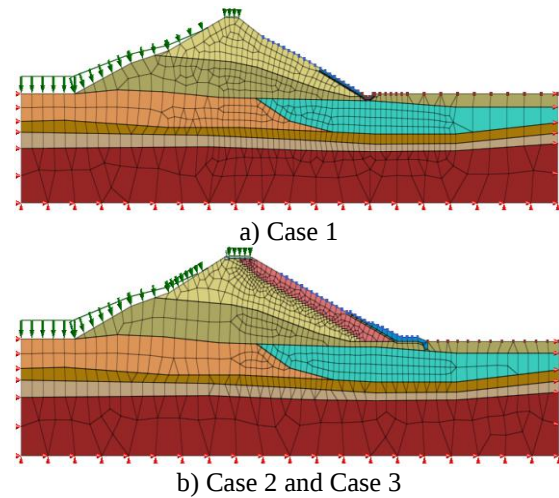
Fig.10 The boundary and loading condition of the numerical model in a) Case 1, b) Case 2 & Case 3.

To determine the optimal mesh size, the mesh dimensions were systematically reduced in each simulation until negligible changes in displacement were observed. In addition, to enhance the accuracy of the calculations, the density of triangular elements was increased near both the toe and structural interfaces. The bottom boundary of the model was fixed in both horizontal and vertical directions, as illustrated in Fig. 10, while the two sides of the model were fixed horizontally. The upstream water loading was applied to the upstream face of the dam, and the traffic loading was added to the top of the dam.

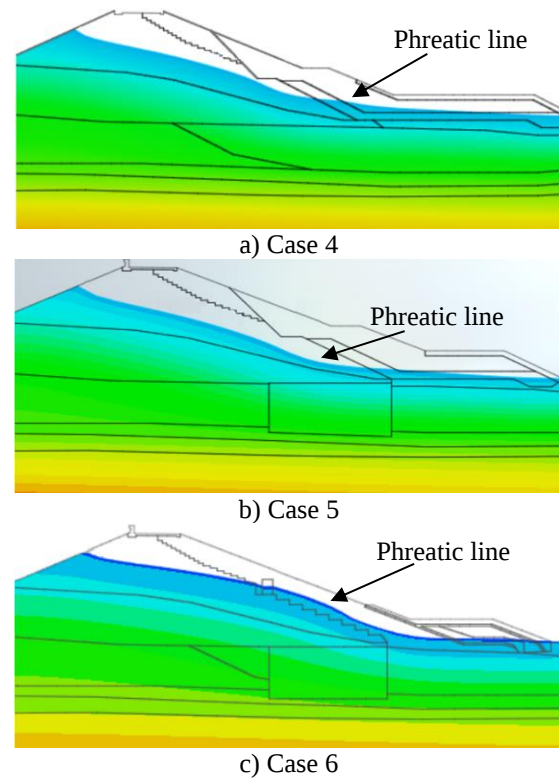
Fig.15 Results of seepage simulation for Cases 4, 5, and 6.

The seepage simulations for cases a, b, and c are depicted in Figures 15a, 15b, and 15c, respectively. Notably, the phreatic curves for all three cases were found to be significantly lower than those presented in Figure 11, which corresponded to the dam's completed state in 1989 and improved state in 2016. Specifically, Case 4 exhibited the lowest phreatic curve compared to Cases 5 and 6. The phreatic lines were then utilized to assess the slope stability of the dam, and the results are presented in Figures 16a, 16b, and 16c.

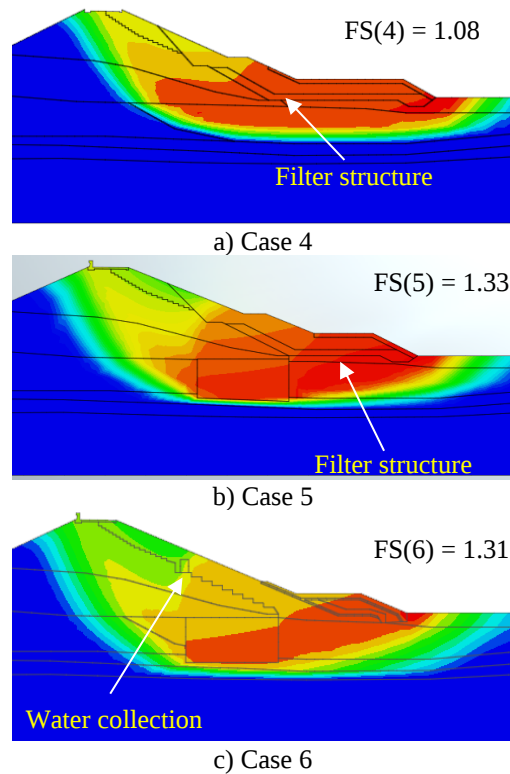
Fig.16 Results of slope stability analyses

According to the TCVN 8216:2009 [23], the factor of safety values (FS values) for all three cases were within a safe range of stability, as depicted in Fig. 16. However, these factors of safety were not far from the threshold value ( $[FS = 1.3]$  [23]). To be specific, using the strength reduction method,  $FS(4) = 1.08$ ,  $FS(5) = 1.33$ , and  $FS(6) = 1.31$ .

In case 4, the FS value was the smallest. For this case, the lower phreatic curve may be attributed to the impact of the new backfill layer that compressed and damaged the soft soil layer's structure. Case 5 showed the highest factor of safety value. It might be due to the effective treatment method that lowered the phreatic line. However, this case has several drawbacks as the construction of a downstream water filter structure may lead to dam

failure due to the current water storage and the impending rainy season. Therefore, Case 6 was chosen as the optimal solution to the dam failure problem.

As mentioned, Case 6 involved constructing a drainage system at the interface between the original dam surface and the new backfill and reinforcing the foundation with soil-cement columns.
