# STUDY OF REPAIRED SPUN PILE TO PILE CAP CONNECTIONS CONTAINING FRACTURED REINFORCEMENTS USING FRP

**ABSTRACT:** There is a need for a study on the seismic performance of foundations to facilitate the implementation of performance-based design for bottom structures in Indonesia. To address this need, two series of experimental studies were conducted specifically on spun pile-to-pile cap connections, which are commonly used in Indonesia. The objective of the study was to analyze the performance of these connections and their post-repair behavior. Two specimens were tested: one with an empty pile (SPPC01) and another with a concrete-filled pile (SPPC03). Despite the limited confinement of the piles, both specimens exhibited ductile behavior, achieving displacement ductility within the range of 3.0 to 6.0. The test found that the connections were capable of developing the inelastic stage of the prestressed bars. Both specimens experienced irreparable damage due to fractures in the bars. They were repaired using Fiber Reinforced Polymer (FRP) and retested. The specimens showed some differences in their behavior. SPPC01R exhibited rocking with uplift because the connection was merely

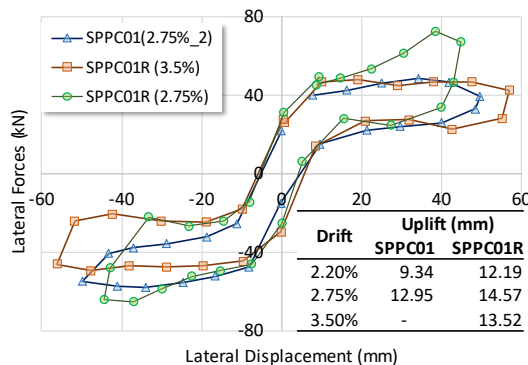
Fig 12. The comparison of the last hysteretic curve of SPPC01 and SPPC01R

The hysteretic curves of both series are presented in Fig 10 and Fig 11. In the case of SPPC01, the strength increased until a drift of 1.35%, while for SPPC01R, the strength continued to increase until a drift of 2.0%. Fig. 12 shows the hysteretic curves of the last cycle for both specimens. The curves are associated with a phenomenon called "rocking" [15], which refers to the condition where the pile becomes detached from the pile cap. In the case of SPPC01R, it occurred at a drift of 3.5%. Similarly, the original specimen, SPPC01, also experienced rocking when the PC bars fractured consecutively, at a drift of 2.75%. Uplift, the vertical displacement or movement of the pile due to rocking, was 12.2 mm for SPPC01 and 14.6 mm for SPPC01R.

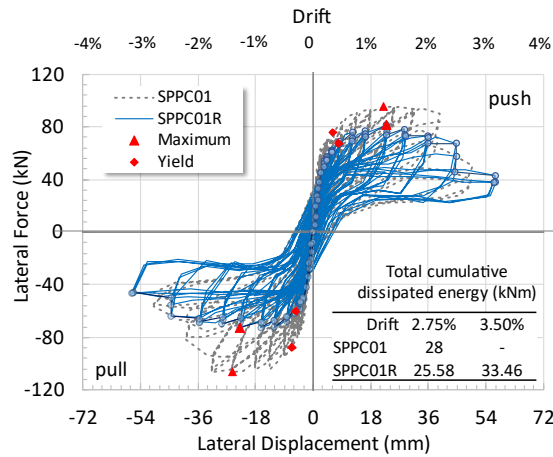
Fig 10. The hysteretic curve of SPPC01/R

The cumulative dissipated energy, which is measured as the area enclosed by the hysteretic curve of each cycle, provides insights into the capacity of the specimens to absorb the energy. The total amount of cumulative dissipated energy for both series is shown in Fig. 10 and Fig. 11. It is observed that the repaired specimens have slightly lower energy dissipation compared to the original specimens at the same drift level. However, due to their ability to reach longer drift levels, the repaired specimens ultimately achieve higher overall dissipated energy. SPPC01R exhibited a dissipated energy of 33.46 kNm, whereas SPPC01 had 28 kNm. SPPC03R achieved a dissipated energy of 72 kNm, which was 36% higher than SPPC03.

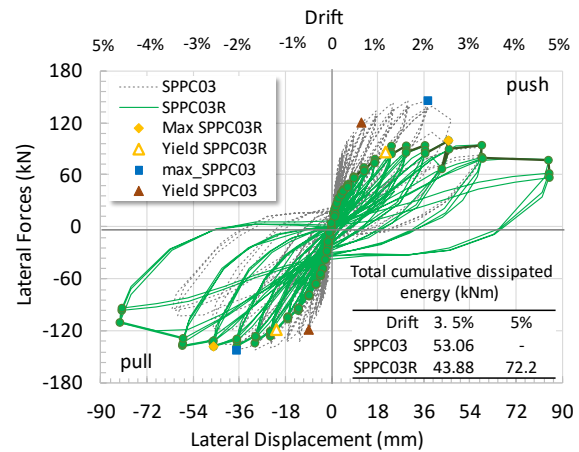
Fig 11. The hysteretic curve of SPPC03/R

The hysteretic curve of SPPC03R in Fig. 11 exhibits an asymmetrical failure mode, which aligns

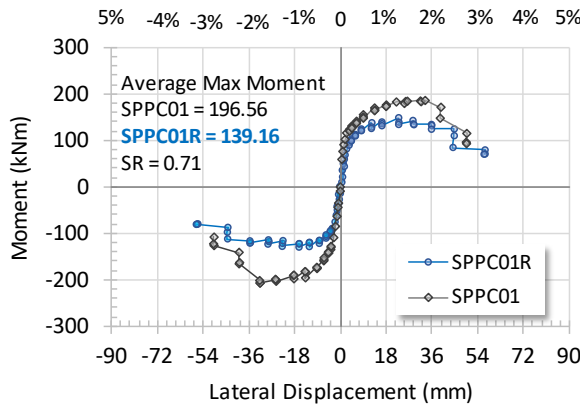
Fig. 13 The envelope curves of SPPC01/R

SPPC01R, which had a different connection detail resulting in a different failure mode, achieved a strength recovery (SR) of 71%, indicating that it was not able to fully restore the strength of SPPC01.

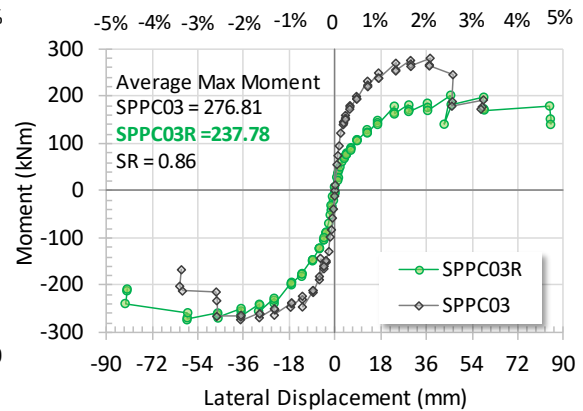
Fig.14. The envelope curves of SPPC03/R

On the other hand, SPPC03R achieved a higher SR of 83%. When comparing the maximum moment obtained in the experiments to the design moment from the P-M interaction, SPPC01R and SPPC03R reached 87% of the strength. This revealed that they almost reached the design moment.

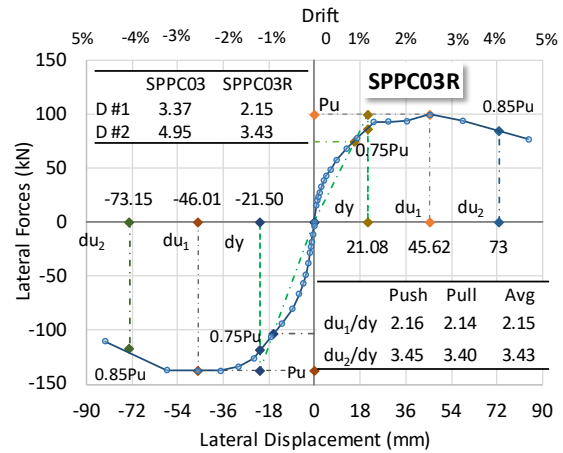
Fig.16 The calculation of ductility of SPPC03R

SPPC03R exhibits lower ductility compared to SPPC03. This is due to the fact that yield occurs at a larger displacement of 21 mm for SPPC03R,

whereas SPPC03 yielded at 10 mm. Consequently, the calculated ductility of SPPC03R is 3.43, which is lower than the ductility value of SPPC03, which is 4.95. However, it is important to note that SPPC03R demonstrates improved rotational capacity and greater lateral displacement than SPPC03, as indicated in Figures 10, 12, and 15. According to AASHTO [8], the displacement ductility of the bottom structure is limited to 4.0, and thus, all specimens are considered ductile.
