DEFECT STUDY ON SINGLE STOREY REINFORCED CONCRETE BUILDING IN WEST SUMATRA: BEFORE AND AFTER 2009 WEST SUMATRA EARTHQUAKE

*Eka Juliafad¹, Hideomi Gokon², and Rusnardi Rahmat Putra¹

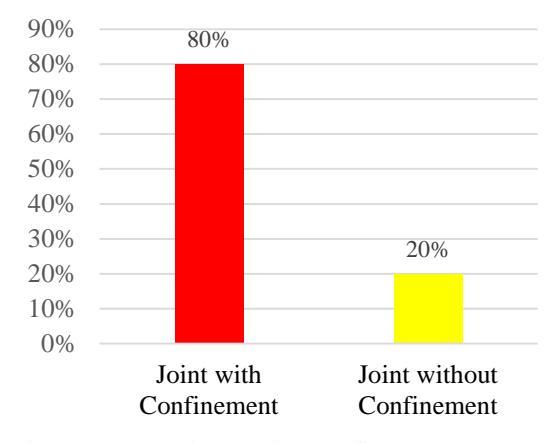
Fig. 8. Beam-Column Joint Confinement

Investigation results show that most of the buildings (80%) have the confinement in the joint area. However, to be noted that almost 40% of the inspected buildings do not have a beam element, and 18% do not have a column (Figure 8). Hence only 40 buildings can be checked for joint confinement. It means that the increasing sample can improve the precision of the results. This analysis comes as the finding of observation that

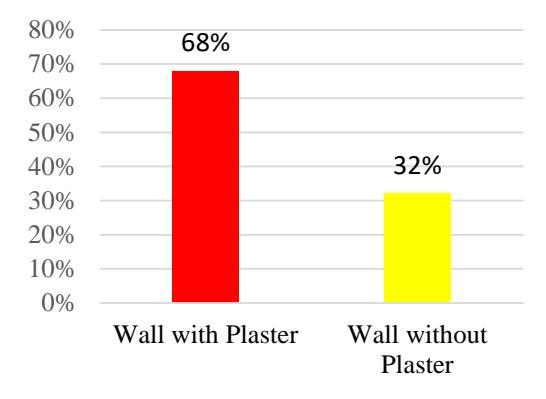
Fig. 10. Masonry Wall Finishing Condition

The results show that there are still many buildings that do not finish the wall construction by using plaster (Figure 11). While by plastering the masonry wall will give stronger wall and show the different behavior comparing to the wall without plaster [15–16]
