# GEOTECHNICAL INVESTIGATION OF A LANDSLIDE INCIDENT IN HULU KELANG, MALAYSIA

**ABSTRACT:** Malaysia is located in a tropical region and receives high rainfall intensity, especially during the monsoon season, which is often associated with landslide disasters. This study conducted a geotechnical investigation to examine the causative factors of a landslide incident on 18 September 2021 at Kemensah Heights, Hulu Kelang, Selangor, Malaysia. The landslide was triggered after three days of rainfall and shifted approximately 2536 m<sup>2</sup> of land, affecting three bungalows and 19 double-story houses located at the top and toe of the slope. The investigation used a combination of a Terrestrial Laser Scanner (TLS) Survey, a Public Work Department Probe Test also known as the JKR Probe Test, laboratory testing, and numerical modeling to analyze the landslide. Soil samples were collected to test grain size distribution, Atterberg limits, permeability, soil density, consolidated-undrained (CU) tri-axial strength, and soil density. The residual soils comprised sand (42%), silt (28%), clay (16%), and gravel (14%), classifying it as 'silty sand'. The average permeability is  $5.96 \times

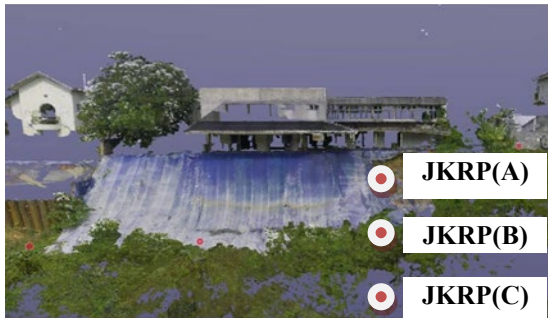
Fig. 6 Locations of the JKR Probe Test conducted on the slope

Fig. 8 presents the results of the JKR probe test, at the top, middle and toe of the slope. The schematic cross-section drawing of the slope profile is interpreted using the JKR probe test results shown in Fig. 9. The hard layer measured from the failure plane varies from 3.5-6.0 m. The hard layer could be bedrock or another dense layer. There are distinct soft and hard layers on the slope profile. The depth of the residual soft soil layer is approximately 17-20 m.

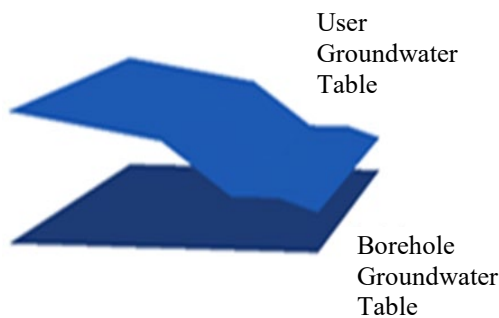
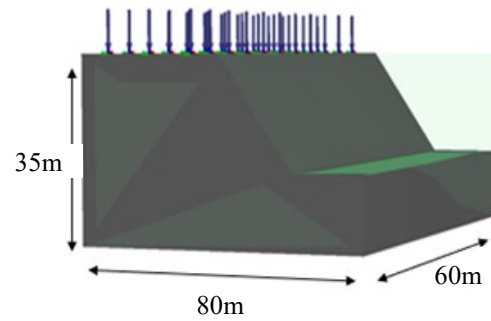
Fig. 7 Groundwater table and slope dimension in Plaxis 3D

Plaxis 3D was used to perform slope stability analysis. The soil was described by a non-linear Hardening Soil Model (HSM). Two levels of groundwater table were used for the flow condition stage: the lower level was a borehole water table located at a depth of 25 m from the ground surface and the upper level was the user-defined water table, located approximately 4 m deep and based on the site investigation conducted by local experts (Fig. 7a). Fig. 7b shows the 3D slope model with a height, length and width of 35, 60, and 80 m, respectively, forming a 35° slope angle. A 50 kPa surcharge load was imposed at the top of the slope to represent the structural load from existing buildings.

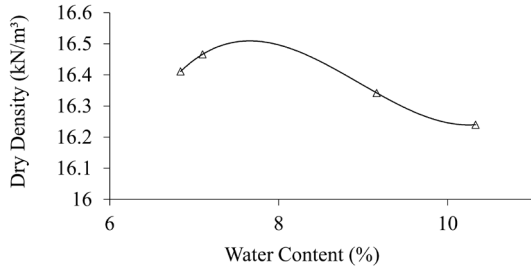
Fig. 11 Soil compaction test results.

Figure 11 shows the result of soil compaction testing, where the maximum dry density of the soil is  $16.51 \text{ kN/m}^3$  at an optimum moisture content of 7.3%.

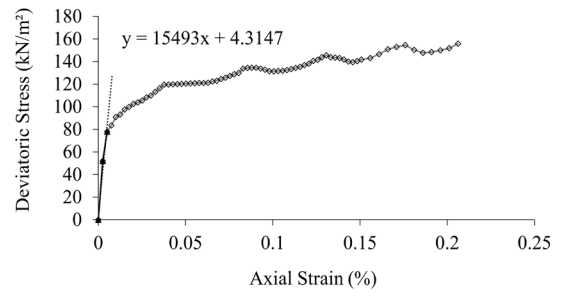
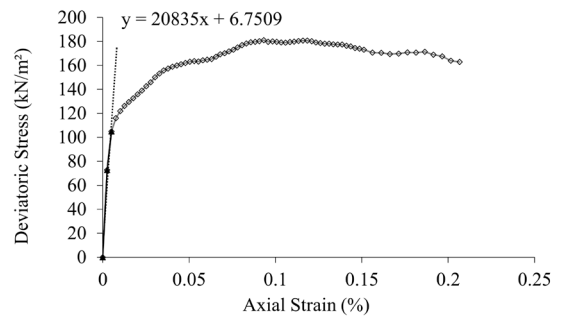
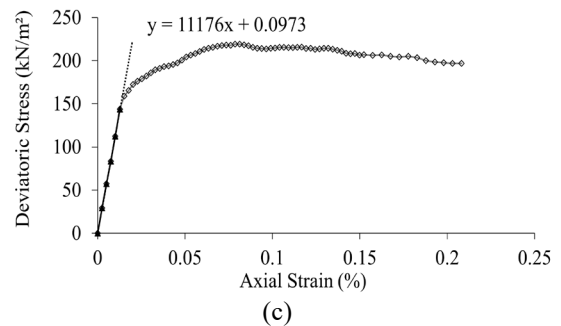
Fig. 14 Determination of the  $E_{50}$  moduli at (a) 50 kPa; (b) 100 kPa; and (c) 200 kPa.

determined from the slope gradient of the stress-strain curve of each sample (see Fig. 14). The average of the slope gradients,  $E_{50}^{ref}$  is 15,835 kPa. The  $E_{ode}^{ref}$  and  $E_{ur}^{ref}$  were calculated using Eq. (1) and Eq. (2). Table 3 summarizes the input strength parameters for the Hardening Soil Model (HSM) obtained from CU triaxial test results.
