SEISMIC ANALYSIS OF DAMAGED BUILDINGS BASED ON POST-EARTHQUAKE INVESTIGATION OF THE 2018 PALU EARTHQUAKE

* Maidiawati¹, Jafril Tanjung², Yasushi Sanada³, Fajar Nugroho¹, and Syafri Wardi¹

¹Civil Engineering and Planning Faculty, Padang Institute of Technology, Indonesia; ²Engineering Faculty, Andalas University, Indonesia; ³Architectural Engineering Department, Osaka University, Japan.

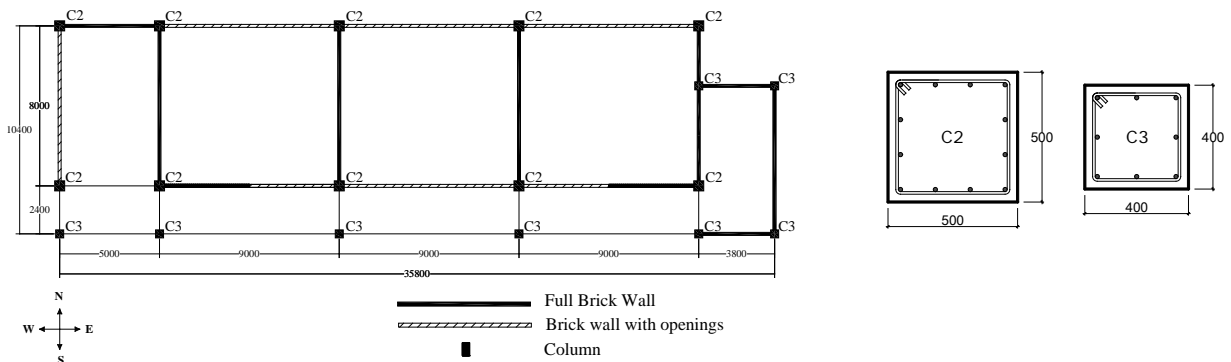
Fig.4 Floor plan first story of Forestry Faculty building of Tadulako University

where, h_0 is a clear height of the column, and D is column depth. Based on R -value, that is slight damage with $95\% \leq R$, light damage with $80\% \leq R < 95\%$, moderate damage with $60\% \leq R < 80\%$, heavy damage with $R < 60\%$, and collapse with $R \approx 0$, the first story of Fire Station building was classified as severe damage. On the other hand, the first story of the Forestry Faculty building totally collapsed.
