# RESEARCH ON CAUSE OF DAM FAILURE FROM VIEWPOINT OF HYDRAULIC FRACTURING – CASE STUDY OF A DAM FAILURE IN VIETNAM

*Keywords: Hydraulic fracturing, Arching action, Culvert, Dam failure, KE 2/20 REC dam.*

A case study of a dam failure in Vietnam, called KE2/20 REC dam, was used for this study. The dam is located in Ha Tinh Province in Central Vietnam. The dam's initial purpose was to create a reservoir to supply irrigation water for farmland (about 30 hectares). Construction of the dam and reservoir was started in October 2006. After 2 years, the dam was completed and was put into operation in July 2008. The related structures consisted of the main dam (maximum height of 12.5 m), a saddle dam, a spillway (width of 11.2 m), and a culvert (design flow of 0.037 m<sup>3</sup>/s). After being in operation for just under one year, the dam failed in June 2009 [1], [8].

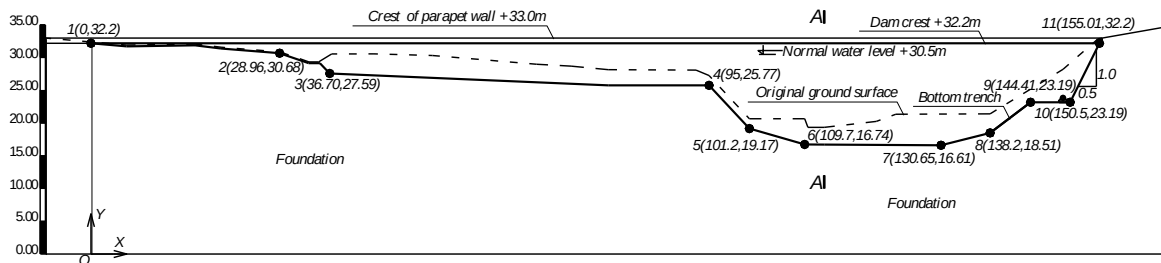
Fig. 3 Longitudinal section and data of nodal points on boundary in numerical model

and 2. The results of in-situ surveys after the dam failure showed that the slope of the excavation on the left side of the culvert (looking from upstream to downstream) was rather steep. In reality, the observed slope was just 1:0.5 (vertical and horizontal directions, respectively), even less than seen in Figs. 1 and 2, even though the required design value was 1:1. Figure 3 shows a longitudinal section of the dam that was idealized from the design section and in-situ observations.

1. In addition, the in-situ tests on the fill soil after the dam failure revealed that the embankment had not been compacted carefully. The real relative compaction (90.4%) had not reached the required value (95%) [1].

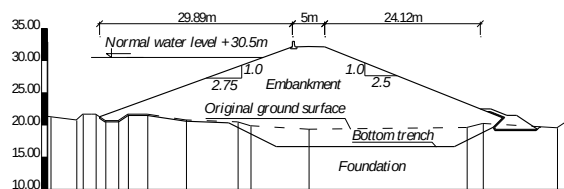
Fig. 4 Cross section of dam (A-A)

Cross sections of the dam and the culvert are presented in Figs. 4 and 5, respectively. It can be seen that the culvert is a reinforced concrete circular conduit and was placed on a foundation bed 0.4 m in depth. The physical parameters of the culvert materials are summarized in Table 1. From the above descriptions, the current authors suspected that the cause of this dam accident might be related to the hydraulic fracturing mechanism. There may have been discontinuities in the fill soil adjacent to the culvert after the construction process. Moreover, due to the effect of the culvert's shape, arching action could have occurred on the left side of the dam. With the excavation of a steep slope and a considerable distinction in the elastic moduli between the embankment and the foundation, arching can become severe. When the water level of the reservoir rose, the water pressure grew higher than the normal stress on both sides of the pipe culvert; the stress was reduced to a small value by the arching action. Under this condition, the discontinuities acted as the initial cracks that were extended and propagated by the water pressure. This process might have led to the dam failure.

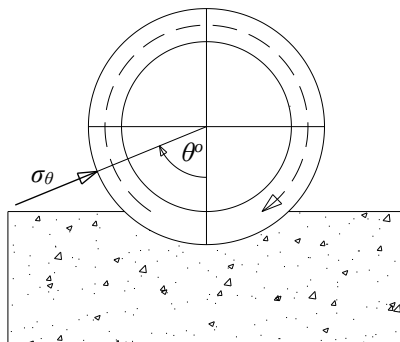
Fig. 9 Convention of theta angle ( $\theta^\circ$ )

As detailed in Fig. 8, when the theta angle is smaller than  $96.0^\circ$  and higher than  $248.7^\circ$ , the normal stress is really exceeded by the water pressure. The minimum value of the normal stress minus the water pressure ( $\sigma_\theta - W$ ) is  $-53.06$  kPa when the theta angle is equal to  $39.4^\circ$ . It can be concluded that hydraulic fracturing may have occurred in these regions. This coincides with the inferences of this early research.

(1) Hydraulic fracturing can occur easily when the normal stress on both sides of a culvert is reduced by the arching effect to be lower than the water pressure. In the case study used here, the minimum value of the normal stress minus the water pressure ( $\sigma_\theta - W$ ) is -53.06 kPa on the right side of the pipe culvert. The arching action may have been related to the KE 2/20 REC dam failure brought about by the hydraulic fracturing mechanism. The regions where theta angle  $\theta$  (as in Figs. 8 and 9) is lower than  $96.0^\circ$  and higher than  $248.7^\circ$  have a high risk of hydraulic fracturing.

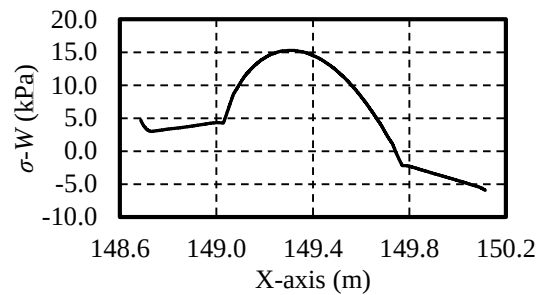
Fig. 11 Distribution of normal stress ( $\sigma$ ) minus water pressure ( $W$ ) versus X coordinate axis around culvert in test case

Figure 11 shows the distribution of normal stress minus the water pressure around the culvert with a new shape in the test case. In this graph, the horizontal coordinate axis was selected to be an X-axis that was different from the horizontal coordinate axis in Fig. 8. Due to changing the culvert shape, the X-axis might be more suitable for demonstrating the relationship of the normal stress and the water pressure around the culvert. As can be seen in Fig. 11, the stress state around the culvert experienced a more significant change than that seen in the results of the former analysis. On the right side of the culvert, the normal stress is really higher than the water pressure; hence, it can be concluded that there was no possibility of hydraulic fracturing on this side. Nevertheless, the normal stress is still lower than the water pressure. This may be due to the effects of the excavation.

By comparing the distribution of normal stress minus the water pressure in Figs. 8 and 11, the results seem to confirm that the stress-strain state around the culvert was affected remarkably by the shape of the culvert. In addition, the slope of the excavation also had an effect on the arching action. This research is thought to be the first study that elucidates the KE 2/20 REC dam failure under the viewpoint of hydraulic fracturing. It suggests that hydraulic fracturing may occur easily around the culvert in a dam body. Therefore, it is necessary to consider the risk of hydraulic fracturing in the design and construction processes of culverts underneath fill dams. Simultaneously, countermeasures to prevent the potential risk of hydraulic fracturing should be proposed.
