# CRACKING OF STEEL GIRDER OF THE VAM CONG BRIDGE - THE INCIDENT CAN BE AVOIDED DURING THE CONSTRUCTION STAGE

\*Luong Minh Chinh<sup>1</sup>

<sup>1</sup> Faculty of Civil Engineering, Thuyloi University, Vietnam

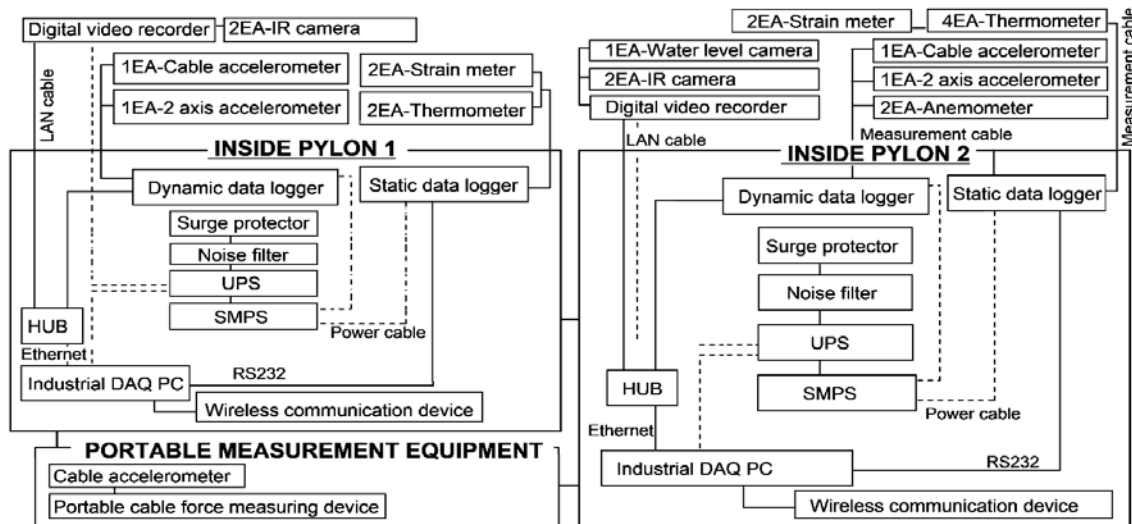
bridge construction. In addition, there are also accelerators and cable sensors to monitor the behavior of the pylons and stay cables during construction and adjust the tension in the longest cable. However, this system shows that it is elementary, only for monitoring and measuring, without analyzing the observed factors. Therefore, this system only achieves the simplest level - Level 1 (basic) [5, 6], as shown in Table 1 (Fig. 12).

Fig. 12 Constitution of SHM system in the construction stage

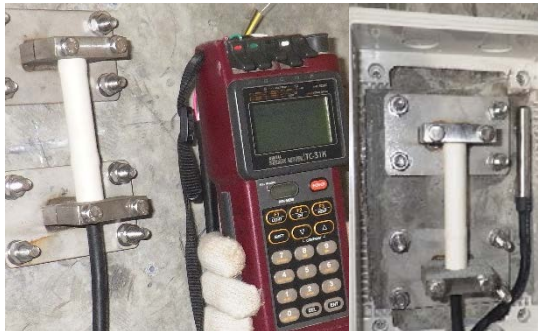
A dual-axis accelerator on the top of the pylon should be placed on the stainless-steel plate to keep the correct level of the device. In fact, the device is mounted directly to the concrete surface of the pylon (Fig. 13). The strain sensors are the only devices left to monitor the behavior of the base inside the bridge pylons. These sensors are carefully installed and calibrated (Fig. 14).

Fig. 14 Installation and calibration one of four strainmeters (with temperature sensor) inside the pylon

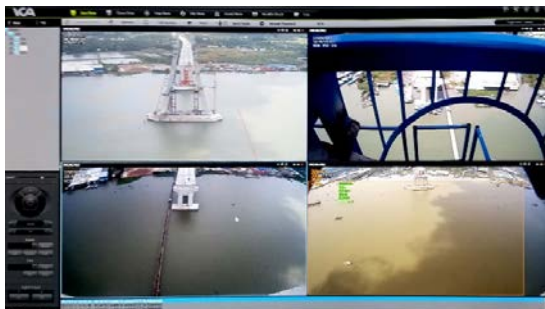
Thus, the remaining monitoring devices are only construction surveillance cameras, water level, temperature, and strain sensors at the tower's base (Fig. 15 and Fig. 16). The contractor explained this by dismantling the equipment mentioned above

Fig. 15 The main screen of the IP Camera shown the approach bridge

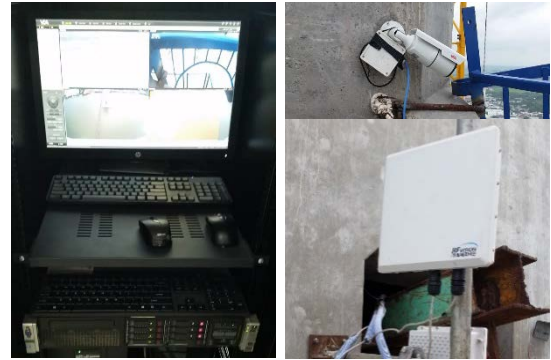
Fig. 16 Installation of the intelligent IP Camera after pylon construction
