## SEISMIC RESPONSE OF DETERIORATED RESIDENTIAL RC BUILDINGS IN THE NORTHEASTERN REGION OF THAILAND

**ABSTRACT:** This paper presents effect of steel corrosion and concrete degradation on seismic response of residential RC buildings in the Northeastern region of Thailand, originally designed without seismic consideration. Two parts of the study are presented, including site investigation to gather information of damages in 10 existing buildings, and nonlinear pushover analysis of deteriorated structure based on damage scenario from the first part. Using procedure and parameters described in ASCE 41 and recent results of seismic hazard assessment, the numerical results revealed that buildings of all material degradation conditions were safe under the Basic Safety Earthquake (BSE). The evaluation of the structures under the Design Earthquake (DE) indicated that the studied building with high deterioration could not withstand the design earthquake, as the most loaded columns would fail in flexure rather than in shear associated with yielding in the beams of the buildings. Ductility of buildings was found to be sensitive to the supposed material degradation.

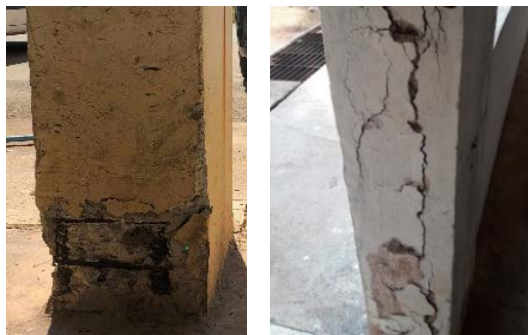
Fig.1 Examples of the damage found in the exterior first floor columns.

To gather information about some typical damages, 10 existing residential building structures were investigated. The buildings were more than 20 years of age, and were not at that time designed to resist any seismic load. Most of the existing damage obtained from the site investigation involved with rebar corrosion. Having rust on surface of the rebar, cross sectional area of the rebar was reduced, adding pressure on the rebar-concrete interface, and leading to cracking and spalling of the surrounding concrete. This type of damage was found in some columns, especially those exposed to water and air, such as exterior ground and exterior first floor columns as shown in Fig.1.
