WEST SUMATRA COASTLINE CHANGE DUE TO ABRASION PROTECTION STRUCTURES: PADANG BEACH

*Abdul Hakam¹, Junaidi¹, Bayu M Adji¹, Shafira Rahmadilla Hape²

¹Engineering Fac., Andalas University, Indonesia; ² Engineering Fac., Gadjah Mada University, Indonesia

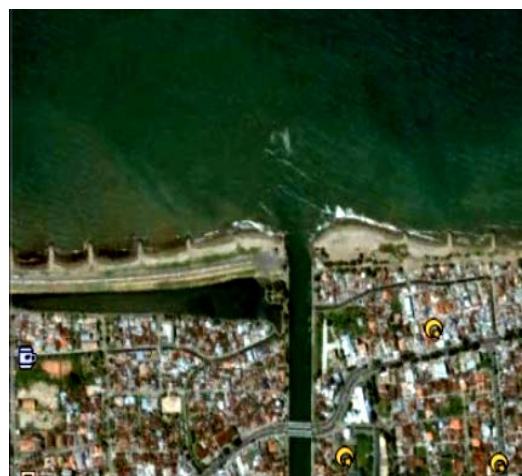
Fig.7 Padang Beach before 2008

It shows that there is a road near the beach does not have a bridge yet to cross the river the north. It is also seen that jetty and groin structure on the mouth of Banjir Kanal has not been constructed. The color of the sea also indicates the origin of the sea water. It can be seen that the water from Banjir Kanal river goes through to the sea straightly. The water of the river meets and bumps directly with currents and waves from the ocean. At that point, the sea waves were breaking. Then theoretically it could be understood that as a result of the silting sidemen causing the wave breaks in the sea. This sediment then will be pushed to the land side and trapped behind the jetty. This theoretical statement is adopted by Padang Government to build the new dry ground behind the planned Jetty and will be used as new land instead of a reclamation work.

prevention construction located in the Bajir Kanal. The map showed the Padang Beach before the construction (before 2008) as shown in Fig.7.

In the Figure also plotted the results of the sieve analysis of the sand beach sample in the same location 35 years ago. From the picture, it is seen that there is no significant change in sand gradation at that point. It is possible that the newly beach sand is originally come from the same area as in the previous year. The source of new sand sediments is likely to originally come from the mouth of the Banjir Kanal where in front of the jetty before it is built. Meanwhile, after the construction of the jetty and groin structures in the mouth of the Banjir Kanal, this sediment was pushed by the sea water and moved to the beach side. This phenomenon is also marked by the loss of breaking wave in the mouth of Banjir Kanal that existed before the construction. Breaking waves can occur when the seabed undergoes shallower, in this case, is due to sand sedimentation, and it is moved after the jetty construction. It can be seen by comparing Fig. 6 and Fig. 7 and 8.

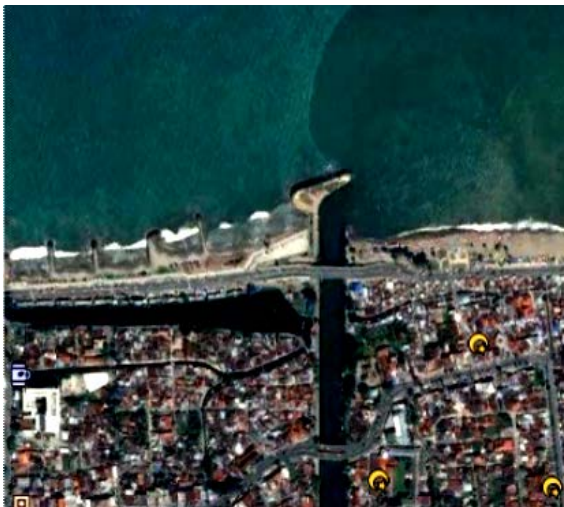
Fig.8 Padang Beach in 2018

Furthermore, Fig.8 shows the current situation, which is 10 years after the jetty and groin structures are constructed in Banjir Kanal. In the picture also can be seen a new bridge connecting the coastal road from the north and south of the parts of Banjir Kanal river. The color of the sea water indicates the water from the Banjir Kanal river has been turned by the jetty to the north direction. This condition contributes to the change of the coastline surrounding area since the water Banjir Kanal river brings sediment particles. The coastline of the north side of the Banjir Kanal river have been gone to the seaward due to the sedimentation.

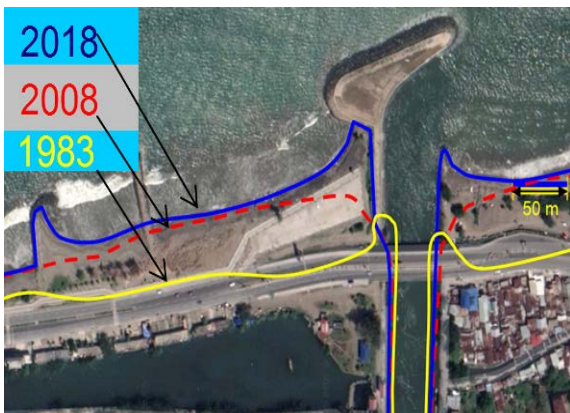
Fig.9 Coastline change at Padang Beach

The shoreline changes can be seen by making up the change of average boundary lines to form the monitored coastline in several years. The available digital documentations of Padang Beach are started in 2008. The shoreline in 2018 then is plotted along with the shoreline in 2008 (Fig.9).

coastal estimates in 1983 (35 years ago). The 1983 shoreline is plotted based on the results of the sedimentation study of Padang Beach [9].

There are noticeable shoreline changes in 1983 (yellow line), 2008 (red line) and 2018 (blue line). Although in general, the change was possible, because in 1983 the picture of Padang beach is still manually drafted so that the change is quite dubious.

While the shoreline changes in the last 10 years, may occur due to the additional length of the groin and jetty constructions at the mouth of Banjir Kanal River. This form of change is still appropriate with the theoretical prediction, even the sediments in the eastern part of the jetty exceed the predicted amount.

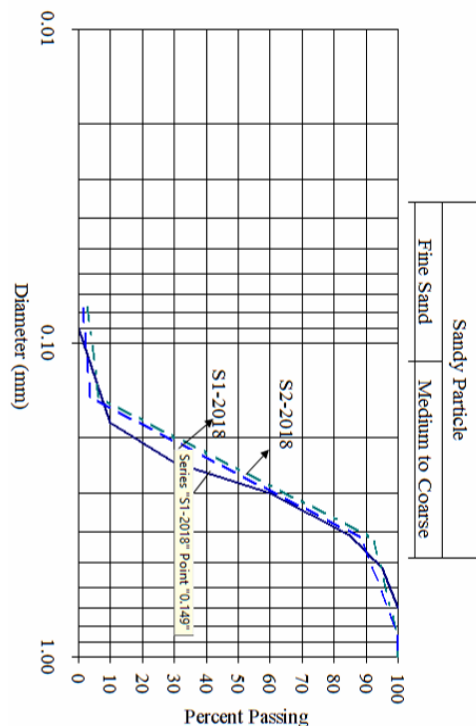
Fig.10 Grain distribution of Padang Beach sands

For that reason, the sediment samples have been taken from Padang Beach at the location adjacent to the mouth of Banjir Kanal. Furthermore, a sieve analysis of sediment sand is conducted. The laboratory test results are plotted on the graph in Fig.10.

This study also attempts to investigate the changes that occur in the nature of the sediment on the coastline (Fig.10).
