# RELIABILITY ASSESSMENT OF WOODEN TRUSSES OF A HISTORICAL SCHOOL

**ABSTRACT:** Records show that the National Structural Code of the Philippines (NSCP) wind load requirement increases over time. Increase wind velocity from stronger typhoon events translates to additional wind pressure. These changes pose a threat to existing historical structures such as Gabaldon schools which were designed and constructed more than a hundred years ago. The Department of Education (DepEd) continues its efforts in its conservation. Reliability assessment of wooden trusses is necessary to check if there is a need to retrofit to maintain its function and preserve its significance in the country's history. In the analysis of the roof trusses affected directly by wind load, all loads are considered as constant except for the uniformly distributed wind load. These constant loads serve as the initial stresses acting within the truss members. Uniformly distributed wind load produces additional stress on top of the initial stress. Any changes in the amount of wind load constitute proportionally to changes in the stresses of truss members. A commercially available software makes it easier to identify corre

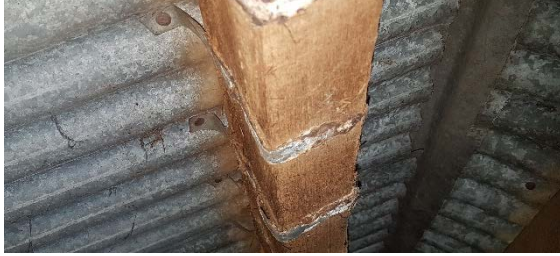
Fig. 4 Actual connection detail of roof panel and purlins

The roof panel is made up of Ga. 20 Corrugated GI sheet. GI plates equally spaced at 0.25m on center are riveted to the roof panel which is anchored by 2 screws on wood purlins as shown in Figure 4.
