## SEISMIC ANALYSIS OF DAM-RELEVANT STRUCTURES IN NORTHERN THAILAND

\*Bhuddarak Charatpangoon<sup>1</sup>, Chayanon Hansapinyo<sup>1</sup>, and Junji Kiyono<sup>2</sup>

**ABSTRACT:** The damages and losses caused by dam failure are significant. Currently, the seismic safety of dams is well established. However, a study concerning the seismic safety of dam-relevant structures is necessary. Occasionally, dams may withstand an earthquake; however, they are often unable to operate after the quake due to malfunctioning dam-relevant structures. Furthermore, the collapse of such structures could lead to a dam failure or cause considerable losses to the society downstream as well. Therefore, the seismic safety of dam-relevant structures cannot be neglected, and such safety precautions must be conducted properly. The main goal of this research is to evaluate the seismic safety of a dam spillway in Northern Thailand and to ensure that it can operate normally after an expected large earthquake. First, a representative dam-relevant structure is selected based on the availability of data and its importance. Afterward, the performance goal of a representative structure will be established upon

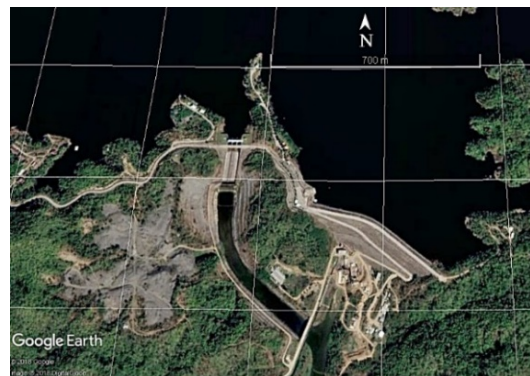
Fig. 2 Kiew Kho Ma Dam and its spillway [16]

The Kiew Kho Ma Dam spillway is located on the right of the main dam (from upstream), as shown in Fig. 2. The spillway is a reinforced concrete structure with three 12.5 x 7.00 m radial gates (Fig. 3). The overall length of the spillway is 800 m, and the drainage channel width is 42.5 m. The maximum reservoir level is 352.90 m (MSL), with a spillway capacity of 1,209 m<sup>3</sup>/s (1,000-year return period) [15].

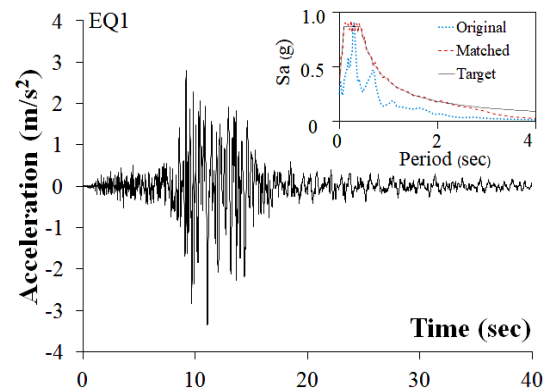
Fig. 4 EQ1

were 3.37, 3.15, and 4.10 m/s<sup>2</sup> for EQ1, EQ2, and EQ3, respectively. The matched ground motions, along with the matched response spectrum, are shown in Figs. 4-6 for EQ1, EQ2, and EQ3, respectively.

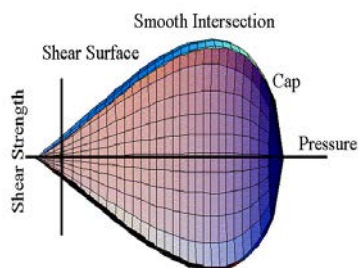
Fig. 7 Failure surface of

MAT\_CONCRETE\_DAMAGE\_REL3 [14]

The commercial finite element package LS DYNA [19] was used in the 3D finite element model adopting a 3D solid element coded ELEMENT\_SOLID for concrete elements and a beam element coded ELEMENT\_BEAM for reinforcing steel. The model was divided into two main parts: the gantry frame and the spillway. The gantry frame was analyzed using the non-linear behavior of both the concrete (MAT\_CONCRETE\_DAMAGE\_REL3, MCDR3) [20], as shown in Fig. 7, and the reinforcing steel (MAT\_PIECEWISE\_LINEAR\_PLASTICITY) by considering the perfect bonding between them. In MCDR3 model, the non-linear behavior of concrete was reproduced through the failure surface (Fig. 7) by giving simple concrete parameters such as density, compressive strength, and Poisson ratio. For the spillway, linear behavior (MAT\_ELASTIC) was assumed.

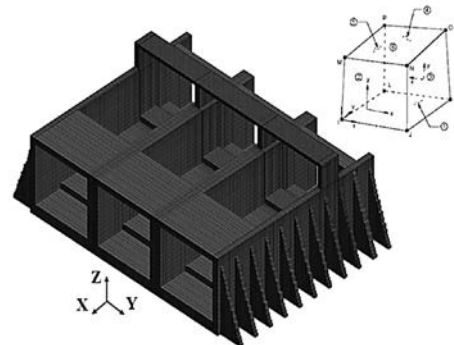
Fig. 8 The Kiew Kho Ma Dam spillway model

The model is comprised of 210,487 elements with 227,392 nodes (Fig. 8). The model was fixed in all directions at the base. In this study, the effect

of reservoir water-soil-structure interaction was neglected. The analysis started by introducing the gravity load to the model. The explicit finite element method was used for the dynamic analyses. Then, three cases of the y-directional input motions were applied at the model's base (longitudinal directions). Fig. 9 shows the dimensions of the Kiew Kho Ma Dam spillway and its components. Fig. 9 illustrates the typical cross-section of the gantry frame's columns and deck.

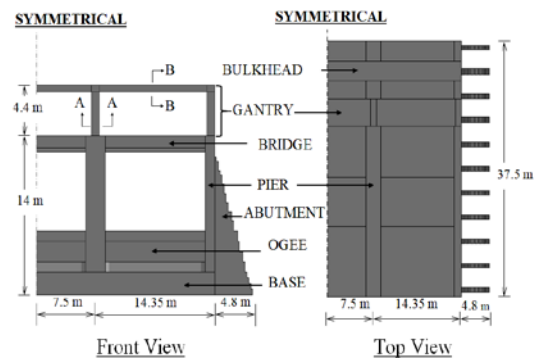
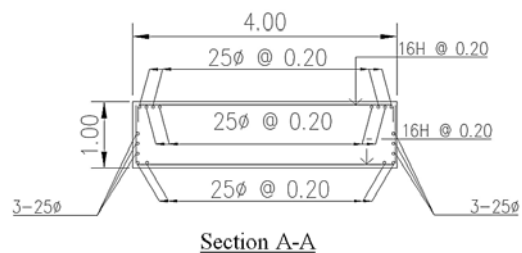
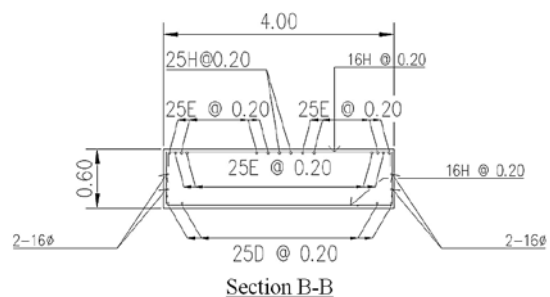
Fig. 9 The Kiew Kho Ma Dam spillway's typical sections

Section A-A

Section B-B

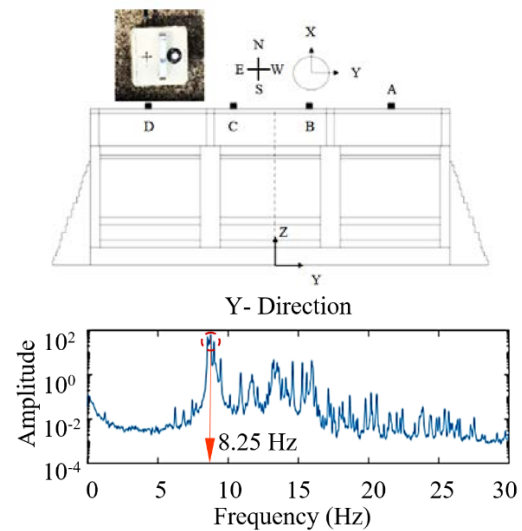
Fig. 10 Ambient vibration measurement

A microtremor test was performed to acquire the linear vibration characteristics of the Kiew Kho Ma Dam spillway. This measurement was performed using velocity sensors. The equipment was composed of four velocity transducers (three directional), with x, y, and z measurements for each sensor. The velocity transducers were placed at the top of the Kiew Kho Ma Dam spillway (points A-D) to obtain the translational vibration mode shape, as shown in Fig. 10. Then, the three directional velocity records in the time domain were changed into the frequency domain by the fast Fourier transformation technique. Hence, the natural frequency can be determined by observing the frequency at the peak value of the Fourier amplitude. The ambient vibration measurements showed that the fundamental mode of this structure is a translation in the y-direction (longitudinal direction), and the natural frequency is approximately 8.25 Hz (Fig. 10), which is within the range of a stiff building characteristic. The translation in the x-direction (transverse direction) is approximately 21.25 Hz.

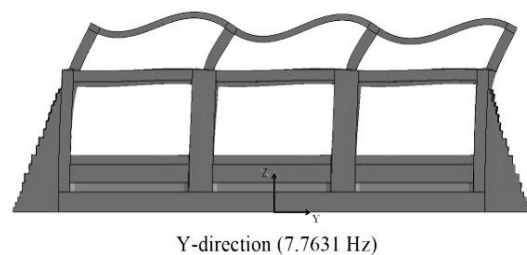
Fig. 11 Fundamental mode (Modal analysis)

From the modal analysis, the fundamental mode of this structure is a translation in the y-

direction (Fig. 11). The natural frequency is approximately 7.76 Hz, with the high movement only in the top part (gantry frame). The second mode is the torsional mode with a frequency of approximately 8.96 Hz. The translation in the x-direction is approximately 20.70 Hz due to the large stiffness in the x-direction.

Table 3 shows that the measurement results and simulation results are in good agreement. The differences between both results were only 5.9% in the y-direction and 2.57% in the x-direction, respectively. Hence, the finite element model is a close approximate to the Kiew Kho Ma Dam spillway.

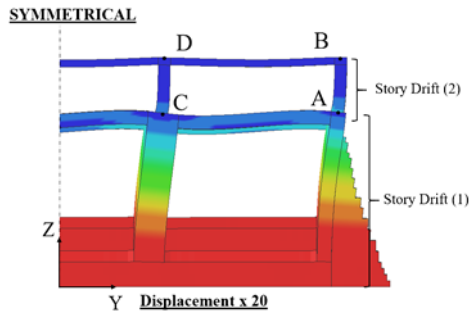
Fig. 12 Observation points and story drift

The structural responses of the Kiew Kho Ma Dam spillway, as determined using finite element analyses, were expressed through the acceleration, deformation, stress, and plastic strain. Fig. 12 provides the observation points that were used to obtain the model's structural responses.

By considering the acceleration responses, the maximum acceleration  $A_y$  is  $3.88 \text{ m/s}^2$  using EQ1. The maximum acceleration can be observed at point A (the top of the pier), while point B (the top of the gantry frame) experienced a slightly lower acceleration. At point B, the maximum acceleration is  $3.5 \text{ m/s}^2$ . The maximum amplification ratios ( $A_{y,MAX}/PGA$ ) are approximately 1.16 for point A and 1.04 for point B. The de-amplification of the gantry frame's acceleration can be observed in all cases. This de-amplification was due to the plastic deformation and the energy dissipation of the material model applied in the gantry frame.

The maximum longitudinal displacement  $U_y$  is 7.95 cm at point A, while the maximum up-downstream displacement  $U_x$  was found to be insignificantly small. The story drifts along the y-direction showed that the piers of the spillway on both ends were displaced more than those at the center. The maximum story drift of the gantry frame (2) is approximately 4.0 cm, while the maximum story drift of the spillway pier (1) is approximately 7.95 cm. According to the Thailand National Standard DPT 1302 [10], the maximum story drift must not exceed  $0.01 H$  ( $H$  is story height). Therefore, the allowable story drift is 4.4 cm for the gantry frame (2) and 14 cm for the spillway pier. Hence, the displacement responses

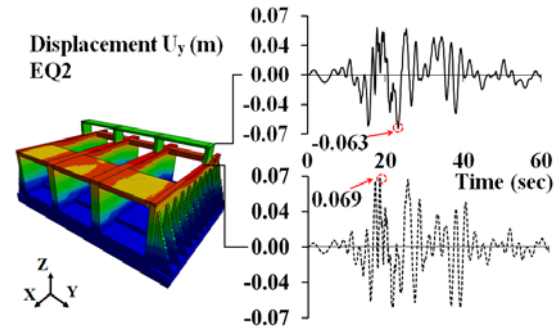
Fig. 13 Displacement,  $U_y$  subjected to EQ2

Fig. 13 illustrated the deformed mesh at 15.0 s and its corresponding longitudinal displacement time-history plots for points A and B when subjected to EQ2. Tables 4-6 provide the responses, such as displacement, story drift, acceleration, and acceleration amplification ratio, of the analysis model when subjected to EQ1, EQ2, and EQ3, respectively.

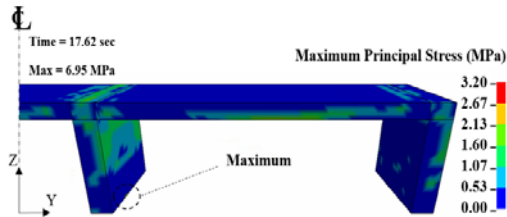
Fig. 14 Maximum principal stress (EQ2)

Figs. 14 - 15 show the maximum and minimum principal stresses of the gantry frame at the time when the peak values were reached. The results showed that the high value of the maximum principal stress (Fig. 14) was observed on the bottom of the gantry deck at its mid-span, column-deck joint, as well as the lower portion of the gantry column. The maximum value of the maximum principal stress was about 6.95 MPa. However, the overall maximum principal stress was extremely small and insignificant. For the

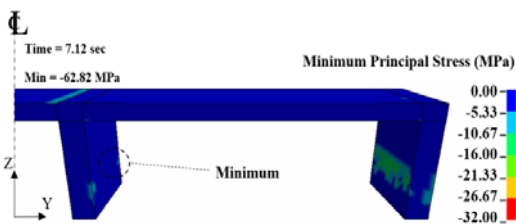
Fig. 15 Minimum principal stress (EQ2)

minimum principal stress, the lowest minimum principal stress was formed at the lower portion of the gantry column. The lowest minimum principal stress was 62.8 MPa. Accordingly, the plastic deformation was expected to occur around that particular location.

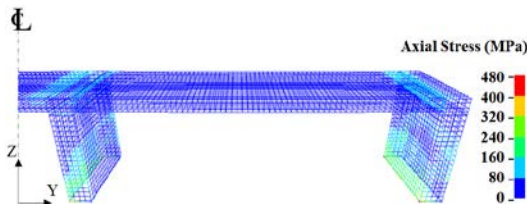
Fig. 16 Axial stress in rebar (EQ2)

Fig. 16 illustrated the axial stress in the rebar. The results yielded that the highest value of the axial stress was formed at the lower portion of the column's rebar. The maximum axial stress was approximately 400 MPa. Hence, the plastic deformation of the rebar was expected to occur.

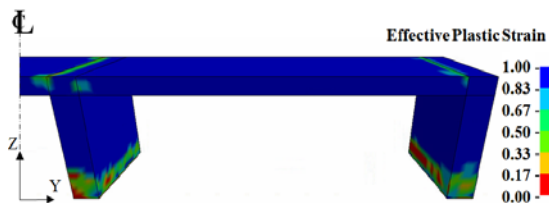
Fig. 17 Effective plastic strain in concrete (EQ2)

Structural damage can be observed via the effective plastic strain. This effective plastic strain can be captured only when using non-linear material models. Therefore, only the damage to the gantry frame can be assessed. For the concrete, the damage can be found mostly around the lower part of the gantry columns (Fig. 17). The results also showed that the gantry columns at both ends were subjected to less damage than those at the center. Similar results were obtained for the reinforcing steel, as the damage can be observed mostly at the lower portion of the gantry columns (Fig. 18).
