# EXPERIMENTAL STUDY ON THE RETROFITTING OF DAMAGED HOLLOW BRICK MASONRY HOUSES USING A FERROCEMENT LAYER

**ABSTRACT:** An experimental study on a hollow brick masonry house with and without a ferrocement layer was conducted to investigate the effects of retrofit on damaged houses using the ferrocement layer. Two specimens of the hollow brick masonry house with a scale 1/4 of the actual size (104 cm x 104 cm x 110 cm) were prepared. The first specimen (B1) is a hollow brick house without retrofitting and mortar plastering tested to suffer heavy damage. In contrast, the second specimen (B2) is a brick wall house retrofitted using a ferrocement layer with a bandage system on both sides of the specimen wall. Both specimens were tested on a shaking table of 304 cm x 190 cm with a load variation of 0.3 g – 1 g. The first test aims to make the B1 specimen severely damaged, in which the heavy damage occurs when the input load is 0.6 g with an additional evenly distributed load of 200 kg. After testing, the cracked B1 specimen was repaired and retrofitted using a ferrocement layer with a bandage system. The second test was carried out on the retrofitted B1 and B2 specimens. The test resul

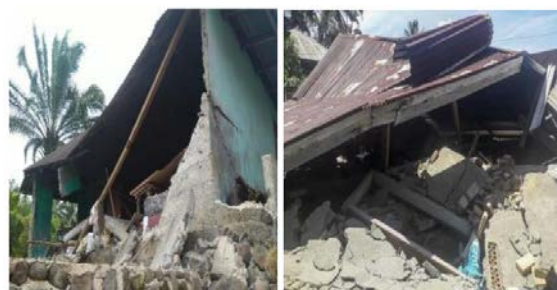
Fig.1 Damage to brick wall houses due to the 2022 West Pasaman earthquake [3]

The characteristics of the brick/hollow brick material make this house brittle and have almost no ductility, which makes the brick walls do not have sufficient resistance to horizontal loads or earthquake loads. These simple unreinforced hollow brick buildings can suffer light and heavy damage when an earthquake occurs, as shown in Fig.1.

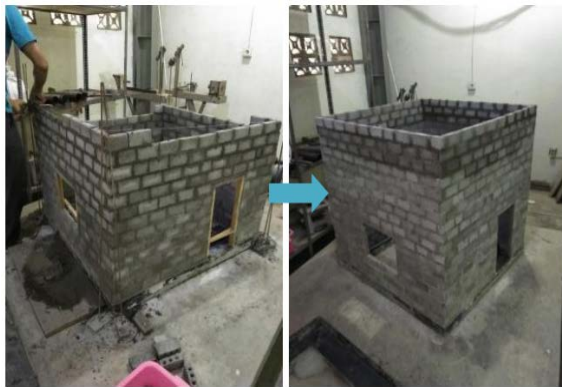
Fig.5 Construction process of B1 specimen

The material properties were tested using ASTM C1314-21 [13] at the materials and structures laboratory, Department of Civil Engineering, Andalas University. The process of making B1 and B2 specimens is shown in Figs.5 and 6.

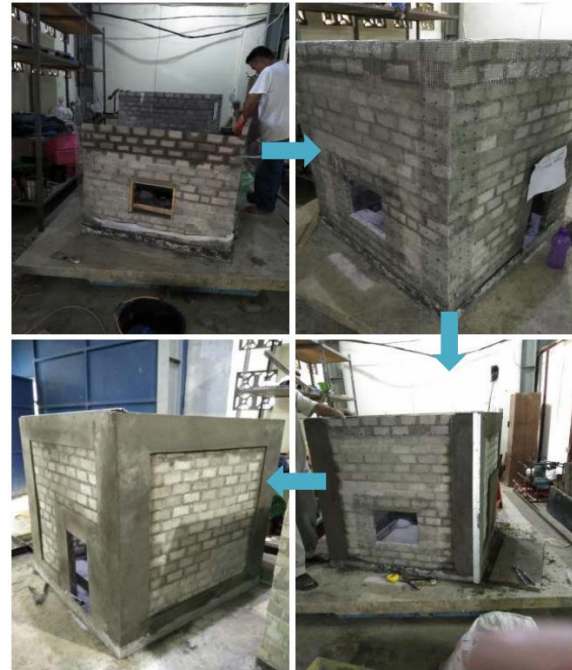
Fig.6 Construction process of B2 specimen

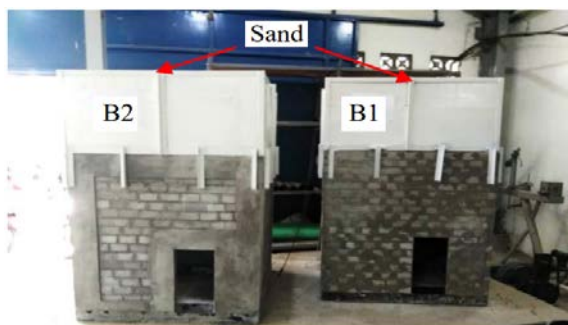
Fig.9 Specimens with additional uniform load using sand-filled sacks (sandbags)

Both specimens were tested again on the shaking table. This retesting (P2) consists of four loading stages: 0.3 g – 400 kg additional dead load, 0.6 g – 400 kg additional dead load, 0.6 g – 500 kg additional dead load, and 1 g – 500 kg additional dead load. The additional dead load referred to is the load using a sand-filled sack placed on top of the specimen, as shown in Fig.9.

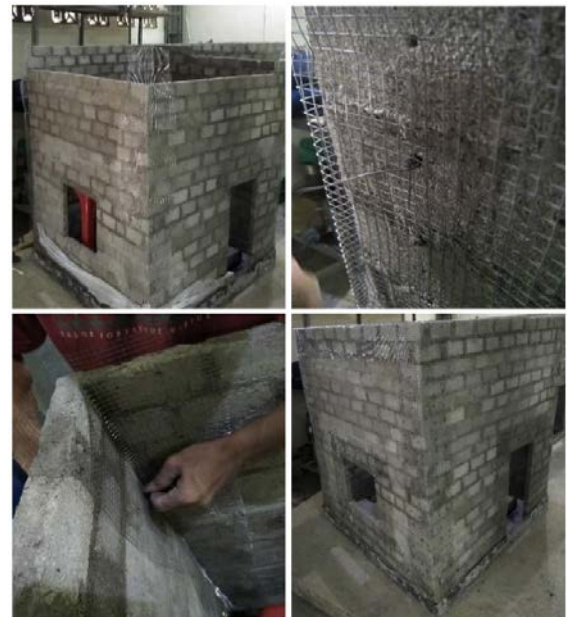
Fig.13 Repair of the concrete crack and installment of woven wire in the damaged B1 specimen

After testing, the heavily damaged B1 specimen was repaired and retrofitted by a ferrocement layer with a bandage system. The repair and retrofitting process of the heavily damaged specimen is shown in Figs.13 and 14.

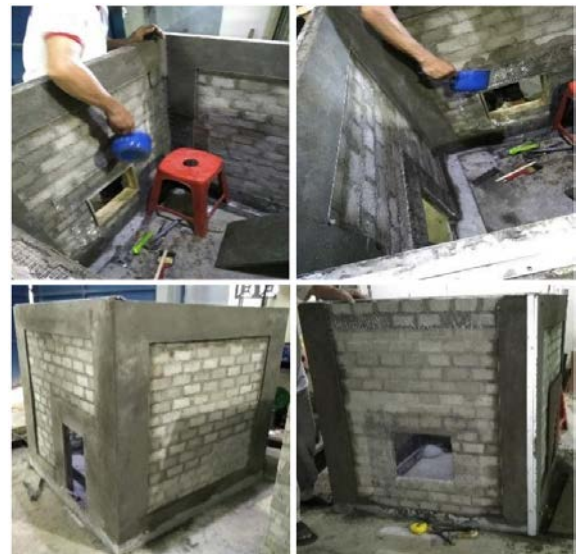
Fig.14 Plastered the woven wire on the damaged B1 specimen

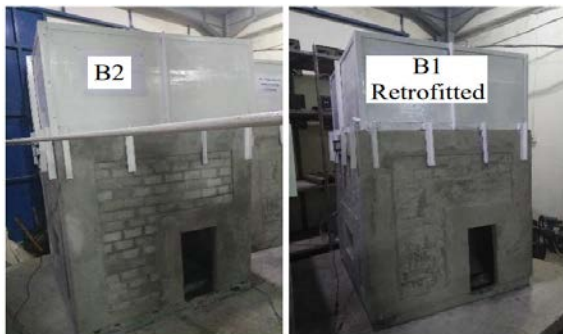
Fig.16 Tested specimens with an input motion of 1 g and an additional uniform load of 500 kg

Both specimens were subjected to an earthquake load of 0.3 g with an additional uniform load of 200 kg (P2-A), 0.6 g with an additional uniform load of 400 kg (P2-B), and 500 kg (P2-C), 1 g with an additional uniform load of 500 kg (P2-D). The test results show that no damage was observed on both specimens after each test until the P2-D test, as shown in Fig.16. The test was only carried out until this stage due to the limitations of the shaking table equipment.

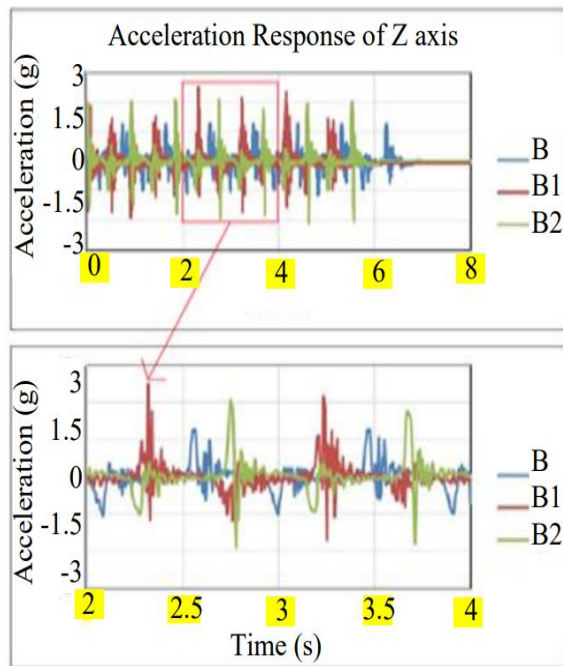
Fig.19 Acceleration response for B1 and B2 specimens with input motion 0.6 g and an additional uniform load of 200 kg on the shaking table test

Figs. 17 and 18 show the crack pattern on the B1 specimen tested until it is severely damaged. The figure shows that the cracks occurred at an earthquake load of 0.6 g with an additional evenly distributed load of 200 kg. The acceleration reading obtained using G-Trace shown in Fig.19 indicates that the maximum acceleration ( $a_{max}$ ) of the B1 specimen when the cracks occur is 2.5 g at  $t = 2.5$  seconds.

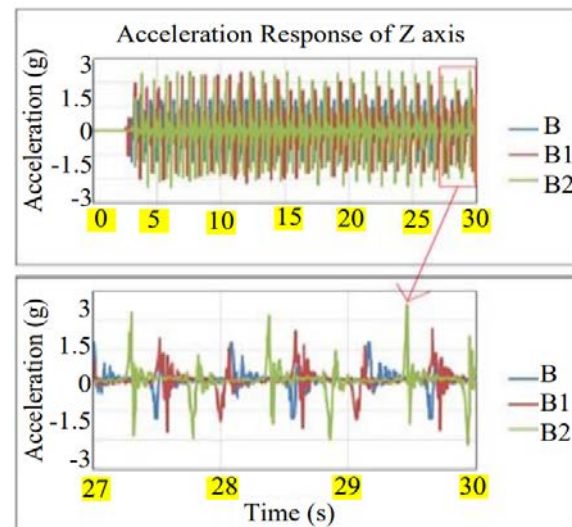
Fig.21 Acceleration response for the B1 and B2 specimens with an earthquake load of 1g and an additional load of 500 kg on the shaking table test

Based on Figs.20 and 21, it is seen that the retrofitted building using a ferrocement layer with the bandage system can withstand a high acceleration of the given earthquake load on the house specimens without any damage.
