# PREVENTION OF SOIL OUTFLOW FROM THE GROUND AROUND BRIDGE ABUTMENT USING CEMENT SOIL STABILIZATION

**ABSTRACT:** In recent years, heavy rains have frequently occurred in Japan, and a large amount of soil, rocks, and trees that were dislodged by landslides have flowed into rivers, causing damage to bridges. When a bridge is blocked by driftwood and boulders, the river water overflows onto and around the bridge abutment and the back face banking of the abutment is eroded, rendering the bridge impassable. We propose cement soil stabilization as a countermeasure to the erosion for the back of abutments. In this study, channel experiments on a 1:15 scale into the effect of cement soil stabilization were carried out. It was observed that erosion started from the downstream corner of the abutment when the overflow water returned to the river at the downstream point. In addition, when the back face banking of the abutment was strengthened with the minimum additional amount of concrete (set as 50 kg/m<sup>3</sup>) and cured for approximately two days, erosion was inhibited in both the reinforced back face banking and the unimproved levee.

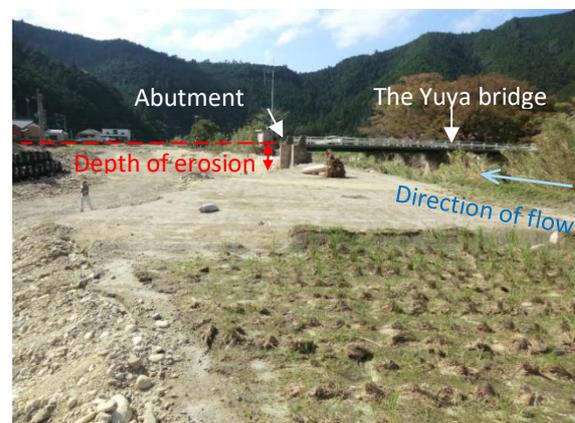
Fig. 1 Erosion at the left bank of the Yuya bridge (Photo was provided by Dr. Kenji Okajima)

In recent years, large-scale rainfall has increased in Japan due to the effects of climate change. It has been reported that trees and rocks have flowed into rivers from collapsed slopes due to heavy rainfall, causing damage to bridges. Driftwood and boulders accumulate between the bridge piers and balustrades that block the flow of rivers, causing the inundation of bridges, erosion of levees by overflow water, and erosion of road embankments adjoining the back faces of bridges by overflow water. Bridges are vital parts of roads and railways; when they are damaged, traffic obstacles occur, which significantly affect evacuation, isolate villages, and hinder post-disaster recovery. For example, the Yuyabashi Bridge over the Ohmata River in Kumano City, Mie Prefecture, was damaged by Typhoon Talas in 2011. Drifts were deposited on the bridge, and water overflowing from the upstream embankment eroded the ground. On the embankment adjoining the abutment, the ground was eroded by up to approximately 5 m, making the bridge impassable, as illustrated in Fig. 1.

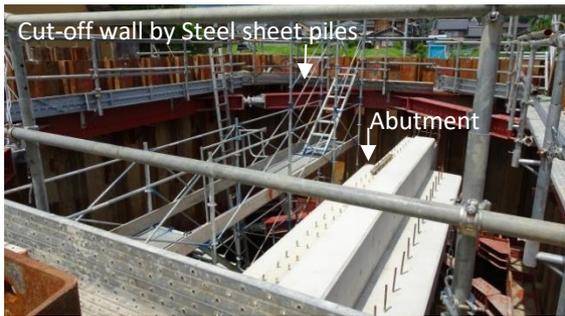
Fig. 2 Construction space by excluding water using steel sheet pile

In this study, we focus on the erosion of the embankment adjoining the abutment by overflow water. Abutments are generally constructed by excavating a space enclosed by inserted steel sheet piles, and this space is then backfilled with on-site soil, as depicted in Fig. 2. Because the enclosed

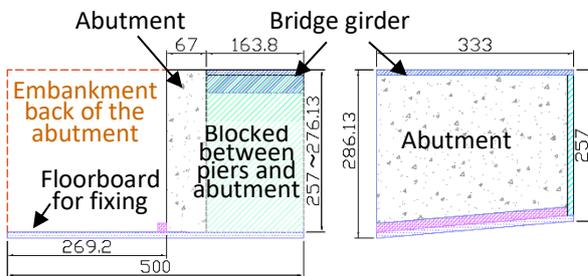
Fig. 3 Bridge model

The bridge model, constructed in this study, combined the following four parts depicted in Fig. 3: the wall of the inverted T-abutment modeled in a simple box shape, bridge girder, panel simulating a blockage between the bridge pier and abutment, and floorboard of the channel width. The bridge model was placed at the center of the experimental section in the lengthwise direction and fixed to the bottom of the water channel.

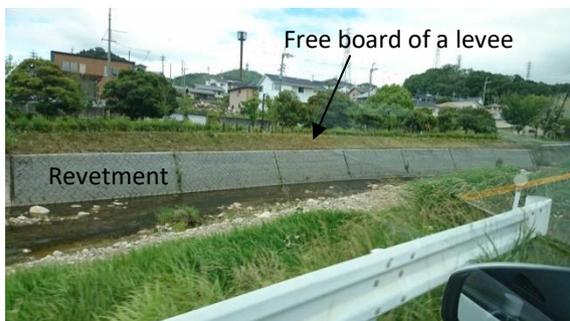
Fig. 4 Revetment and free board of a levee

The part of the free board of the levee, which is the revetment top end to the levee top end, and the surface of the embankment was assumed to be bare ground, and the embankment surface was assumed to be horizontal. The image of the experimental model on the actual embankment is depicted in Fig. 4, and the experimental model is illustrated in Fig. 5.

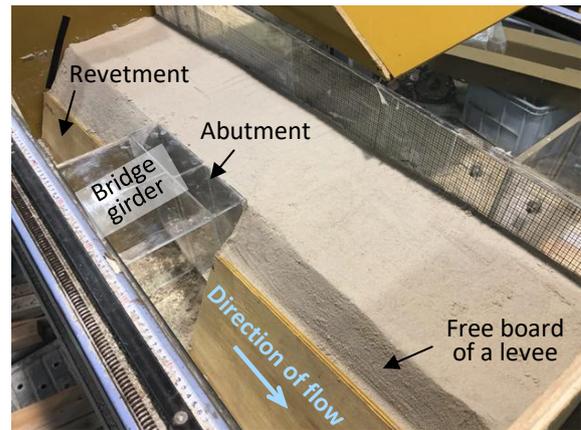
Fig.5 Experimental model (Case 1)

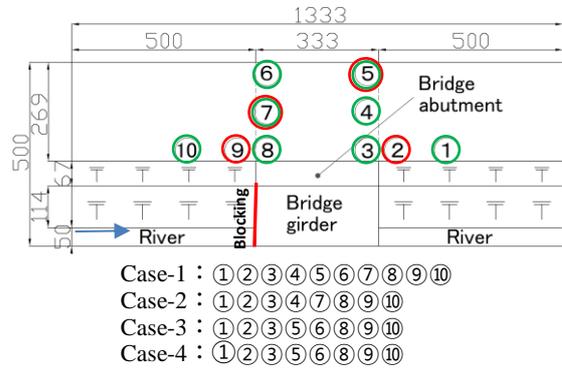
Fig. 6 Tilt sensor arrangement plan

To quantitatively evaluate the amount of displacement of the embankment, inclinometers were installed at symmetrical positions on the upstream and downstream sides, centering on the center of the bridge abutment. The two-dimensional diagram of the inclinometer installation position is illustrated in Fig. 6. Ten inclinometers were installed in Case-1, and eight inclinometers were installed in Case-2, Case-3, and Case-4. These inclinometers are the PMP-S5HT manufactured by Midori Sokki co, Ltd and can detect inclination from  $-5^\circ$  to  $+5^\circ$  in one direction by the leaf spring pendulum method. They were installed with the condition that when they incline toward the downstream side, the output change is positive; their bases were embedded to a depth of 100 mm. If the output is positive, the erosion is considered to be scraped from the ground surface. In addition, if the output is negative, it is considered that slip failure or progressive erosion

The direction of the inclination of the inclinometers was analyzed to consider the state of erosion. The green circle in Fig. 6 indicates that the upper part of the inclinometer fell toward the downstream side when the inclinometer started to move. With only inclinometers No. 2 and No. 9 close to the improved part, the lower parts of the inclinometers fell toward the downstream side. It is inferred that they moved along with the sliding soil due to the strong flow from upstream to downstream. In the case of the other inclinometers, their upper parts fell toward the downstream side. It is inferred that deep progressive erosion was suppressed, and the influence of erosion from the ground surface was greater than the influence of deep progressive corrosion.

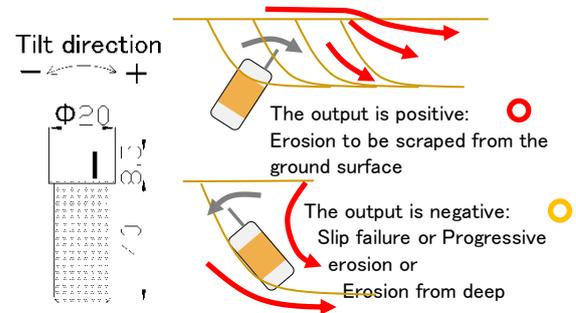
Fig. 7 Tilt direction and interpretation of results

or erosion from deep position occurs. The external dimensions and interpretation of the direction of inclination are depicted in Fig. 7 [11].

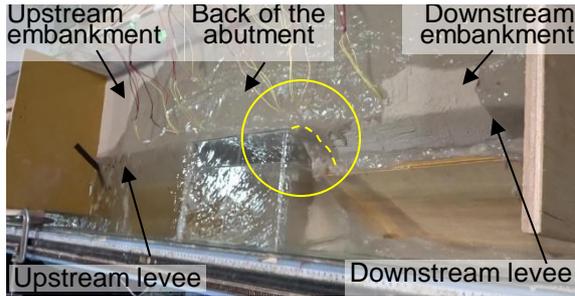
Fig. 8 Start of erosion (After 6 s from the onset of overflow)

The state after the water flow is depicted in Fig. 8, and the tilt fluctuation around each measurement point is depicted in Fig. 9. The overflow water reached the end of the downstream embankment adjacent to the abutment 6 s after the onset of the overflow, and the erosion started approximately 1 s after that. The 2nd inclinometer initially started to move. The erosion expanded from the end of the downstream embankment, which was adjacent to the abutment. The downstream embankment flowed out 17 s after the start of overflow. Subsequently, the eroded area expanded downstream and upstream. All the inclinometers leaned within 60 s. The red circle in Fig. 6 indicates that the upper part of the inclinometer fell toward the downstream side. The inclination direction of the inclinometer at each point was uneven, and the characteristic tendency was not observed in the erosion direction.

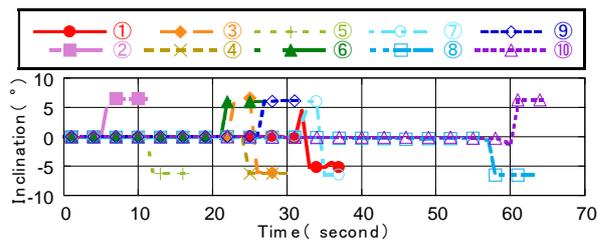
Fig. 9 Tilt fluctuation (Case 1)

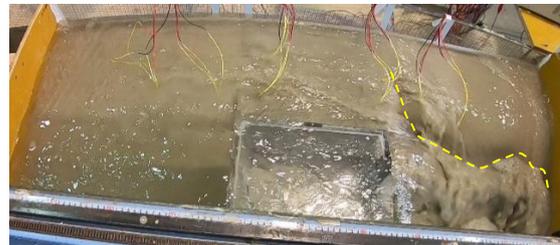
Fig. 10 Erosion at the boundary between the improved part and levee embankment on the downstream side

The state after the water flow is depicted in Figs. 10 and 11, and the tilt fluctuation around each measurement point is depicted in Fig. 12. The overflow water reached the end of the downstream embankment adjacent to the abutment 7 s after the onset of the overflow, and the erosion of the embankment started after approximately 1 s as in Case 1. However, the subsequent erosion process differed from that in Case 1, and the erosion near the back face of the abutment did not progress rapidly.

The downstream levee without cement soil stabilization was notably eroded by the surface flow, and the erosion progressed slowly at the boundary between the ground improvement part adjoining the abutment and downstream embankment depicted in Fig. 10. Furthermore, the erosion of the upstream embankment progressed, as indicated by the yellow arrowed line in Fig. 11. Then, the embankment just below the improved part was washed away. Inclinerometers of the improved part, which are inclinometers No. 3, No. 4, No. 5, and No. 6, indicated by the red points in Fig. 11, started to gradually incline at approximately 2 min and 40 s from the start of overflowing, and they significantly inclined downstream all at once after 3 min and 27 s. Because the four inclinometers demonstrated the same behavior simultaneously, it is clear that the ground improvement part became integrated, as indicated by Fig. 12. Inclinerometer No. 8, represented by the blue point in Fig. 11, in the upstream embankment part continues to incline gently from approximately 2 min and 27 s to the

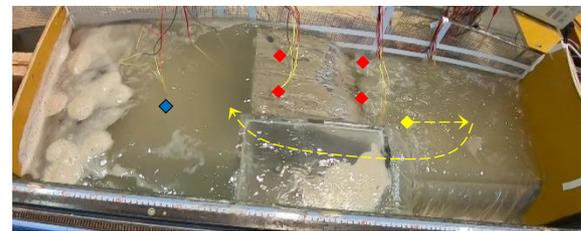
Fig. 11 Broken ground improvement part and process of displacement (After 3 min 40 s from the start of overflow)

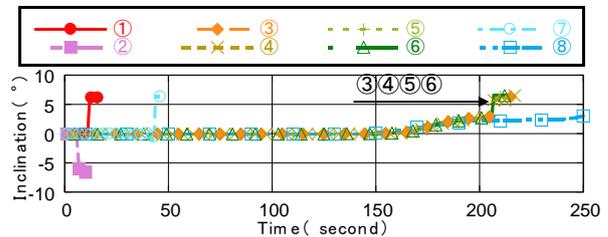
Fig. 12 Tilt fluctuation (Case 2)

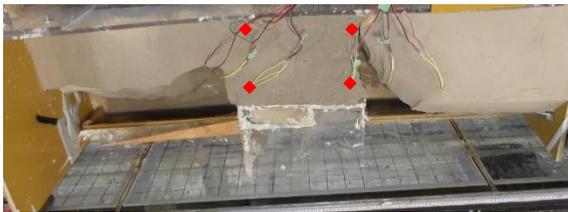
Fig. 13 Scour-like erosion and flow at the upstream side

The inclination of inclinometer No. 7, which was displaced first approximately 4 min after the overflow, is depicted in Fig. 14. Inclinometers of the improved part, which are inclinometers No. 3, No. 4, No. 5, and No. 6, indicated by the red points in Fig. 13, had not displaced even approximately 8 min after the overflow when the experiment ended. Thus, the effect of soil cement stabilization was also confirmed in the Case-3 experiment.

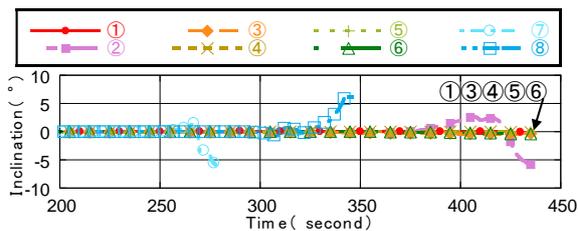
Fig. 14 Tilt fluctuation (Case 3)

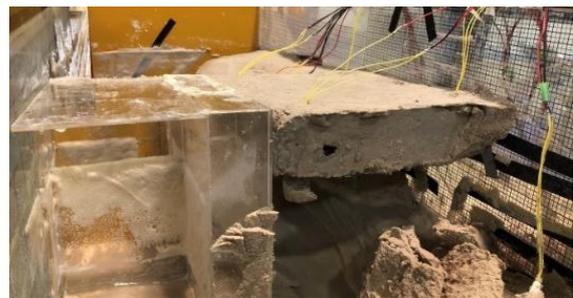
Fig. 15 Improved soil after the experiment

In Case 4, a more considerable amount of time passed before an overflow occurred because of the low flow rate as in Case 3. The erosion started from the upstream levee. After the erosion area approached the bottom of the upstream levee, the unimproved ground immediately below the improved ground adjoining the abutment was eroded in the downstream direction, and water flowed analogous to a tunnel penetrated

underneath the improved part, as depicted in Fig. 15. The results demonstrate that when the flow volume is low, that is, the flow velocity is low, the embankment erosion by the penetration on the upstream side is notable, and the erosion progresses in the riverbed direction. Additionally, because the amount of overflow water is small, the amount of erosion at the downstream embankment is small. The erosion gradually progressed at the boundary between the improved part and levee on the downstream side until approximately 2 min and 30 s after the start of overflow. Subsequently, the downstream embankment was completely washed away by the water flow; thus, the experiment ended approximately 40 min after the start of the experiment.

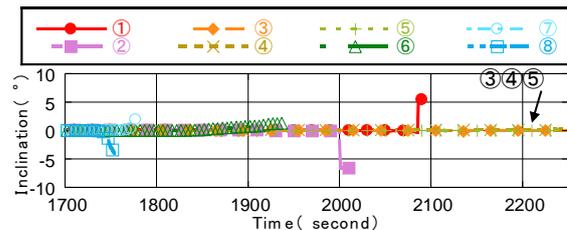
Fig. 16 Tilt fluctuation (Case 4)

The inclinometers No. 3, No. 4, and No. 5, in the improved part had not displaced, as depicted in Fig. 16. The cause of displacement of inclinometer No. 6 in the improved part close to the upstream revetment is that the base of the improved part was slightly eroded by the water flow.
