EXPERIMENTAL STUDY ON RETROFITTING OF URM HOUSES USING FERROCEMENT LAYERS WITH A BANDAGE SYSTEM

ABSTRACT: The 2022 West Pasaman earthquake in Indonesia caused significant damage, particularly to Unreinforced Masonry (URM) houses. Generally, most URM houses in West Pasaman are constructed without essential structural components, such as columns and beams. Consequently, these houses lack resilience against earthquake loads due to the absence of proper load distribution from the roof to the base of the building. To prevent severe damage to URM houses during future earthquakes, an experimental study was conducted on retrofitting damaged URM houses. The proposed retrofitting method involves applying ferrocement layers with a bandage system. This study aims to investigate the seismic performance of URM houses reinforced with these ferrocement layers. The specimen was built at a 1:4 scale of the original house in West Pasaman. The experimental work was carried out in two phases: the first test was conducted on the Original House (OH) specimen, which was subsequently repaired and retrofitted with ferrocement layers. The second test was then conducted on the Retrofitted House (RH) specimen

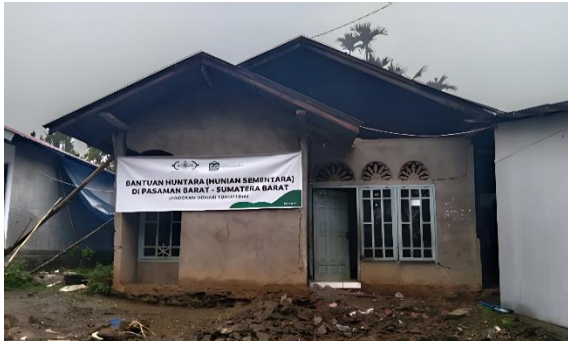
Fig.2 URM hollow brick community house in West Pasaman

Generally, URM houses in West Pasaman are constructed using half-brick ($\frac{1}{2}$ -brick) masonry walls

with a thickness of approximately 10 cm, as shown in Fig. 2. These structures lack sufficient seismic resistance because they do not incorporate structural elements, such as beams and columns, and their wall thickness does not meet the minimum standard of 20 cm [6–10]. To prevent sudden collapse or severe damage to URM houses during earthquakes, it is essential to conduct experimental research on strengthening post-earthquake damaged URM houses [11–13].

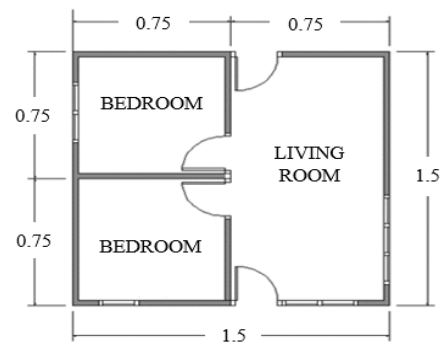
Fig.3 Plan view of the specimen

relative to this prototype. Consequently, the dimensions of the scaled specimen plan were 150 cm x 150 cm x 100 cm, with the bedrooms partitioned at 75 cm x 75 cm and the living room at 150 cm x 75 cm, as shown in Fig. 3.

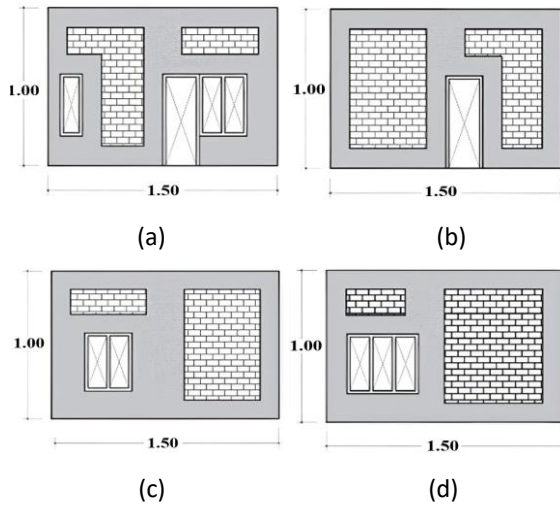
Fig.5 Elevation view of the specimen RH; a) Front view, b) Back view, c) Left side view, and d) Right side view

The experimental work was carried out in two phases. The first test was conducted on the unreinforced specimen, designated as the "Original House" (OH) specimen (Fig. 4), which was subsequently repaired and retrofitted with ferrocement layers. The second phase of testing was then conducted on the retrofitted structure, designated as the "Retrofitted House" (RH) specimen, as shown in Fig. 5.

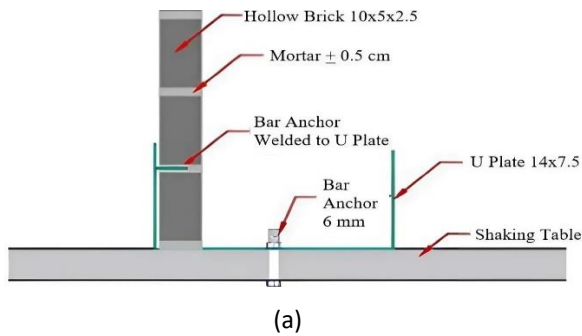
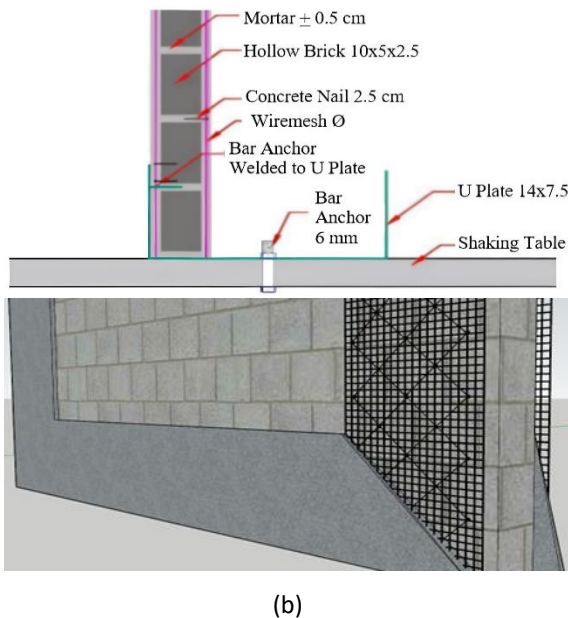
Fig.6 Wall details of the specimens: a) OH and b) RH

The detailed drawings of the specimen walls, featuring a mortar layer thickness of 0.5 cm, are presented below. Fig. 6(a) shows the wall details of Specimen OH, while Fig. 6(b) illustrates the wall details of Specimen RH, which include woven wire installed at the wall corners. Following the installation of the woven wire, the plaster layer was applied to the retrofitted area. The plaster mortar was prepared with a cement-to-sand ratio of 1:4.

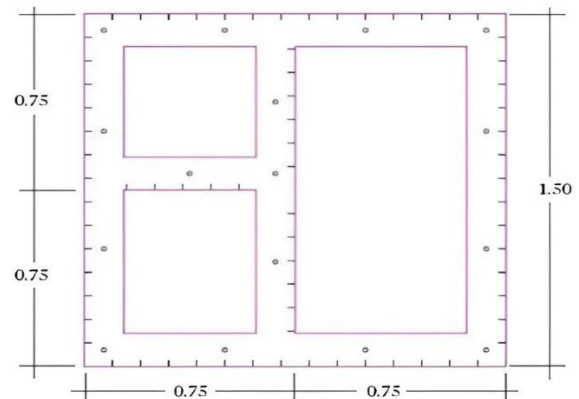
Fig.7 U-plate used as a specimen foundation for the shaking table test

The process of making Specimen OH begins with the installation of the model house foundation as a model of sample house stands on a vibrating table made of a U plate with a thickness of 2 mm and its

shape that has been adjusted to the dimensions of the Specimen OH, as shown in Fig. 7. The U-plate will be anchored to the concrete plate of the vibrating table with a slope of 16° along the x-axis as seen in Fig. 8.

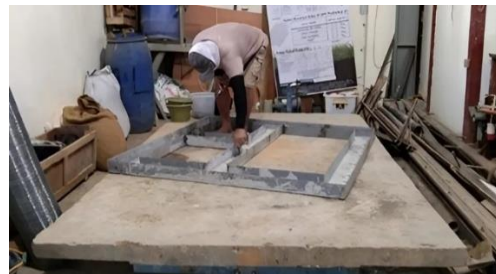
Fig.8 Installation of the U-plate on the shaking table

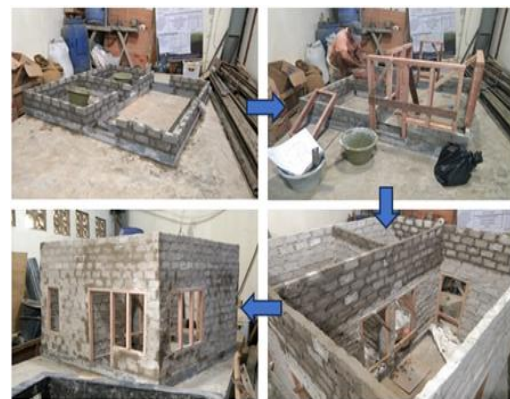
Fig.9 Construction of the brick wall for Specimen OH

After the U plate is attached, the bricks will be arranged on the U plate with a specimen thickness of 0.5 cm. The process of installing a brick wall of the Specimen OH, as shown in Fig. 9. The roof frame was made of wood as the truss, while the roof covering used a zinc roof with a thickness of 0.25 mm. The process of making the roof frame of the model house is shown in Fig. 10.

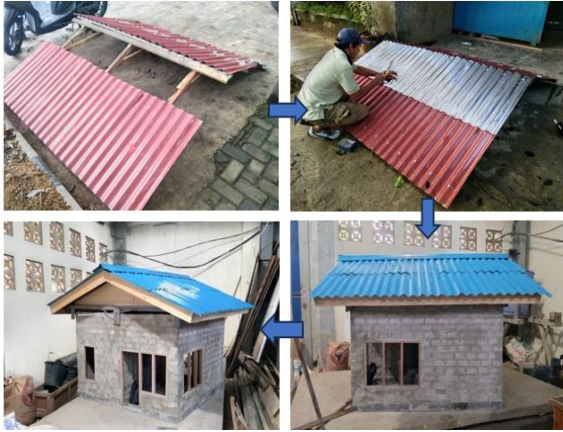
Fig.10 Fabrication of the roof frame and installation of the roof on the specimen

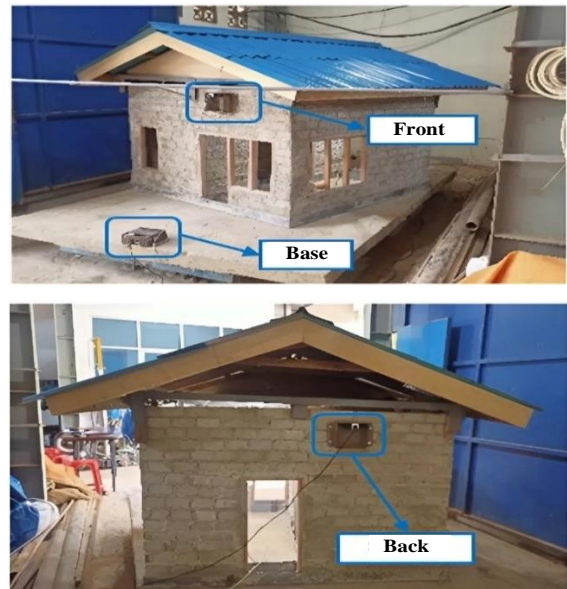
Fig.11 G-Trace tool sensor locations

The G-Trace tools used to record earthquake acceleration values were installed at three points. First, a sensor labeled 'BASE' was placed on the shaking table platform to record the input acceleration. Second, a sensor labeled 'FRONT' was positioned on the front wall of the specimen. Third, a sensor labeled 'BACK' was attached to the rear wall. The FRONT and BACK sensors recorded the response acceleration of the specimen, as shown in Fig. 11. These three devices were connected to a computer.

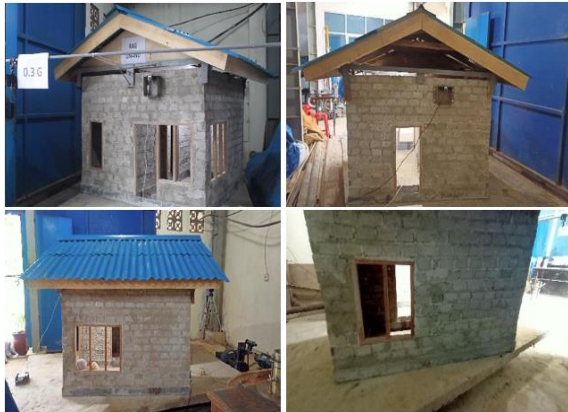
Fig.12 Specimen OH after testing under a 0.3g input motion

Observation of Specimen OH revealed that no damage occurred during the 0.3g earthquake acceleration, as shown in Fig. 12. However, at an acceleration of 0.6g, the specimen experienced wall cracking and partial wall collapse, as shown in Fig. 13.

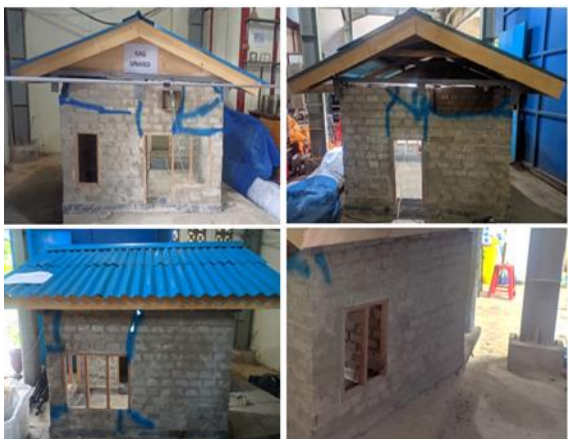
Fig.13 Specimen OH after testing under a 0.6g input motion

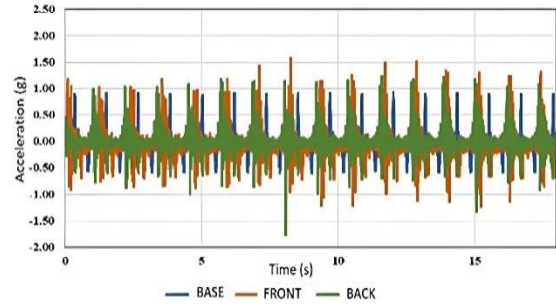
Fig.14 Acceleration response graph of Specimen OH under a 0.3g earthquake load (input motion)

The earthquake acceleration responses of Specimen OH under 0.3g and 0.6g loads for 15 seconds are shown in Figs. 14 and 15. In these response graphs, the blue line represents the acceleration recorded by the shaking table instrument (BASE), the orange line represents the acceleration on the front wall (FRONT), and the green line represents the acceleration on the rear wall (BACK).

The maximum acceleration recorded under the application of a 0.3g earthquake load was 0.98g at the BASE, 1.64g at the FRONT, and 1.30g at the BACK.

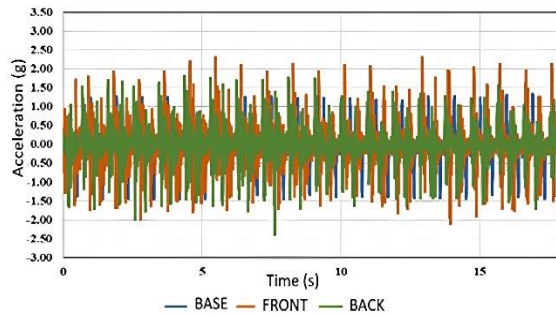
Fig.15 Acceleration response graph of Specimen OH under a 0.6g earthquake load (input motion)

When the applied earthquake acceleration was raised to 0.6g, the maximum acceleration values increased to 0.6g, the maximum acceleration values increased to 1.32g at the BASE, 2.22g at the FRONT, and 1.72g at the BACK. The crack patterns on the specimen under the 0.6g earthquake acceleration are illustrated in Fig. 16.

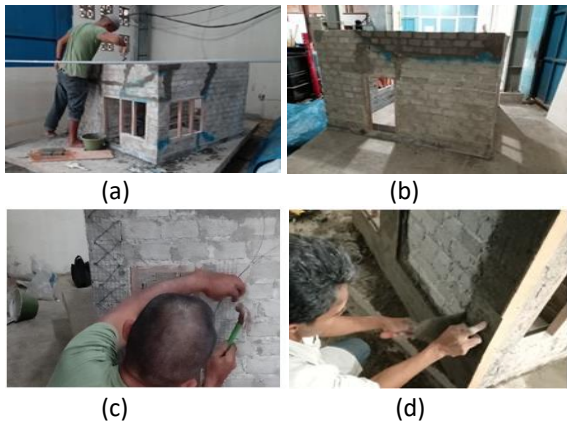
Fig.17 Repair and retrofitting process: a) patching cracked sections; b) installing bricks; c) installing woven wire mesh; d) plastering the retrofitted area

The damage to Specimen OH resulting from the first test was repaired and retrofitted using ferrocement layers with a bandage system, and this retrofitted structure was subsequently designated as Specimen RH. The procedure for repairing and retrofitting the specimen included patching the cracked sections (a), installing bricks (b), installing woven wire mesh (c), and applying plaster over the retrofitting area (d), as shown in Fig. 17.

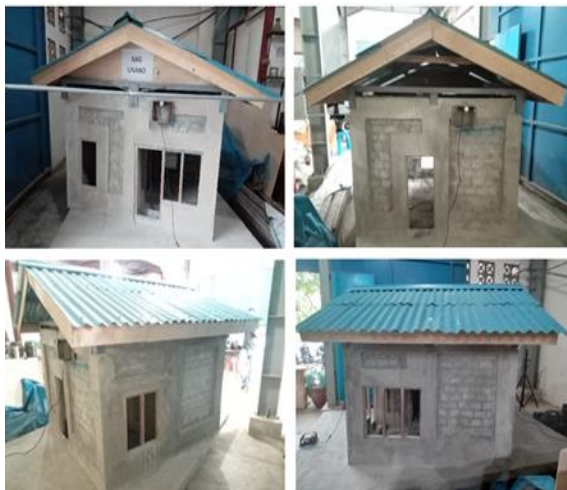
Fig.18 Specimen RH after completion of repair and retrofitting using the ferrocement layers method

After the specimen was repaired and retrofitted using the ferrocement layers method, it was subjected to a second shaking table test following the same procedure as the previous test. The final condition of Specimen RH, fully prepared for the second test, is shown in Fig. 18.

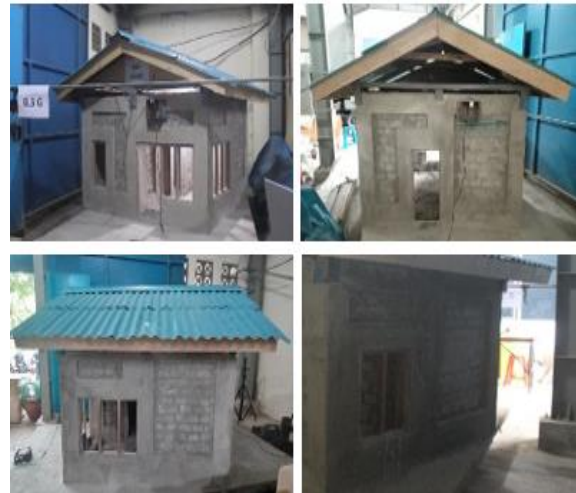
Fig.19 Specimen RH after testing under a 0.3g input

Observation of Specimen RH revealed no damage after 15 seconds of testing under earthquake accelerations of 0.3g, 0.6g, and 1.0g, as well as after 10 seconds under a 1.5g acceleration, as shown in Figs. 19-22.

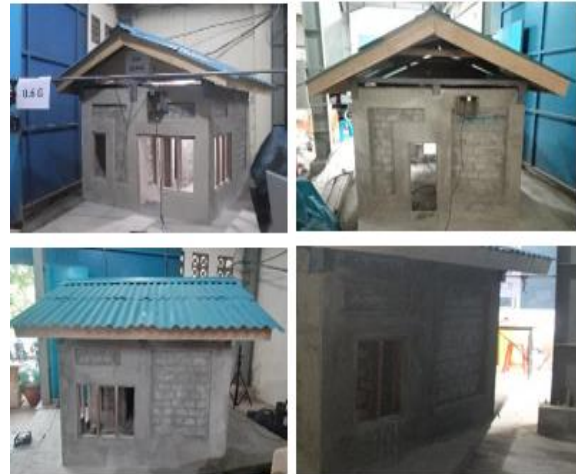
Fig.20 Specimen RH after testing under a 0.6g input motion

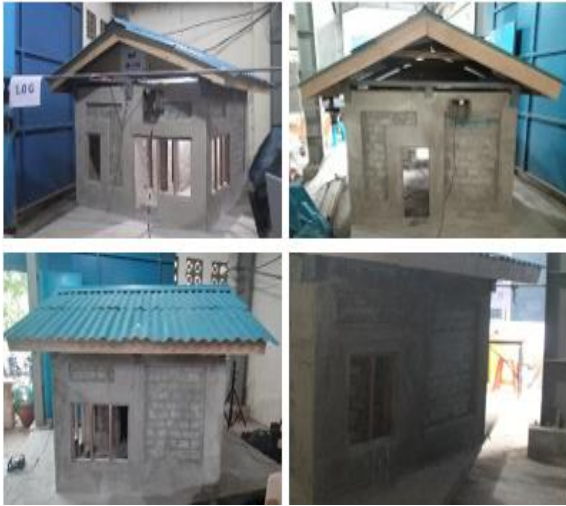
Fig.21 Specimen RH after testing under a 1.0g input motion

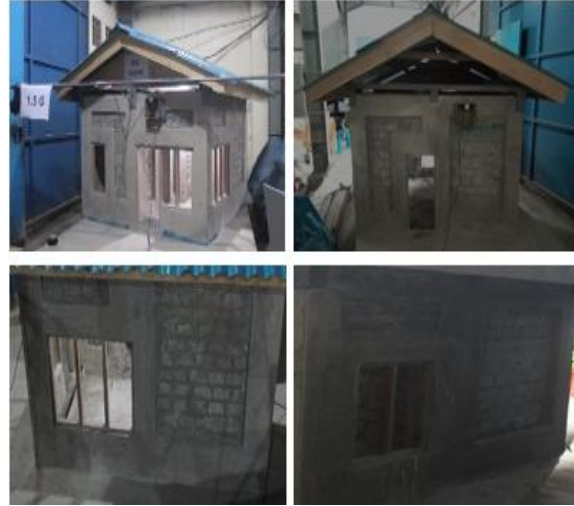
Fig.22 Specimen RH after testing under a 1.5g input motion

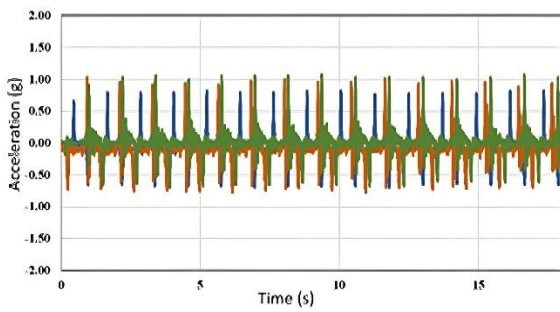
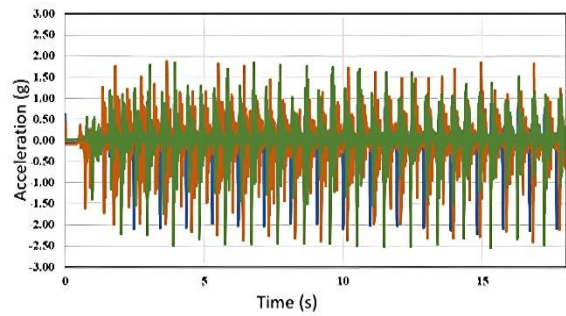
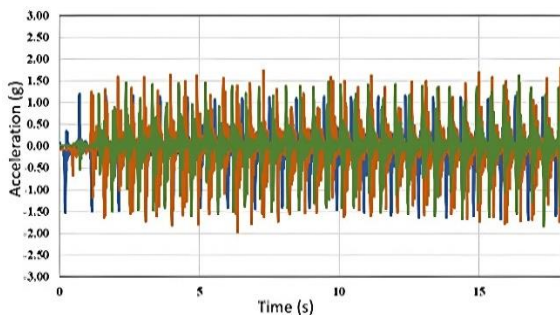
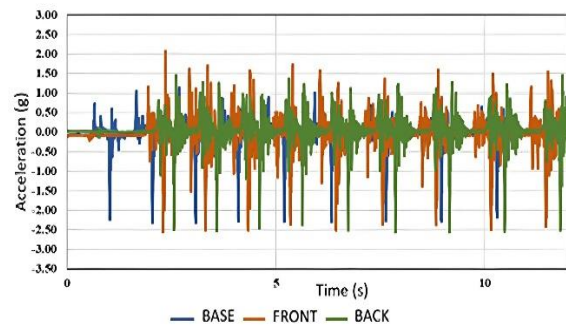
Fig.23 Acceleration response graphs of Specimen RH under earthquake loads of: a) 0.3g; b) 0.6g; c) 1.0g; and d) 1.5g

Fig. 23 shows the earthquake acceleration response graphs for the 0.3g, 0.6g, and 1.0g inputs (15-second duration) and the 1.5g input (10-second duration) from the shaking table testing of Specimen RH. As shown in the figure, under the 0.3g earthquake load, the maximum acceleration reached 0.92g at the BASE, 1.12g at the FRONT, and 1.06g at the BACK.
