## Experiments on Rockfall Protection Embankments with Geogrids and Cushions

**ABSTRACT:** There are various protection measures against rockfalls. An embankment is effective in rockfall hazard mitigation at a dangerous slope end. The slope rockfall tests on full-scale embankments have been carried out. These embankments are made of sandy soil reinforced with geogrids. The cushioning layers which are made of geocells filled with crushed stones of 5-13 mm in diameter are also placed on the mountain side of the embankment. A boulder, i.e., RC block rolls down the test-site slope, and hits against the embankment. A new system of measuring instruments is employed in order to evaluate the impact force and the impact energy. One of important observations is a possibility that a rolling boulder carries it toward the top of an embankment because of its rolling momentum. The experimental results, especially the relationship between impact force and impact energy is discussed in this paper.

International Journal of GEOMATE , Oct. 2011, Vol. 1, No.1 (Sl. No. 1)

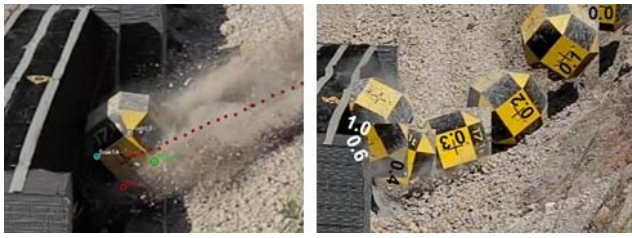
Fig. 8 RC-block trajectory by highspeed images of test No. 7

(f) *Translation Velocity* and (g) *Angular Velocity* are estimated using high-speed images taken just before the impact of an RC block on an embankment. Fig. 8 shows the trajectory of an RC block and a composite image in which numerical values indicate the time in seconds and express the rotational direction of an RC block. It is possible for the rolling momentum of an RC block to carry it toward the top of an embankment after the initial collision. It might be dangerous for us to ignore the rolling motion of a rockfall in order to design an embankment. This boulder's rolling motion has been left out of the past experiments on not only rockfall protection embankments but also rockfall protection fences.

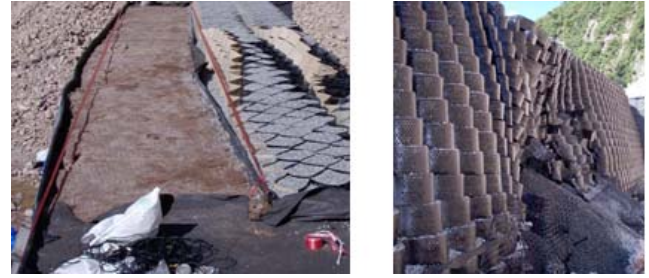
Fig. 10 After the impact of test No. 7

Figs. 10 and 11 show the deformation of embankments and cushion layers after test Nos. 7 and 8, respectively. The cushion layer is indeed damaged in exchange for playing the role of an absorber for the embankment but can be rebuilt easily. On the contrary it is not so easy to repair the embankment damaged by the direct impact of a boulder. Therefore a cushion layer is effective in not only protecting embankments but also reducing life cycle costs.
