EXPERIMENTAL INVESTIGATION ON BOX-UP COLD-FORMED STEEL COLUMNS IN FIRE

ABSTRACT: Cold-formed steel is a popular material with various advantages. Its easy production and assembly give engineer an option to speed the construction process. However, thinness relates to the major issue of buckling, especially when dealing with high temperature. The unprotected cold-formed steel behaviour under fire is expected to have a little strength as compared to hot-rolled steel. Information on such behaviour is still limited. Fire resistance testing on built-up box CFS column was presented in this paper. Two fire resistance tests were carried out under compression load. The Standard ISO 834 Fire Resistance Test under 50% and 70% degree of utilisation measured the temperatures at several points of the steel column surface by using a surface thermocouple and axial column deformation. For reference purpose, one same static test at ambient temperature was carried out to assess the load bearing capacity. Results found that the failure temperature of built-up CFS could reach up to 515 °C and 443 °C within 8 minutes and 7 minutes resistant time for 50 % and 70% degree of utilisation, respectively. Base

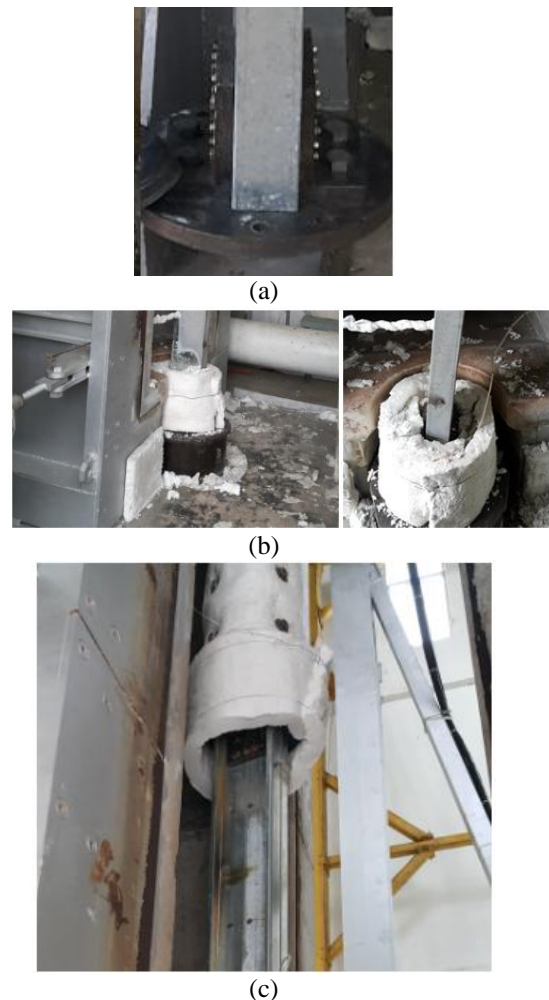
Fig. 1. Support condition of the column.

The end column was screwed to the two steel angles at both column webs as in Fig. 1 (a). It used to restrain lateral movement of the column. A circular steel plate was used to place the bottom and top end of the column. It is used to ensure the load was uniformly distributed over the column cross-section. Column top was attached in the same manner at the bottom. Meanwhile, fire test support was improved to prevent support expansion due to fire. All steel-end plates, angle and steel-based, were coated with 3 mm high temperature coating paint. 20 mm ceramic fibers, which were covered with steel-based and thermocouple were placed at the bottom of the column to monitor the temperature as shown in Fig. 1 (b) and (c). Temperature measured was less than 100°C.

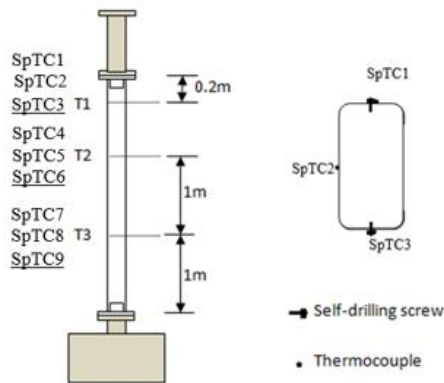
Fig. 2. Location of thermocouple on the column

The rise of temperature data in the column was captured by a surface type K thermocouple. The thermocouple position along the length of the column and in the column section was according to BS EN 13381-4:2013 (E) recommendation. Fig. 2 shows the of the thermocouples position on the column height and at the cross-section. Fig. 3

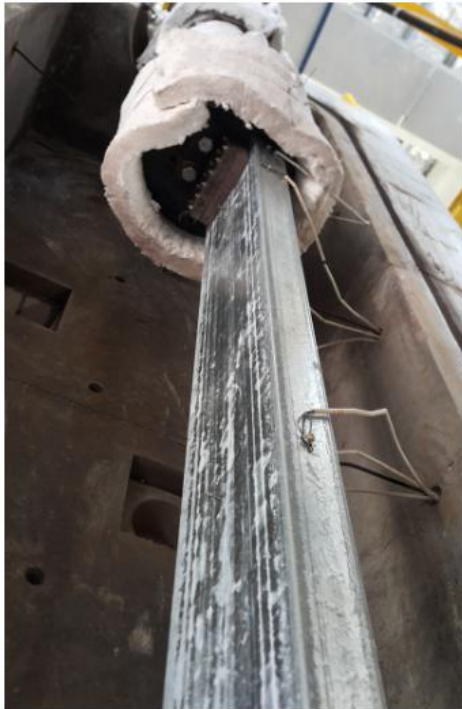
Fig. 3. Attachment of the thermocouple on the column.

shows the actual thermocouples attach to the column. Since the column is unrestrained, the axial deformation was allowed during fire exposure. The axial deformation of the column was also monitored based on the actuator movement. The ambient and a series of fire tests were conducted under the same actuator and loading frame. At ambient test, the CFS column was loaded until it failed. During the fire test, the column was loaded till reach a constant load level for 5 to 10 minutes before the fire was introduced into the furnace. The test was stopped until the load dropped, which was considered that the column had failed. A hydraulic jack loading system with a maximum load of 1000kN was used to load the column with a loading rate of 0.25 kN/s.

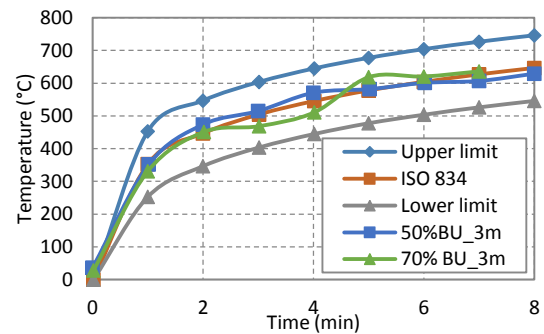
Fig. 4(a) Furnace average temperature during testing for Box-up column.

ISO 834 standard fire curve and 15 % percentage deviation (de) from a standard fire curve, as shown in Fig. 4(a), was according to BS EN 1363-1:2012 (E). The graph also plots the furnace average temperature curve for all samples during testing. The furnace consists of six blowers. 3 blowers located at left and right side of the furnace, which by location were at the top side, middle side and bottom side of the furnace. Furnace fire was produced by a gas furnace which transfers heat to the CFS through radiation and convection. Convection will cause the air particles (gases) to spread out and become dense, causing a movement of gases. Cooler gas is dense and warmer gas is less dense and thus causes warmer gases to rise up. Radiation does not require a medium to transfer heat. The CFS shiny surface is poor in absorbing radiation heat.

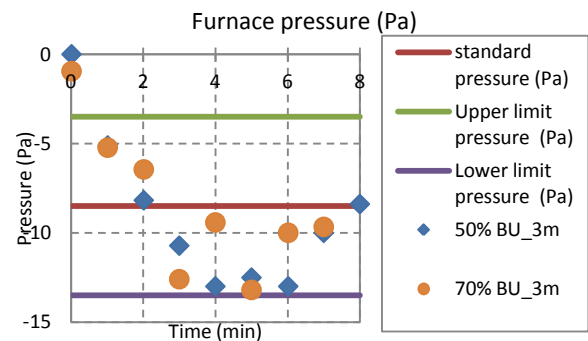
Fig. 4(b) Furnace pressure

The furnace pressure should be approximately 8.5 Pa per-metre height within ± 5 Pa after 5 minutes during fire, as recommended in BS EN 1363-1:2012 (E). The pressure inside the furnace was presented in Fig. 4 (b), which shows that the furnace pressure during the fire test was within an acceptable range.

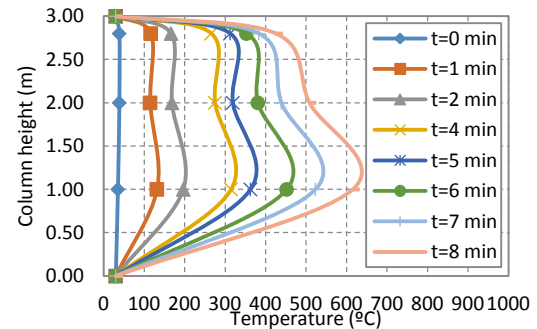
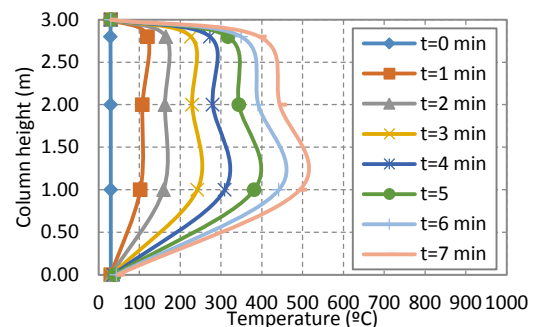
Fig. 5. Temperature evolution along the length of Box-up column

Fig. 5 shows the temperature evolution of CFS column due to different load utilisation. At the beginning of fire exposure until failure time both columns evolved at a uniform temperature and slightly higher temperature at the bottom. The evolution of temperature was independent to the degree of utilisation of the column.

Nine thermocouples gave reliable results, whereby the steel temperature rise over time of fire exposure was observed. It was found that the CFS temperature rise was propositional to the fire exposure time for all stations. Thermocouples located at 200 mm from top support and loading were known as SpTC1–SpTC3. The rise of temperature at this location was lower the Standard ISO 834 fire for all degrees of utilisation until the column failed. The rate of temperature rise of 50% and 70% degree of utilisation was similar for all the thermocouples except for SpTC6. This may happen due to uneven fire blow during testing. The rate of temperature rise was also similar for different degrees of utilisation. It can be concluded that the rate of temperature rise of the BU CFS column was constant for CFS and independent to the degree of utilisation. It was found that rise of temperature at the bottom was faster as compared to the top. This may happen because the heat in the furnace was pressured to the bottom of the furnace and may be due to some heat losses from the ceramic fibre on top of the furnace. A technician can feel the temperature around the outer furnace top. The 70% load utilisation failed at lower temperatures as compared to the 50% load utilisation. In addition, the 70% load utilisation had a lower failure temperature than Standard ISO 834 fire curve in contrast with the 50% load utilisation, was failed when approaching the ISO 834 fire curve.

SpTC5, SpTC7, SpTC8, and SpTC9 for 50% degree of utilisation rose up to the Standard ISO 834 fire curve at failure while for 70% degree of utilisation, the column failed at lower temperatures.

SpTC7, SpTC8, and SpTC9 were temperatures at the lower column. SpTC5 was the temperature at 2m from the bottom, specifically at the web of the box-up CFS. SpTC4 and SpTC6 were located at the flanges which had a double thickness, resulting in a lower failure temperature. The greater web thickness and thermal conductance between the two CFS profiles have caused these

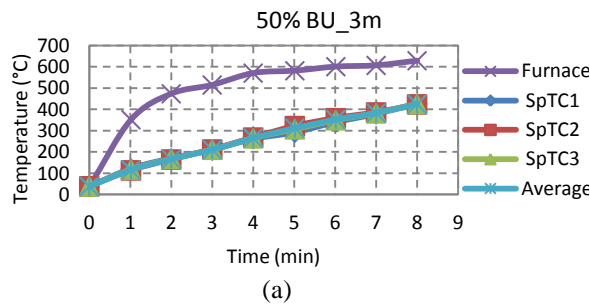
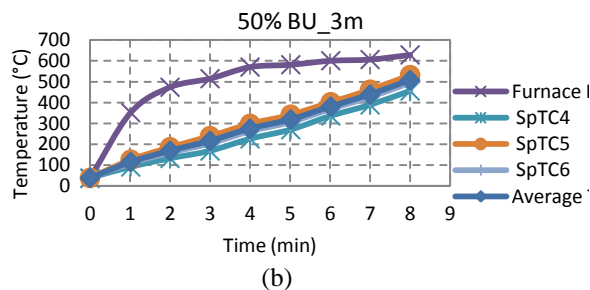
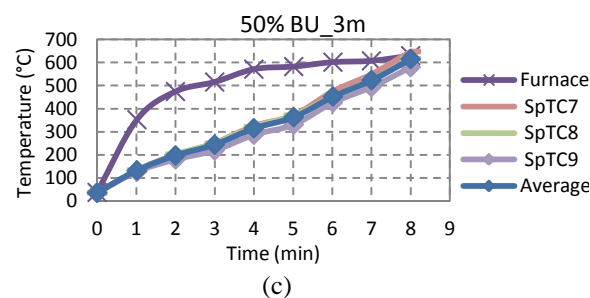
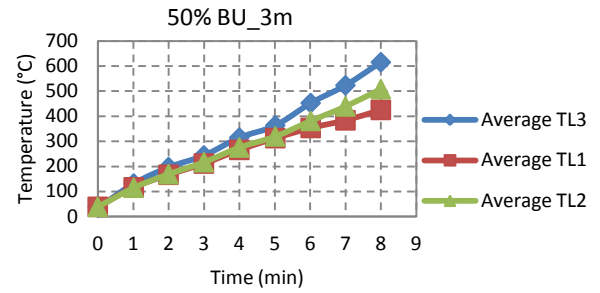
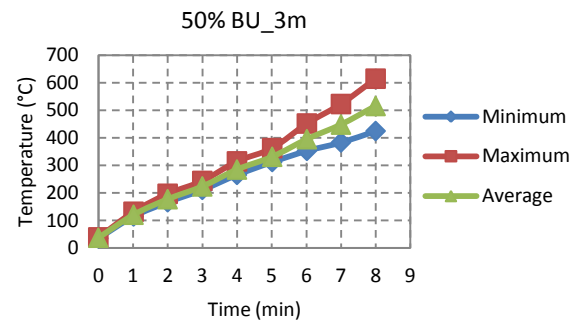
Fig. 6 Evaluation of mean temperature along the column for 50 % degree of utilisation

This section explains the analysis of a mean temperature for the column. The evaluation of mean temperature along the column was calculated by using the weightage area methods in which the temperatures recorded were multiplied to the area of column surface and divided by the total area of the column. This method was applied to account for the area coverage near the thermocouple that represented the flange and web surface temperature. Figure 6 and Figure 7 shows the temperature for 50% and 70% load utilisation, respectively.

Level T1 for 50% load utilisation recorded a similar value for all surfaces as in Fig 6(a). Hence, the average is directly determined by a simple average. As the lower side of the column was high in temperature at, a difference in temperature at respective levels was found. The temperature at web was higher than at the flanges due to the thicker thickness as in Fig 6(b) and (c). However, the difference in temperature was less than 10%, hence the calculated simple average can be

accepted. The analysis was continued with depth detail on the average TL for each column. TL3 resulted in a higher average followed by TL2 and TL1 as in Fig. 6(d). This behaviour was similar to the 70% degree of utilisation. All columns had the same temperature rise behaviour where the upper thermocouple registered a lower temperature until column failure. This may be caused by the thermocouple located nearer to the ceramic fibre which supported the column end. The heat was shielded by a ceramic fibre that restricted the conductance of heat to this position.

To select the appropriate mean temperature for the column, the minimum, maximum and average temperature for each level was plotted. Again, the difference between all values was small, hence the average value was selected. Table 1 shows the mean temperature for each degree of utilisation.

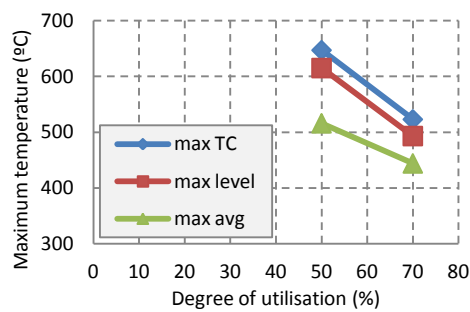
Fig. 7 Evaluation of critical temperature

The consideration in fire safety design is concerned about preventing structural failed before resistant period. The evaluating of the critical temperature steel column is characterised as a uniform temperature all over the column surface. The critical temperature was determined by evaluating the results of the maximum temperature gain from the experiment, the highest values of the average temperature for each thermocouple level, and the highest value from the mean temperature. Fig. 7 plots the temperature values against degrees of utilisation. Furthermore, the safe temperature

value in selecting the critical limiting temperature, the smallest value was considered. As expected, the resistant time was decreased as the degree of utilisation was increased. Then, both the initial and average heating rates were calculated by using the temperature at the first 1 minute, meanwhile the value of the average heating rate was according to the temperature and time of the column at failure. The load applied on the column does not affect the heating rate of the column and this was also reported by [11]. The heating rate of 60 °C/min was constant for all box-up column. The initial heating rate of 84 °C/min is higher at for the column due to the rate of Standard ISO 834 was higher at 329 °C/m at the first 1 minute. The critical temperature of the box-up column was 515.95°C and 443.77 °C and the critical time was 8 and 7 minutes for 50% and 70% degree of utilisation, respectively. The degree of utilisation was increased results in decreasing of critical temperature and time.

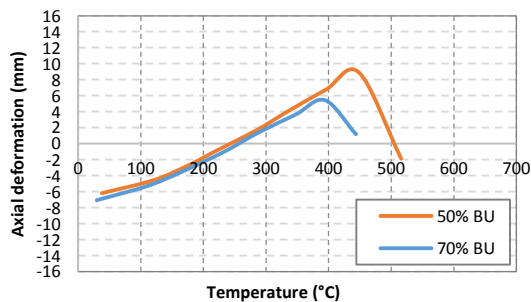
Fig. 8. Variation of axial deformation over the box-up CFS column means temperature.

The axial deformation of the column was analysed against the mean temperature rise of the column and the results were presented in Fig. 8. The column had an initial deformation due to load level application of 50% and 70% load utilisation. The axial deformation was accounted after the column was fired. According to the buckling temperature definition given by [12], the buckling temperature is considered at the maximum axial deformation of the column. It was found that the buckling temperatures of the column were 448 °C and 394

°C, with a critical time of 7 minutes for 50 % and 70% degree of utilisation, respectively. This concluded that the higher degree of utilisation resulted in lower buckling temperatures of the columns. Both values, critical temperature and buckling temperature, would be significant in predicting future CFS fire resistance design. Fig. 9 shows the testing configuration and buckling failure of the CFS column under Standard ISO 834 fire exposure.
