CONSTRUCTION OF EARTH FILL STRUCTURE FOR SMALL FARM POND BY USING BHUTANESE TRADITIONAL WALL MAKING METHOD

In this paper, a concept and a construction procedure of the earth fill structure for small farm pond constructed in KB are described. Then, the results of the follow-up of the earth fill structure are also reported.

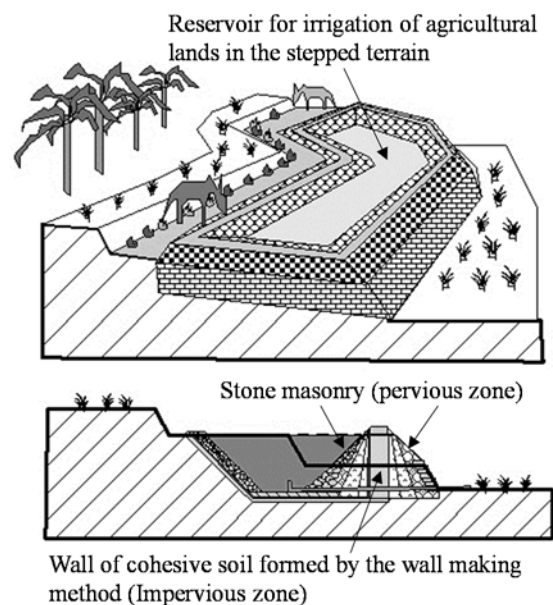
Fig.2 Schematic diagram of the small-scale reservoir with the concept in which Bhutanese traditional techniques is actively utilized

earth fill structures, in the construction of reservoirs with a modern design concept, bodies of the reservoir have often been designed with a couple of zones of earth materials [6] which have high strength (for the pervious zone) or low permeability (for impervious zone). In the construction of such zoned bodies of the reservoir, the stone masonry work seemed applicable to the construction of the pervious zone because stone masonry has a stable structure. On the other hand, the permeability of the wall of cohesive soil formed by the wall making method would be small, so this technique may be applied to the construction of the impervious zone. The design and construction techniques for small-scale reservoirs in which Bhutanese traditional techniques are actively utilized should be developed for sustainable agricultural production in KB. Fig.2 shows a schematic diagram of the reservoir for

irrigation of agricultural lands in the stepped terrain with the concept mentioned above.

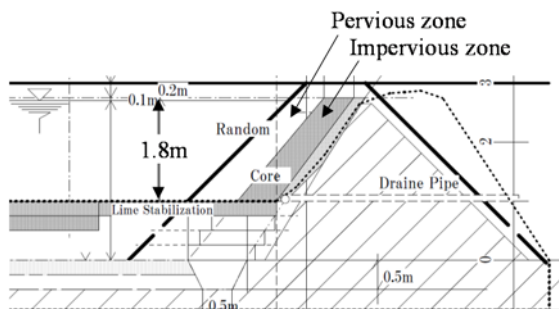
Fig.4 Cross section of the small farm pond originally planned

Construction of the earth fill structure for small farm pond was started with the support of Japanese NGO in Gebekha village (Fig.3) in 2015. Cross section of the small farm pond in the original plan is shown in Fig.4. Originally, the cross-section of the small farm pond was planned as a sloping core type dam. A timeline of the construction is outlined below.

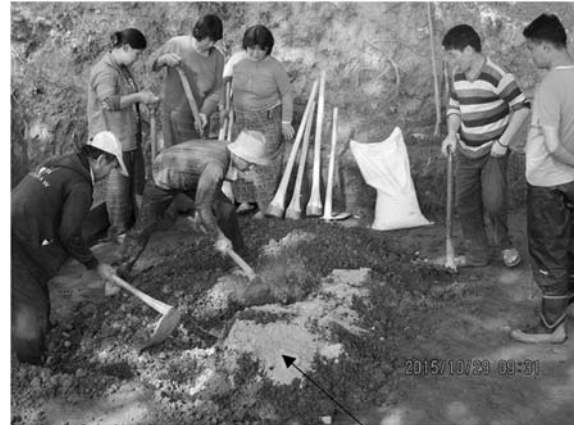
Fig.5 Stabilization treatment of foundation by cement-mixed soil

Firstly, the stabilization treatment of the foundation was conducted. Machinery excavation of original ground up to 1.5m depth was initially planned to obtain a more stable foundation. However, this plan was changed to manual excavation up to 25 – 50 cm depth because the excavation machine couldn't be prepared. After removing unsuitable things for the foundation of reservoirs such as plant fragments from excavated soil, the foundation was reconstructed by tamping cement-mixed soil which was obtained by mixing the excavated soil and cement because enough bearing capacity of foundation couldn't be achieved by only tamping the excavated soil. The mixing ratio of cement was around 6 %. Fig.5 shows stabilization treatment of foundation by cement-mixed soil.

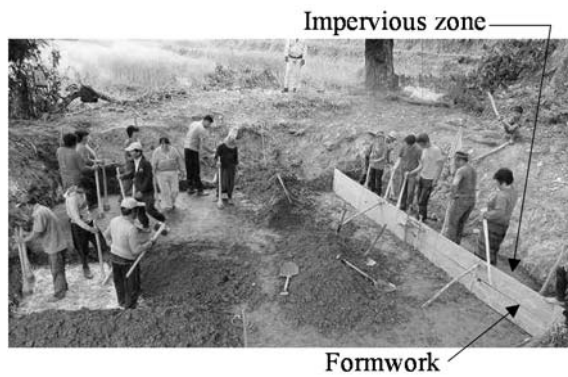
Fig.6 Compaction of impervious zone by the wall making method

Earth material used for impervious zone was gathered from abandoned paddies and fields near from construction site. After removing large size gravel, the water content of earth material was adjusted by sprinkling water from a mountain stream. Although natural and optimum water contents [7] couldn't be measured, the water content of earth material suitable for compaction was decided according to its texture. In the compaction of the impervious zone, the wall making method was utilized (Fig.6). The thickness of each layer of earth material was controlled so as to be about 8 cm after compaction. Every completion of compaction of three layers, permeability of the compacted layer was

measured by the in-situ permeability test. After confirming hydraulic conductivity of the compacted layer was lower than 1×10^{-5} cm/sec, the compaction of the upper layers was started. Dry density of compacted layers was not measured.

utilizing Bhutanese traditional wall making method in 2015 (Fig.6). These tests were performed at three points. The testing points are shown in Fig.9. In this tests, a cone with a diameter of 25 mm was driven into the impervious zone in steps of 100mm by blows from a slide hammer with a mass of 5 kg falling through a distance of 500 mm. The numbers of blows required for this penetration were recorded as the penetration resistance N_d . Test results N_d were converted into N value which obtained by the standard penetration test (SPT), by employing Eq.(1) [9].

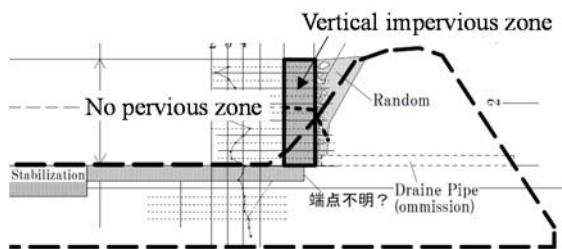
Fig.7 Cross section of the small farm pond completed

After the harvest of agricultural products, farmers restarted the construction of the earth fill structure for a small farm pond by themselves. Co-authors left advice about construction techniques and procedure according to the original plan. However, farmers didn't completely obey that advice. They changed the cross-section of the small farm pond. Cross section of the small farm pond completed is shown in Fig.7. The small farm pond completed quite differ from that originally planned. Firstly, although cross-section of the small farm pond was planned as a sloping core type dam as shown in Fig.4, that was changed to a vertical core type dam. Secondly, there was no pervious zone which should exist in front of the impervious zone. The previous zone is very important to increase the resistance of the body of the reservoir against external forces and to protect the impervious zone from erosion. However, the impervious zone of the small farm pond completed has been exposed to impounded water and rain. Reasons, why farmers changed cross-

section of the small farm pond, were that they didn't want to reduce a reservoir capacity and that they couldn't understand the importance of pervious zone. For developing water resource steadily by farmers themselves, it is crucial to obtain a better understanding of farmers about design concepts of reservoirs.

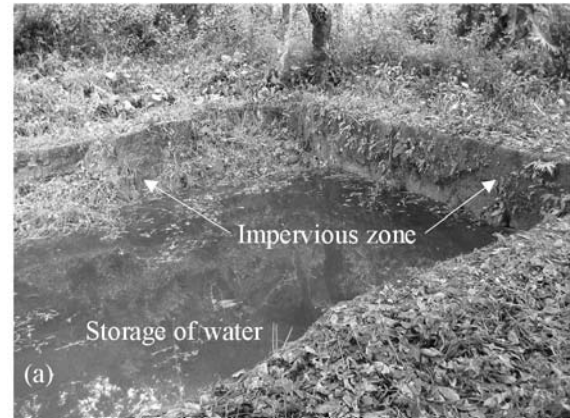
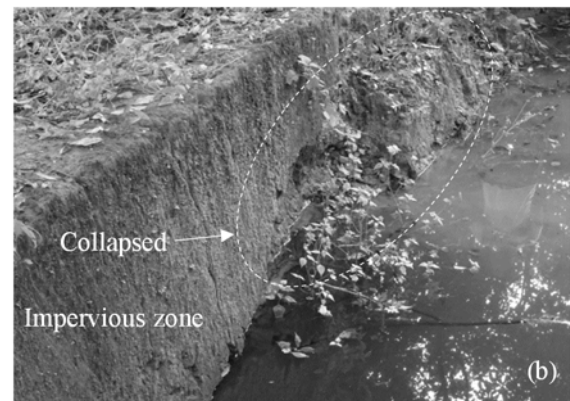
Fig.8 Condition of the earth fill structure at the follow-up

Authors conducted a follow-up of the earth fill structure for a small farm pond in September 2017 to confirm the current condition of the small farm pond and to evaluate the performance of the wall making method as a construction technique for reservoirs. External observation and the portable dynamic cone penetration tests [8] were performed. Fig.8 (a) and (b) shows the condition of the small farm pond at the time of the investigation. Water was stored up to half of full capacity. Impervious zone had been collapsed partly because it was formed into the shape of the vertical wall and was not protected from impounded water and rain by pervious zone (Fig.8 (b)).

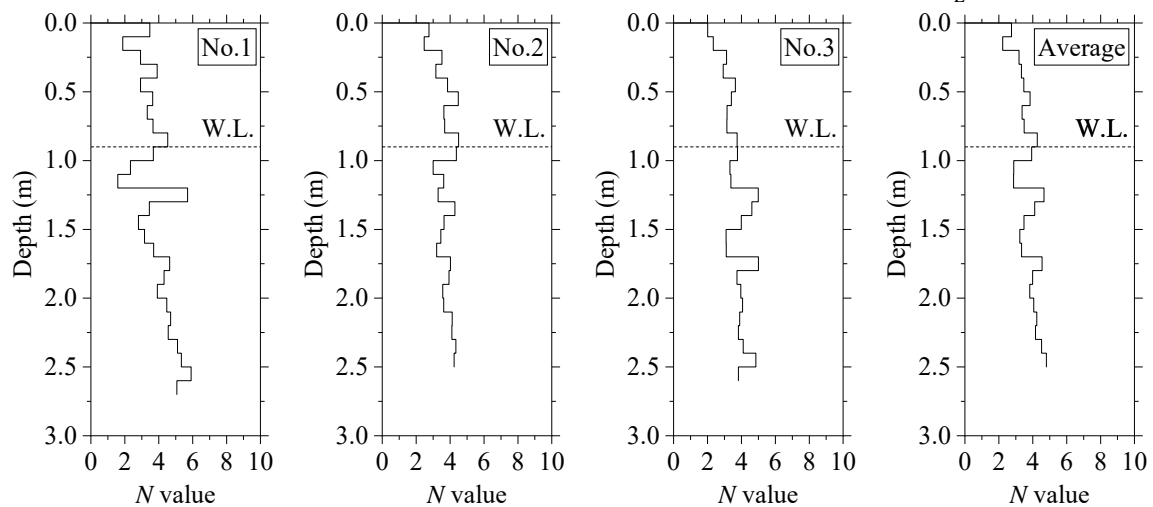
Fig. 10 Relationships between N value and depth

Relationships between N value and depth are shown in Fig.10. With an increase in depth, N values increase gradually. Variation of N values between each testing point was comparatively large for No.1, while it was not so large for No.2 and No.3. The difference in a variation of N value might have been resulted by the difference in compaction conditions because No.1 was on a corner of the impervious zone. In the corner of the impervious zone, around No.1, compaction energy might have been biased due to a restriction of working space. Almost N values are plotted in a range of 3 to 5. Based on the results of the portable dynamic cone penetration tests, it is supposed that the wall making method couldn't achieve sufficient compaction energy for compaction of bodies of the reservoir because observed N values were comparatively small compared with that obtained from embankments constructed by modern compaction techniques. Therefore, in the construction of bodies of the reservoir by utilizing Bhutanese traditional wall making method, improvement in compaction technique should be considered according to conditions of bodies of the reservoir to be constructed and its foundations.

$$\begin{aligned}
 &N_d > 4 \\
 &N = 0.7 + 0.34 N_d \text{ (Coarse-grained material)} \\
 &N = 1.1 + 0.30 N_d \text{ (Sand)} \\
 &N = 1.7 + 0.34 N_d \text{ (Cohesive soil)} \\
 &N_d \leq 4 \\
 &N = 0.50 N_d \text{ (Coarse-grained material)} \\
 &N = 0.66 N_d \text{ (Sand)}
 \end{aligned}
 \tag{1}$$

$$N = 0.75 N_d \text{ (Cohesive soil)}$$

where N_d is the number of blows required for the penetration of 100mm and N is N value obtained by SPT. In this investigation, the equations for cohesive soil were employed.
